# DAILY FIELD REPORT

| <b>Project</b> | Former A&A Brake Service Site | <b>Report No.</b> | 25 |
| <b>Location</b> | 558 Sackett Street | <b>File No.</b> | 0206384 |

## WEEKLY MONITORING REPORT

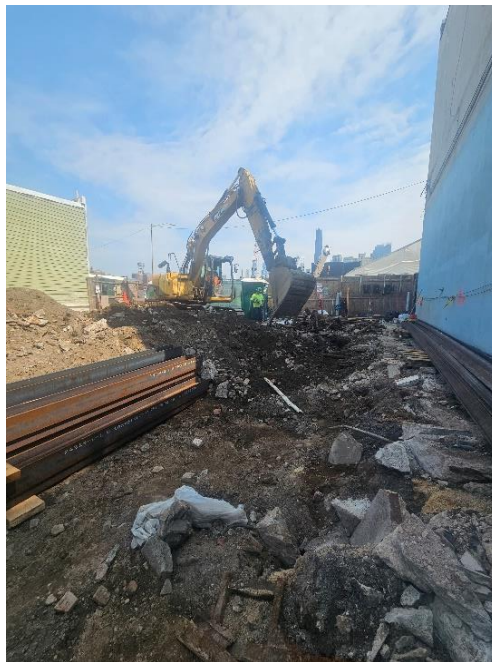
*Photo 2: View of contractor stockpiling soil for off-Site disposal, facing Northwest.*

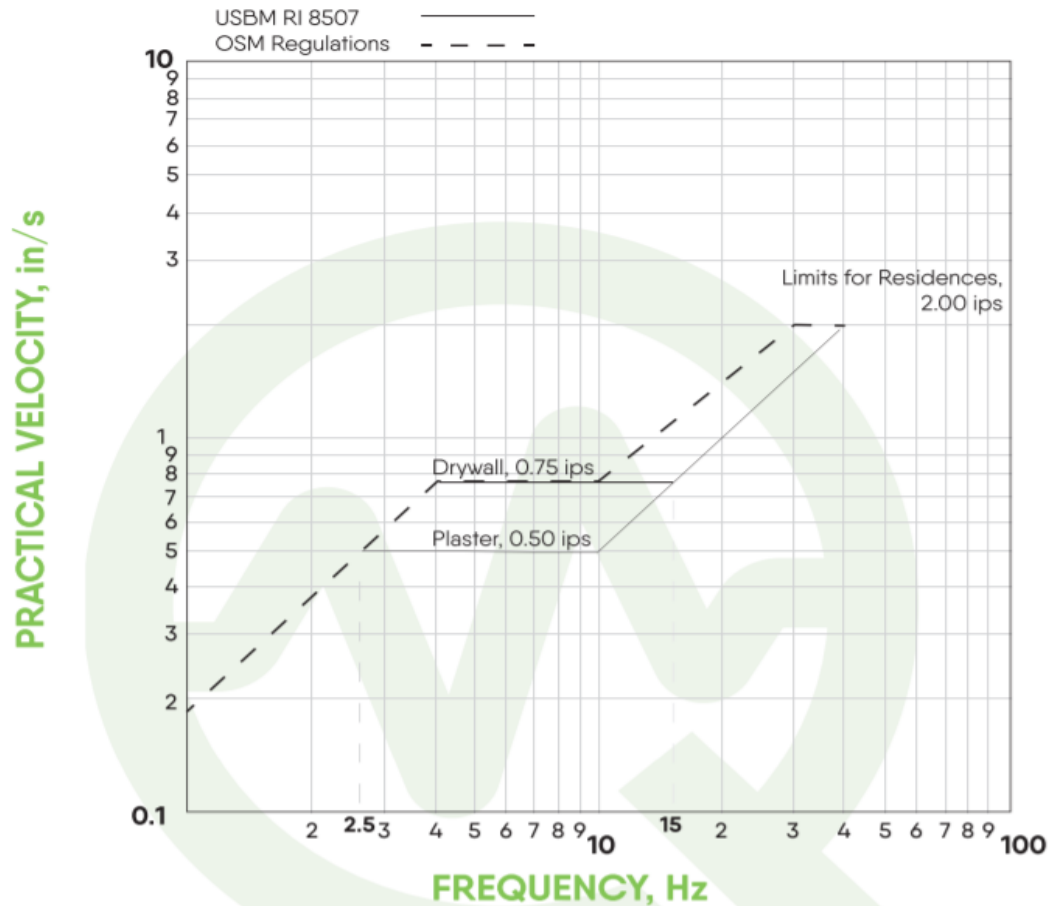
# USBM REPORT OF INVESTIGATION 8507 DIAGRAM

The USBM Report of Investigation 8507 graph is shown on the following page. Above 12 hertz, the allowable vibration intensity Increases to 2.0 inches per second as the frequency increases up to 40 hertz. Above 40 hertz, a constant 2.0 inches per second level is recommended to protect

the interior walls and ceiling of structures, regardless of construction material. With respect to vibration induced soil settlement, and underground structure and utility damage, other research has shown that vibration levels in excess of 5.0 inches per second are required for this to occur.
