# DAILY FIELD REPORT

<b>Project</b>	Former A&A Brake Service Site	<b>Report No.</b>	26
<b>BCP Site</b>	NYSDEC BCP SITE C224372	<b>Date</b>	7/30/2024
<b>Location</b>	558 Sackett Street	<b>File No.</b>	0206384
<b>Client</b>	Sackett Heights LLC	<b>Temperature</b>	H: 87 L: 74
<b>Contractor</b>	Blue Sky Builders, International Concrete	<b>Wind Direction</b>	S to N 14 mph
<b>Weather</b>	Clear	<b>Personnel on Site</b>	G. Poulton
<b>Humidity</b>	61%	<b>Time on Site</b>	6:30 am to 4:00 pm

H & A of New York Engineering and Geology, LLP (Haley & Aldrich) was present document implementation of the May 2024 NYSDEC-Approved Remedial Action Work Plan (RAWP) and Decision Document for the Former A&A Brake Service Site C224372, located at 558 Sackett Street, Brooklyn, NY. Site observations are summarized below.

## WEEKLY MONITORING REPORT

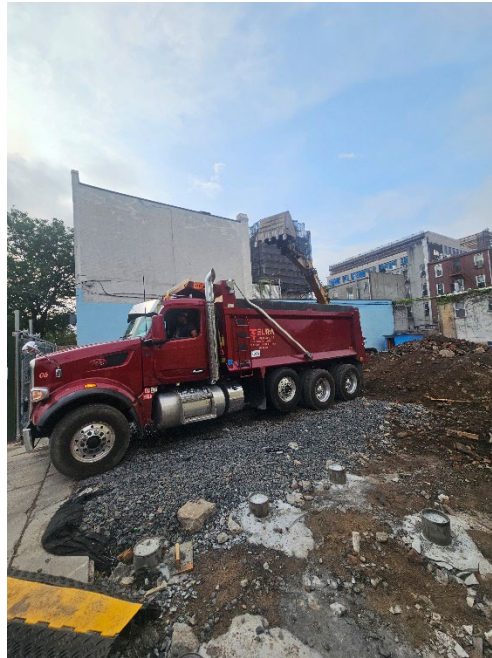
*Photo 1: View of contractor loading soil for off-Site disposal, facing Southeast.*

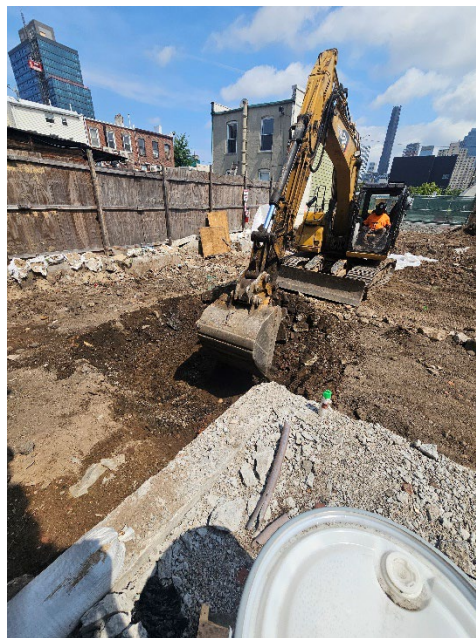
*Photo 2: View of contractor stockpiling soil for off-Site disposal, facing Northwest.*
