DAILY FIELD REPORT

Project	Former A&A Brake Service Site	Report No.	27
BCP Site	NYSDEC BCP SITE C224372	Date	7/31/2024
Location	558 Sackett Street	File No.	0206384
Client	Sackett Heights LLC	Temperature	H: 91°F L: 76°F
Contractor	Blue Sky Builders, International Concrete	Wind Direction	SW to NE, up to 17 mph
Weather	Clear, moderate rain	Personnel on Site	G. Poulton, C. Jackson
Humidity	55%	Time on Site	6:30 am to 4:00 pm

H & A of New York Engineering and Geology, LLP (Haley & Aldrich) was present document implementation of the May 2024 NYSDEC-Approved Remedial Action Work Plan (RAWP) and Decision Document for the Former A&A Brake Service Site C224372, located at 558 Sackett Street, Brooklyn, NY. Site observations are summarized below.

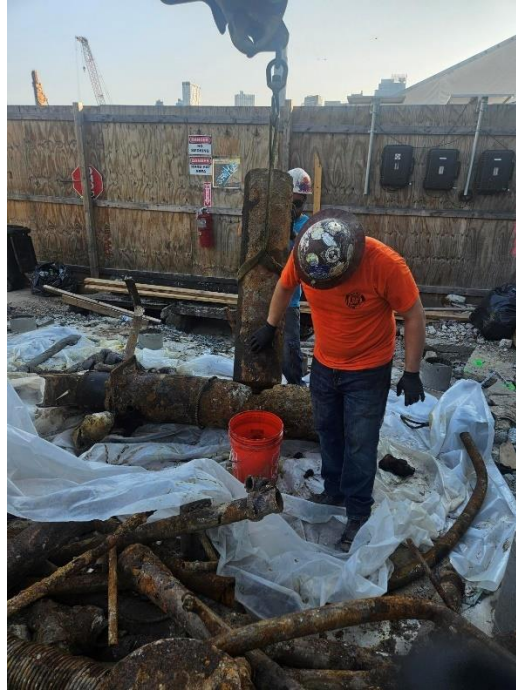
- A hydraulic lift was found on site, and we observed approximately 15 gallons of liquid residual. Since there were no leaks, we have transferred all the residuals into a drum.

Photo 1: View of hydraulic lift found on site, facing Northwest.

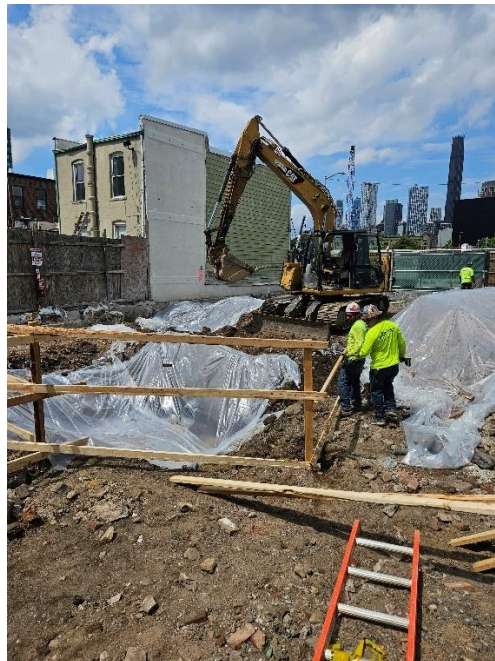
- Contractor stockpiled soil in the central region of the Site in preparation for off-Site transport and disposal.
- During the excavation of hotspot CS06, impacted soils were observed at approximately 9 feet below grade surface (ft bgs). The excavation was covered with excavated soil and polyethylene sheeting to mitigate odors. Due to groundwater encountered, excavation activities will continue once dewatering measures are implemented.

Photo 2: View of contractor excavating hotspot CS06, facing Northwest.
