Project	Former A&A Brake Service Site	Report No.	29
BCP Site	NYSDEC BCP SITE C224372	Date	8/2/2024
Location	558 Sackett Street	File No.	0206384
Client	Sackett Heights LLC	Temperature	H: 93°F L: 76°F
Contractor	Blue Sky Builders, International Concrete	Wind Direction	SE to NW, up to 18 mph
Weather	Clear	Personnel on Site	G. Poulton
Humidity	49%	Time on Site	6:30 am to 4:00 pm

H & A of New York Engineering and Geology, LLP (Haley & Aldrich) was present document implementation of the May 2024 NYSDEC-Approved Remedial Action Work Plan (RAWP) and Decision Document for the Former A&A Brake Service Site C224372, located at 558 Sackett Street, Brooklyn, NY. Site observations are summarized below.

WEEKLY MONITORING REPORT

Weekly Monitoring
8/1/2024 - 8/1/2024

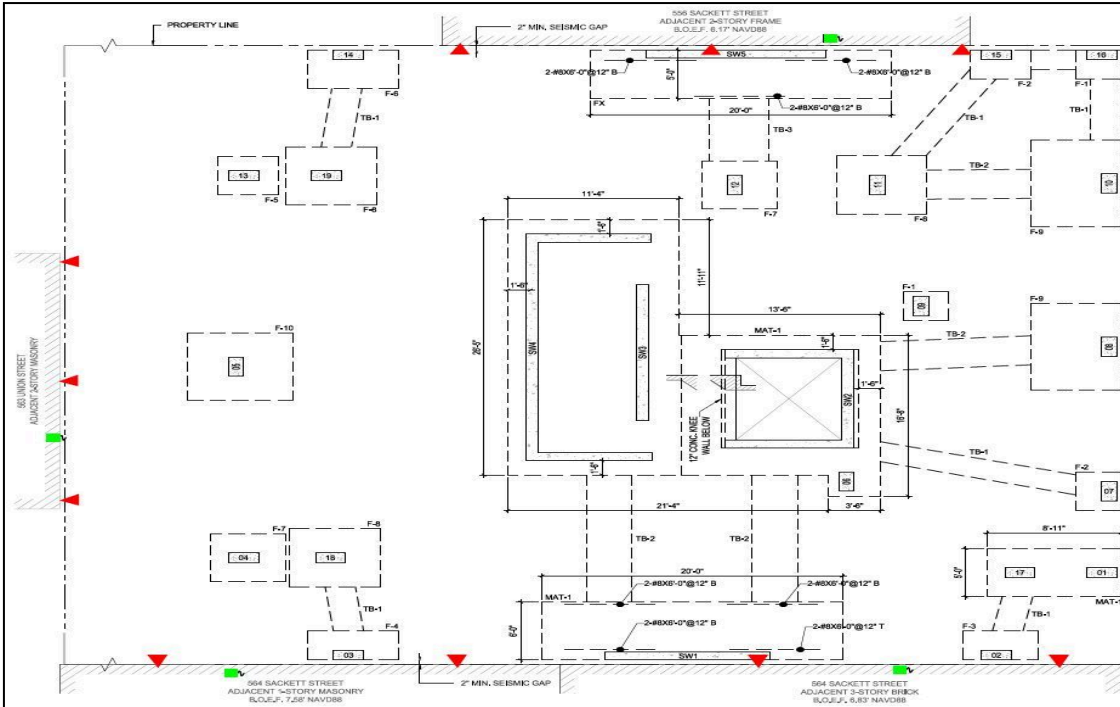
2 MONITORING PLAN

- SCALE: 1/4" = 1'-0"
- MONITORING PROTOCOL:**
- FOR ALL FOUNDATION AND FOOTING INFORMATION, SEE FC-101.
 - ALL MONITORING REPORT MUST BE SENT TO [MONITORING@ELEVATEDENGINEERINGNYC.COM](mailto:info@quivermonitoring.com)
 - REFER TO MONITORING NOTES ON FC-001 FOR DETAILS.
 - VIBRATION MONITORING SHALL BE PLACED BEFORE EXCAVATION AND PROVIDE REALTIME ALERT TO ENGINEER OF RECORD.
 - OPTICAL MONITORING SHALL BE PLACED PRIOR TO EXCAVATION AND READING IS REQUIRED ONCE A WEEK DURING EXCAVATION WORK
 - THE FOLLOWING ARE THE MONITORING LIMITS:

MONITORING LOCATION	THRESHOLD TYPE	
	REVIEW LEVEL	ACTION LEVEL
ADJACENT BUILDINGS	OPTICAL	
ADJACENT BUILDINGS	1/4 INCH	1/2 INCH
NYCT STRUCTURES	1/4 INCH	1/2 INCH
STREET AND SIDEWALK PAVEMENT	1/2 INCH	1 INCH
ADJACENT BUILDINGS	VIBRATION	
ADJACENT BUILDINGS	1.0 INCH/SECOND	2.0 INCH/SECOND
NYCT STRUCTURES	0.25 INCH/SECOND	0.5 INCH/SECOND
ADJACENT BUILDINGS	CRACK GAUGES	
ADJACENT BUILDINGS	3 MILLIMETERS	6 MILLIMETERS

NOTICE : this monitoring plan was drafted based on the SOE Plan of the subject property. This Monitoring Plans is intended for Monitoring Layout purpose only.

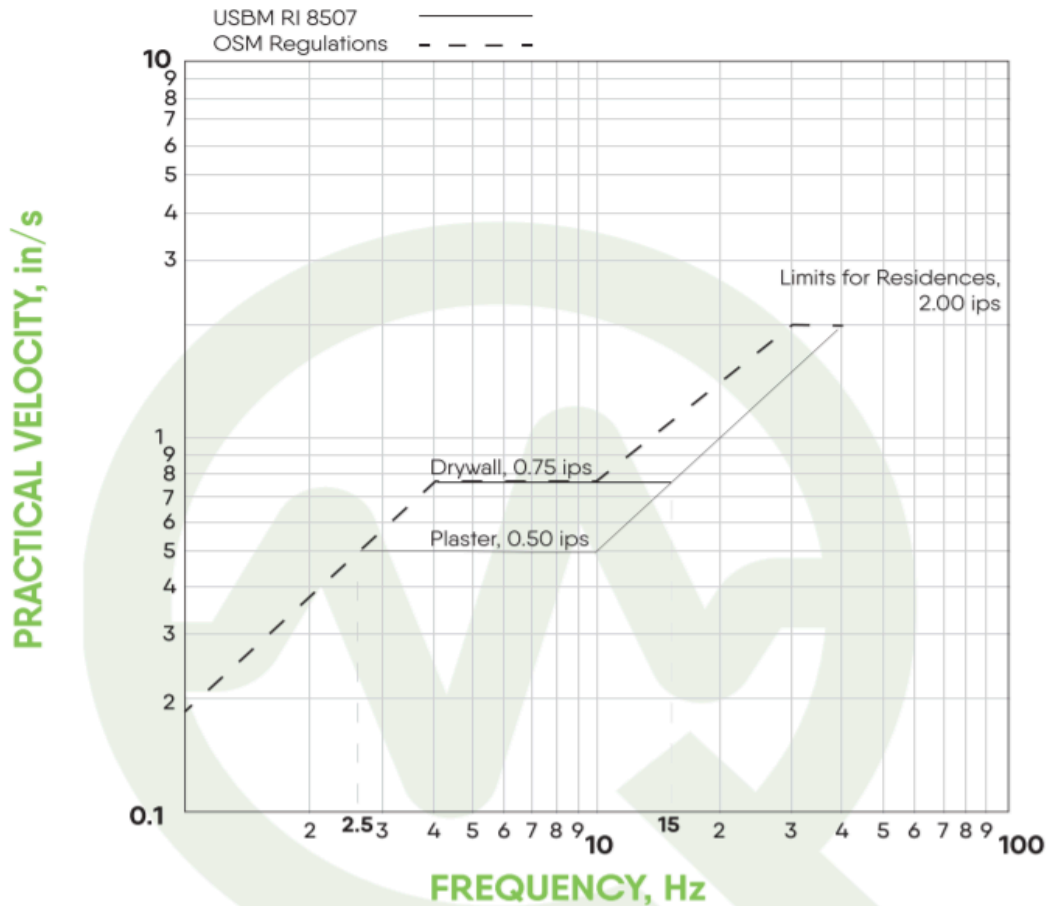
USBM REPORT OF INVESTIGATION 8507 DIAGRAM

Classification	Description of Damage
Threshold	Loosening of paint, small plaster cracks of joints between elements, lengthening of old cracks.
Minor	Loosening and falling of plaster, hairline cracks in masonry around openings near partitions, falling of loose mortar.
Major Weakening	Cracks of several millimeter sin walls, structural fall of masonry, e.g. chimneys, and load support ability.

The USBM Report of Investigation 8507 graph is shown on the following page. Above 12 hertz, the allowable vibration intensity increases to 2.0 inches per second as the frequency increases up to 40 hertz. Above 40 hertz, a constant 2.0 inches per second level is recommended to protect

the interior walls and ceiling of structures, regardless of construction material. With respect to vibration induced soil settlement, and underground structure and utility damage, other research has shown that vibration levels in excess of 5.0 inches per second are required for this to occur.

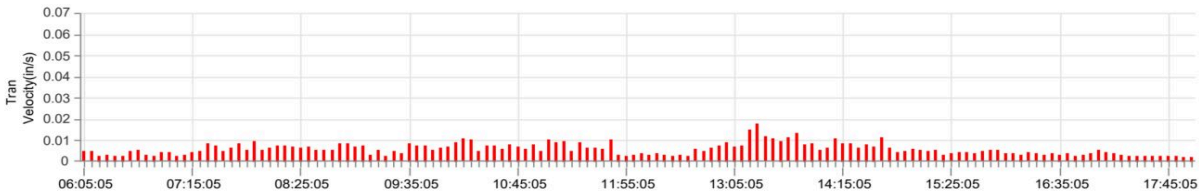
UM22524

Geophone	Tran	Vert	Long
Peak Particle Velocity	0.0180 in/s	0.0317 in/s	0.0590 in/s
Zero Crossing Frequency	6.2 Hz	8.7 Hz	10.2 Hz
Date	Aug 1, 2024	Aug 1, 2024	Aug 1, 2024
Time	13:20:05	13:20:05	13:20:05
Sensor Check	✓ Passed	✓ Passed	✓ Passed
Frequency	7.3 Hz	7.5 Hz	7.3 Hz
Overswing Ratio	4.6	4.4	4.2
Peak Vector Sum	0.0668 in/s at August 1, 2024 13:20:05

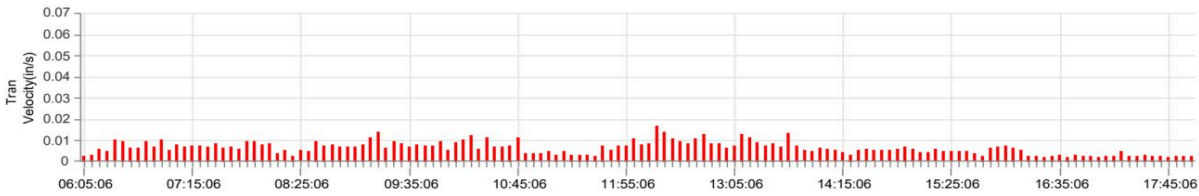
UM17486

Geophone	Tran	Vert	Long
Peak Particle Velocity	0.0164 in/s	0.0323 in/s	0.0618 in/s
Zero Crossing Frequency	4.8 Hz	7.8 Hz	>100 Hz
Date	Aug 1, 2024	Aug 1, 2024	Aug 1, 2024
Time	12:15:06	12:45:06	12:25:06
Sensor Check	✓ Passed	✓ Passed	✓ Passed
Frequency	7.3 Hz	7.7 Hz	7.3 Hz
Overswing Ratio	4.0	3.7	4.2

Peak Vector Sum 0.0621 in/s at August 1, 2024 12:25:06
