# DAILY FIELD REPORT

<b>Project</b>	Former A&A Brake Service Site	<b>Report No.</b>	30
<b>BCP Site</b>	NYSDEC BCP SITE C224372	<b>Date</b>	8/5/2024
<b>Location</b>	558 Sackett Street	<b>File No.</b>	0206384
<b>Client</b>	Sackett Heights LLC	<b>Temperature</b>	H: 89°F L: 75°F
<b>Contractor</b>	Blue Sky Builders, International Concrete	<b>Wind Direction</b>	S to N, up to 10 mph
<b>Weather</b>	Clear	<b>Personnel on Site</b>	G. Poulton
<b>Humidity</b>	43%	<b>Time on Site</b>	6:30 am to 4:00 pm

H & A of New York Engineering and Geology, LLP (Haley & Aldrich) was present document implementation of the May 2024 NYSDEC-Approved Remedial Action Work Plan (RAWP) and Decision Document for the Former A&A Brake Service Site C224372, located at 558 Sackett Street, Brooklyn, NY. Site observations are summarized below.

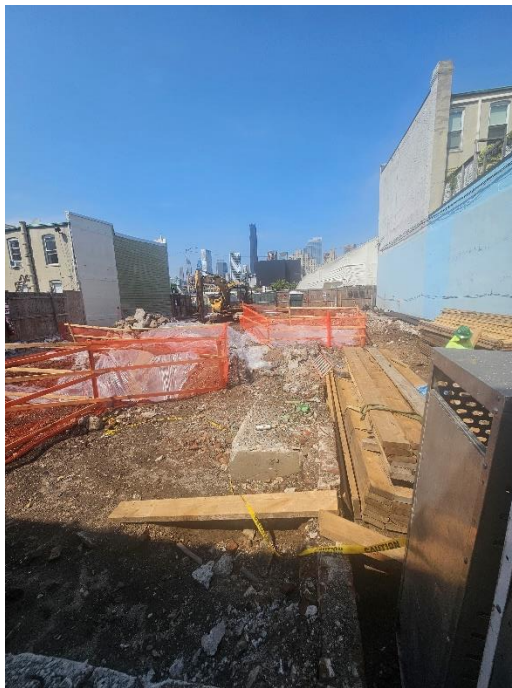
*Photo 2: View of Site conditions at shift end, facing North.*
