# DAILY FIELD REPORT

<b>Project</b>	Former A&A Brake Service Site	<b>Report No.</b>	32
<b>BCP Site</b>	NYSDEC BCP SITE C224372	<b>Date</b>	9/4/2024
<b>Location</b>	558 Sackett Street	<b>File No.</b>	0206384
<b>Client</b>	Sackett Heights LLC	<b>Temperature</b>	H: 77°F L: 59°F
<b>Contractor</b>	Oriel Plumbing and Sewer Corp.	<b>Wind Direction</b>	SE to NW, up to 12 mph
<b>Weather</b>	Sunny	<b>Personnel on Site</b>	C. Lorthioir
<b>Humidity</b>	41%	<b>Time on Site</b>	6:45 am to 6:30 pm

H & A of New York Engineering and Geology, LLP (Haley & Aldrich) was present document implementation of the May 2024 NYSDEC-Approved Remedial Action Work Plan (RAWP) and Decision Document for the Former A&A Brake Service Site C224372, located at 558 Sackett Street, Brooklyn, NY. Site observations are summarized below.

## WEEKLY MONITORING REPORT

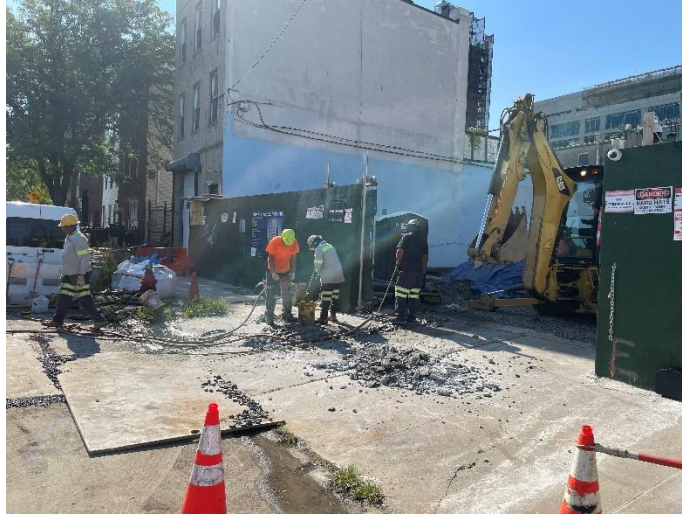
- Contractor (Oriel) conducted utility work related to the sewer connection for dewatering activities.
- Charlie Lambert and Chris DiScafani from WSP arrived on-Site to document field activities on behalf of the NYSDEC. No complaints were noted.
- NYS DOT arrived on site to oversee compaction tests of backfilled material.

*Photo 1: View of utility work, facing southeast.*

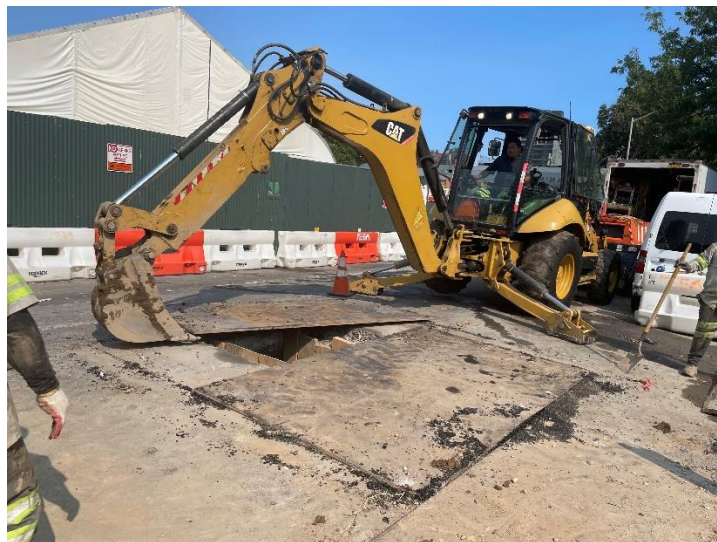
*Photo 2: View of utility work, facing South.*

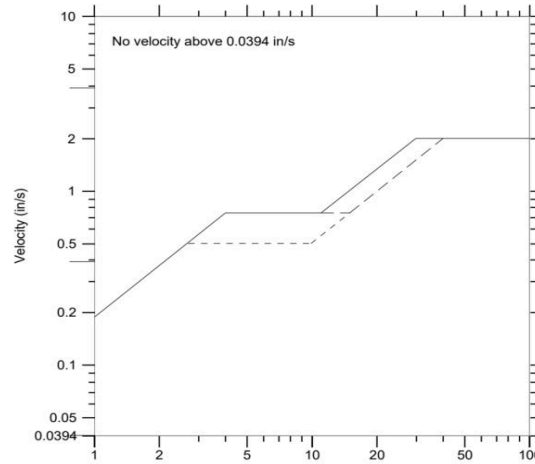
USBM R18507 And OSMRE  
Velocity versus Frequency (Zero Crossing)

0.0286 in/s at September 4, 2024 18:50:31

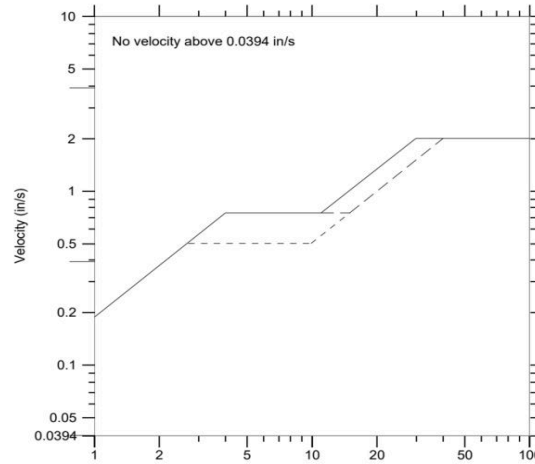
**USBM R18507 And OSMRE**  
Velocity versus Frequency (Zero Crossing)

Peak Vector Sum 0.0081 in/s at September 4, 2024 19:00:27
