# DAILY FIELD REPORT

<b>Project</b>	Former A&A Brake Service Site	<b>Report No.</b>	33
<b>BCP Site</b>	NYSDEC BCP SITE C224372	<b>Date</b>	9/5/2024
<b>Location</b>	558 Sackett Street	<b>File No.</b>	0206384
<b>Client</b>	Sackett Heights LLC	<b>Temperature</b>	H: 75°F L: 63°F
<b>Contractor</b>	Oriel Plumbing and Sewer Corp.	<b>Wind Direction</b>	NE to SW, up to 17 mph
<b>Weather</b>	Clear	<b>Personnel on Site</b>	G. Poulton
<b>Humidity</b>	59%	<b>Time on Site</b>	6:30 am to 4:30 pm

## WEEKLY MONITORING REPORT

**Project Address:**  
558 Sackett Street,  
Brooklyn,  
Brooklyn NY 11215  
BBL:/443/55

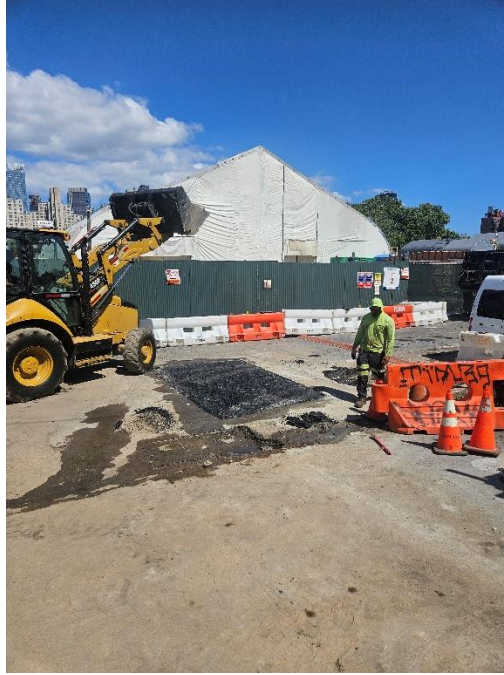
*Photo 1: View of restoration work, facing north*
