DAILY FIELD REPORT

Project	Former A&A Brake Service Site	Report No.	37
BCP Site	NYSDEC BCP SITE C224372	Date	9/18/2024
Location	558 Sackett Street	File No.	0206384
Client	Sackett Heights LLC	Temperature	H: 74°F L: 67°F
Contractor	Blue Sky Builders, International Concrete	Wind Direction	NE to SW, up to 15 mph
Weather	Overcast	Personnel on Site	G. Poulton
Humidity	78%	Time on Site	6:30 am to 4:00 pm

WEEKLY MONITORING REPORT

Weekly Monitoring
9/18/2024 - 9/18/2024

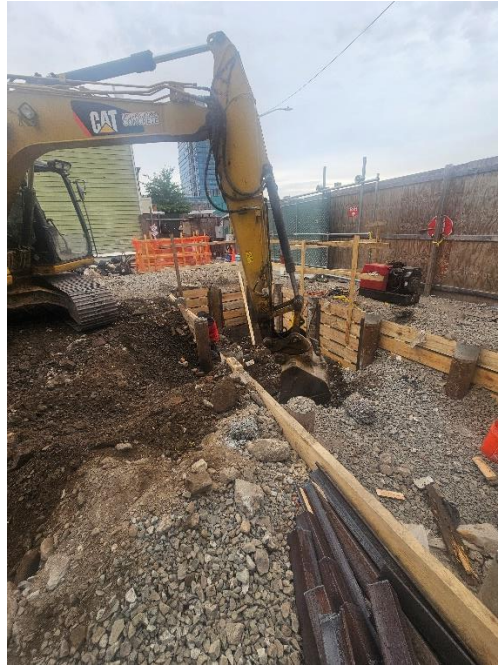
Photo 1: View of contractor excavating soil in the northeastern area of the Site, facing Northwest.

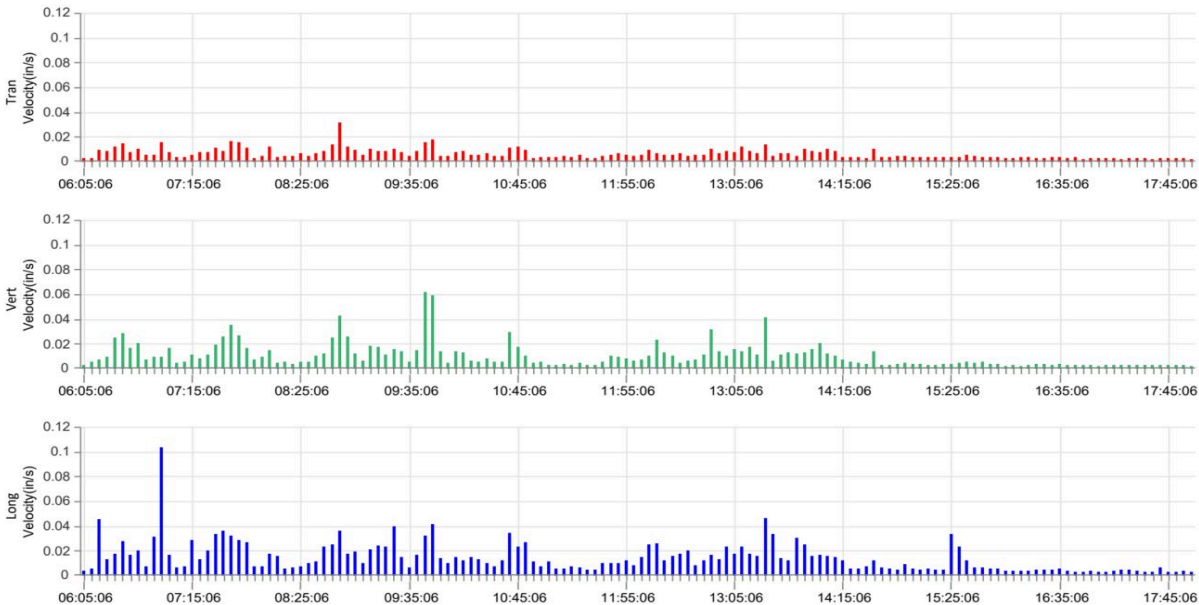
USBM R18507 And OSMRE
Velocity versus Frequency (Zero Crossing)

Peak Vector Sum 0.1046 in/s at September 18, 2024 06:55:06

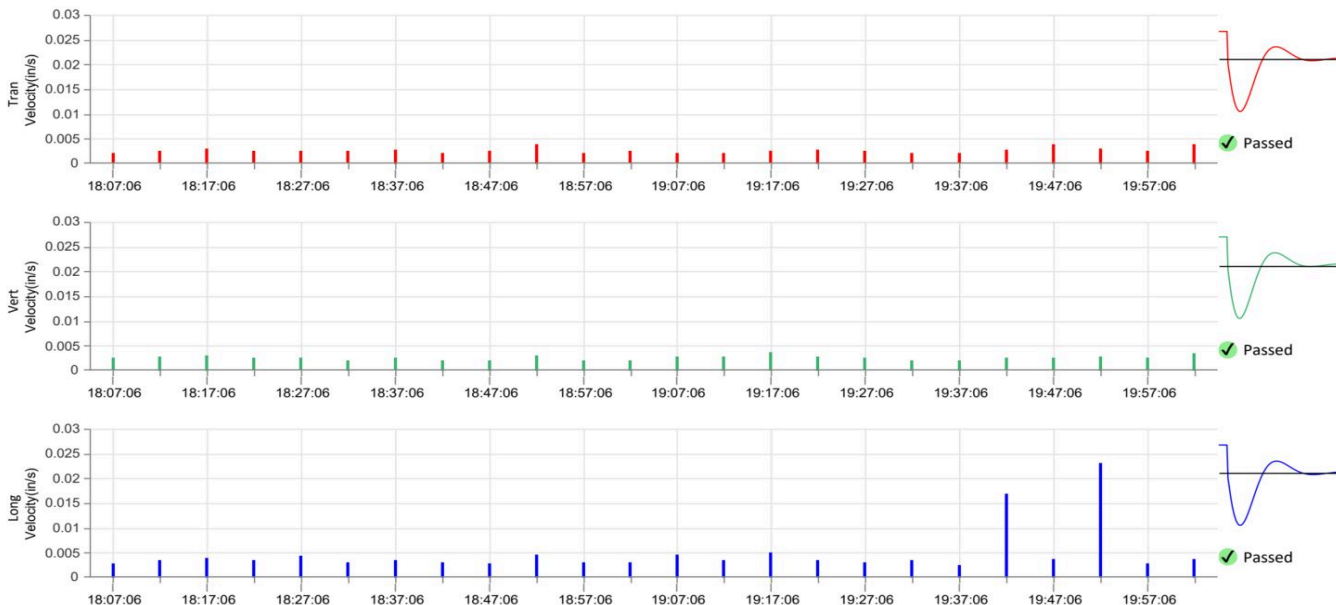
USBM R18507 And OSMRE
Velocity versus Frequency (Zero Crossing)

0.0230 in/s at September 18, 2024 19:52:06
