Project	Former A&A Brake Service Site	Report No.	38
BCP Site	NYSDEC BCP SITE C224372	Date	9/19/2024
Location	558 Sackett Street	File No.	0206384
Client	Sackett Heights LLC	Temperature	H: 84°F L: 68°F
Contractor	Blue Sky Builders, International Concrete	Wind Direction	NE to SW, up to 12 mph
Weather	Clear	Personnel on Site	G. Poulton
Humidity	38%	Time on Site	6:30 am to 4:00 pm

H & A of New York Engineering and Geology, LLP (Haley & Aldrich) was present document implementation of the May 2024 NYSDEC-Approved Remedial Action Work Plan (RAWP) and Decision Document for the Former A&A Brake Service Site C224372, located at 558 Sackett Street, Brooklyn, NY. Site observations are summarized below.

WEEKLY MONITORING REPORT

Project Address:
558 Sackett Street,
Brooklyn,
Brooklyn NY 11215
BBL:/443/55

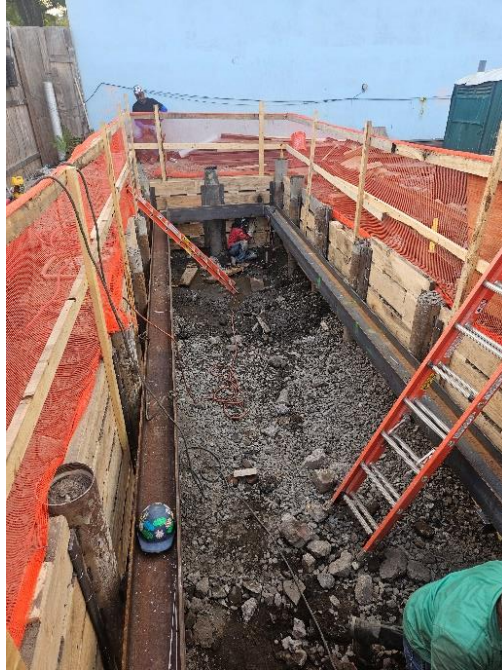
Photo 1: View of contractor welding I beams in the northeastern area of the Site, facing East.

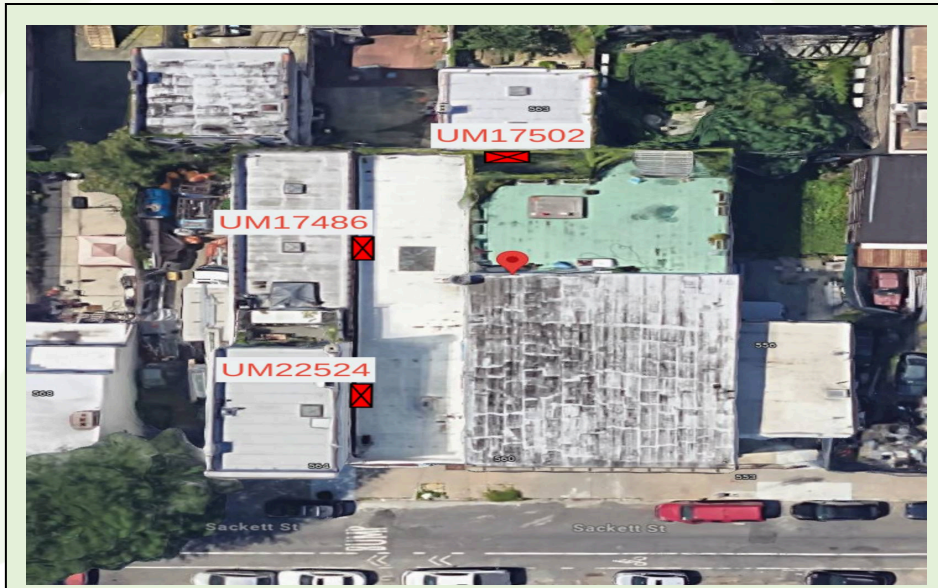
Quiver Monitoring recommends the following vibration monitoring layout.

1. **UM17486:** Is installed at the 564 Sackett Street Exterior, front.
2. **UM17502:** Is installed at the 563 Union Street Exterior.
3. **UM22524:** Is installed at the 564 Sackett Street Exterior, rear.

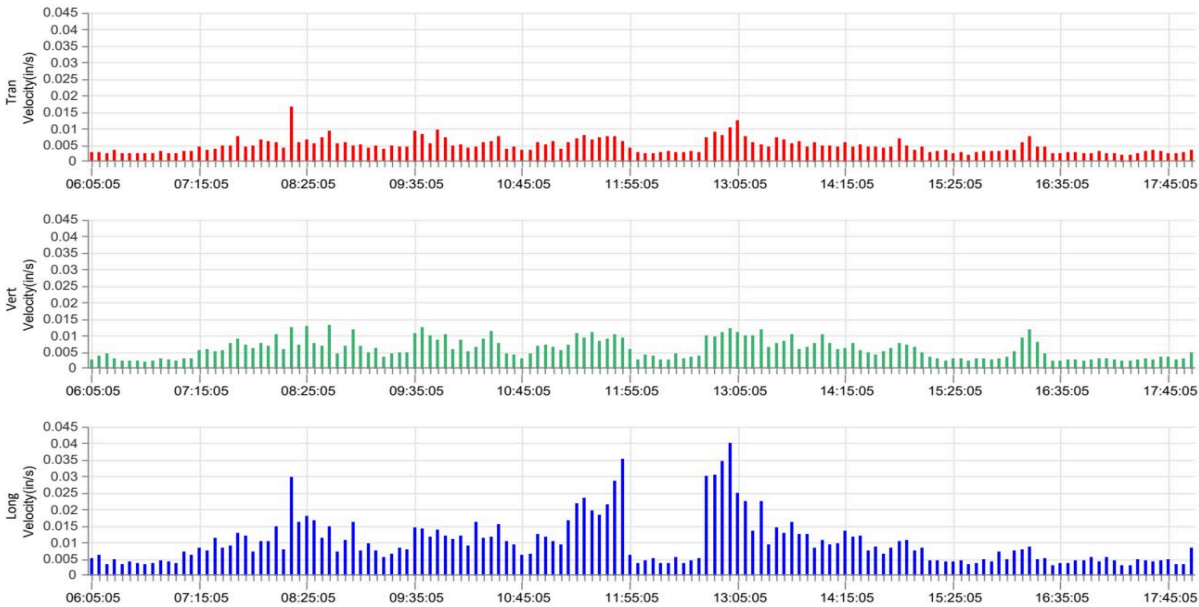
USBM R18507 And OSMRE
Velocity versus Frequency (Zero Crossing)

Geophone	Tran	Vert	Long
Peak Particle Velocity	0.0164 in/s	0.0130 in/s	0.0400 in/s
Zero Crossing Frequency	5.6 Hz	8.5 Hz	10.0 Hz
Date	Sep 19, 2024	Sep 19, 2024	Sep 19, 2024
Time	08:15:05	08:40:05	13:00:05
Sensor Check	✓ Passed	✓ Passed	✓ Passed
Frequency	7.3 Hz	7.5 Hz	7.3 Hz
Overswing Ratio	4.6	4.5	4.2
Peak Vector Sum	0.0404 in/s at September 19, 2024 13:00:05

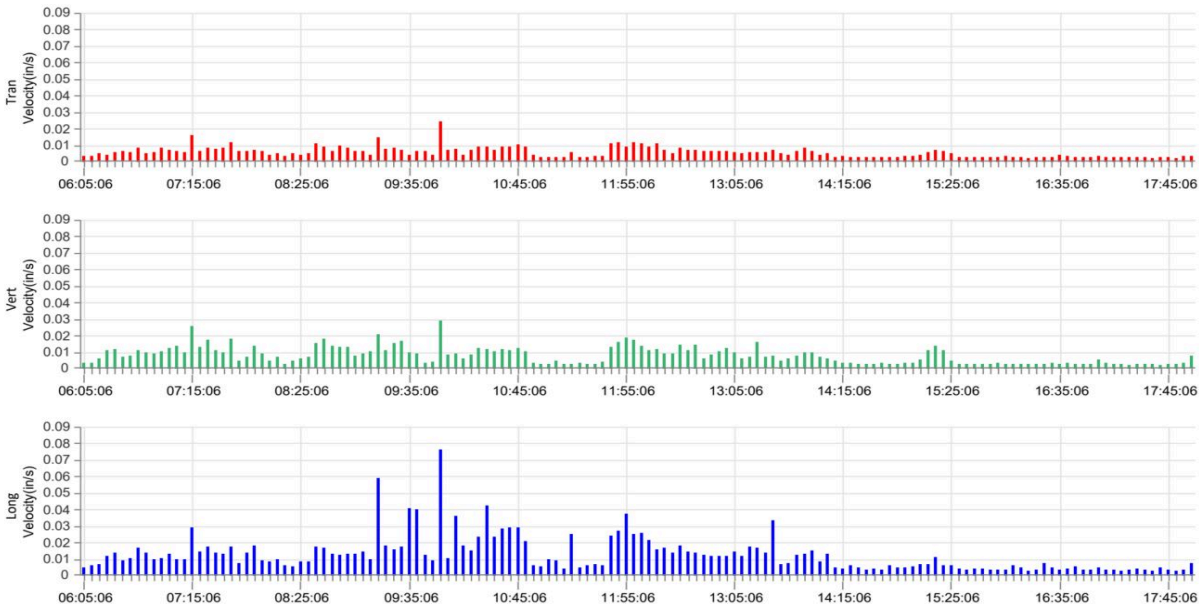
USBM R18507 And OSMRE
Velocity versus Frequency (Zero Crossing)

Peak Vector Sum 0.0801 in/s at September 19, 2024 09:55:06
