<b>Project</b>	Former A&A Brake Service Site	<b>Report No.</b>	39
<b>BCP Site</b>	NYSDEC BCP SITE C224372	<b>Date</b>	9/20/2024
<b>Location</b>	558 Sackett Street	<b>File No.</b>	0206384
<b>Client</b>	Sackett Heights LLC	<b>Temperature</b>	H: 80°F L: 68°F
<b>Contractor</b>	Blue Sky Builders, International Concrete	<b>Wind Direction</b>	NE to SW, up to 14 mph
<b>Weather</b>	Clear	<b>Personnel on Site</b>	G. Poulton
<b>Humidity</b>	50%	<b>Time on Site</b>	6:30 am to 3:30 pm

H & A of New York Engineering and Geology, LLP (Haley & Aldrich) was present document implementation of the May 2024 NYSDEC-Approved Remedial Action Work Plan (RAWP) and Decision Document for the Former A&A Brake Service Site C224372, located at 558 Sackett Street, Brooklyn, NY. Site observations are summarized below.

## WEEKLY MONITORING REPORT

**Weekly Monitoring**  
9/20/2024 - 9/22/2024

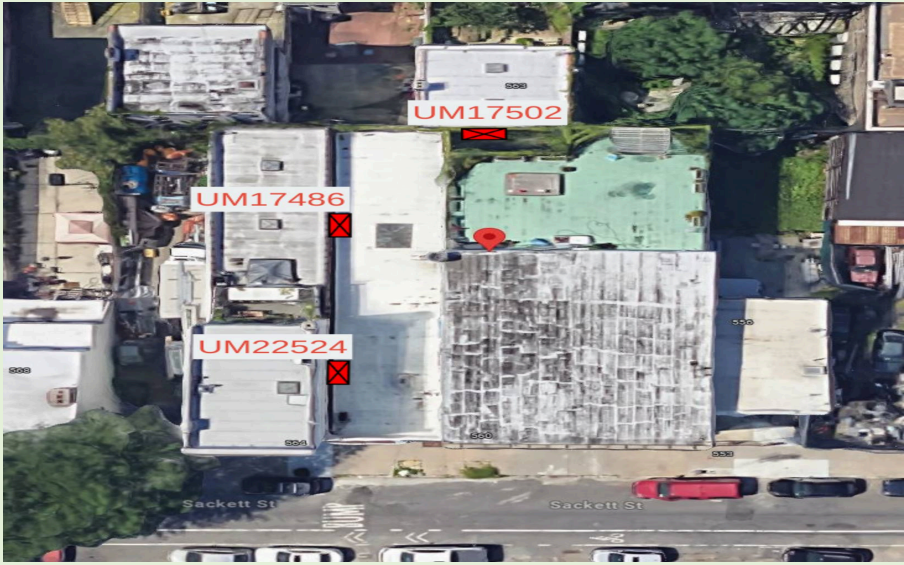
<p><b>QUIVER</b> MONITORING</p>	<p>Vibration Monitoring Layout 558 Sackett Street, Brooklyn Brooklyn NY 11215</p>	<p>Date of Installation MM/DD/YY 06/24/24</p>
---	---	---

Quiver Monitoring recommends the following vibration monitoring layout.

1. **UM17486:** Is installed at the 564 Sackett Street Exterior, front.
2. **UM17502:** Is installed at the 563 Union Street Exterior.
3. **UM22524:** Is installed at the 564 Sackett Street Exterior, rear.

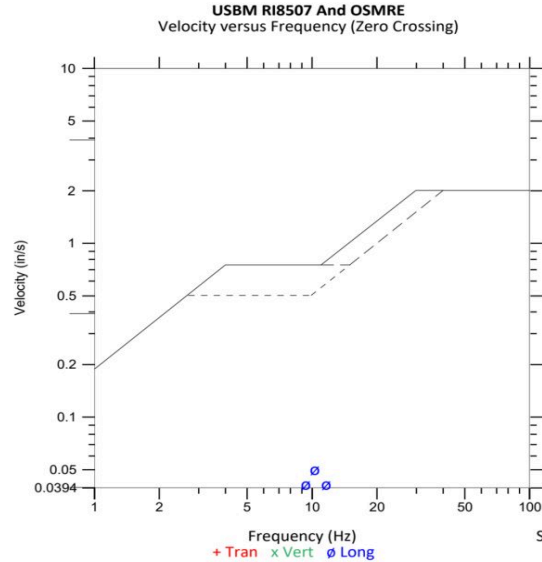
Geophone	Tran	Vert	Long
Peak Particle Velocity	0.0155 in/s	0.0341 in/s	0.0500 in/s
Zero Crossing Frequency	6.8 Hz	10.9 Hz	10.2 Hz
Date	Sep 20, 2024	Sep 20, 2024	Sep 20, 2024
Time	10:45:05	08:25:05	08:25:05
Sensor Check	✓ Passed	✓ Passed	✓ Passed
Frequency	7.3 Hz	7.5 Hz	7.3 Hz
Overswing Ratio	4.6	4.5	4.2
Peak Vector Sum	0.0557 in/s at September 20, 2024 08:25:05

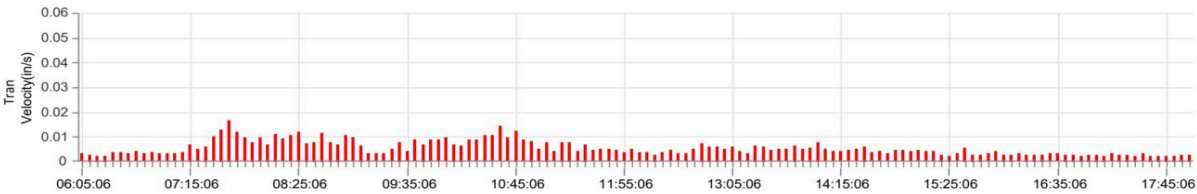
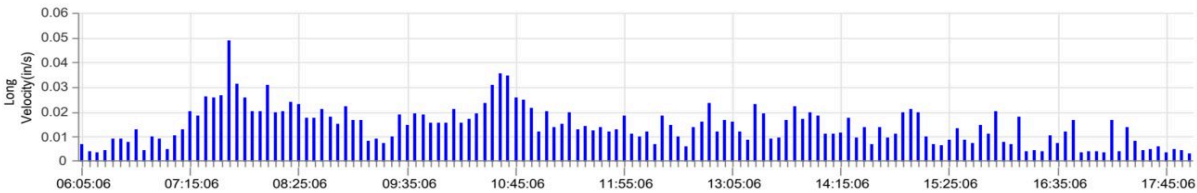
**USBM R18507 And OSMRE**  
Velocity versus Frequency (Zero Crossing)

**Peak Vector Sum** 0.0493 in/s at September 20, 2024 07:40:06

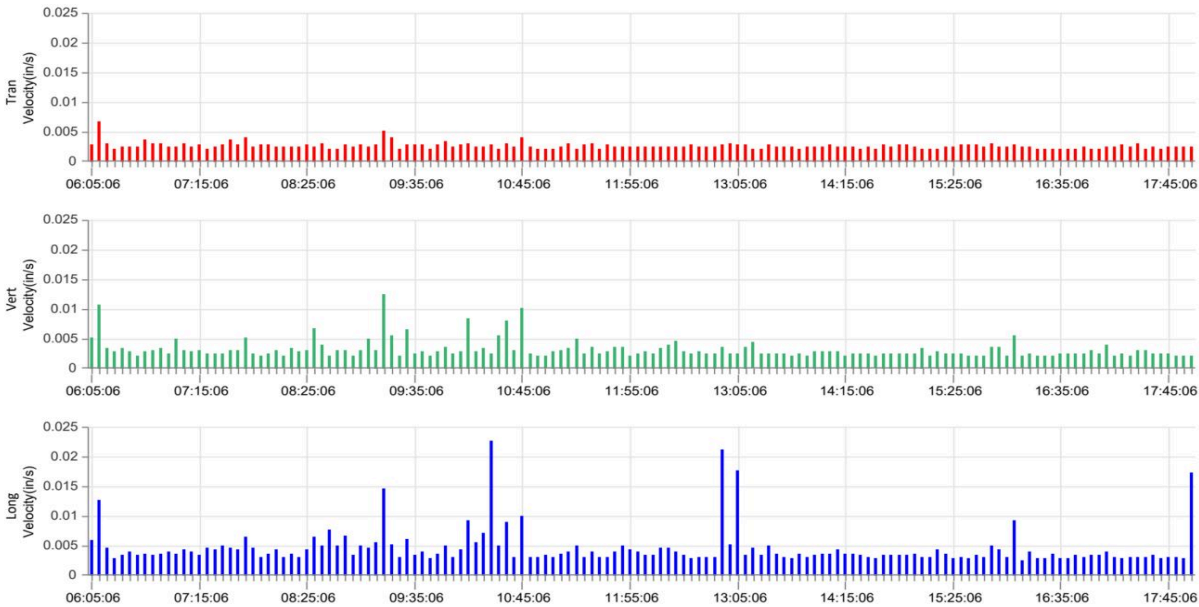
Geophone	Tran	Vert	Long
Peak Particle Velocity	0.0068 in/s	0.0124 in/s	0.0227 in/s
Zero Crossing Frequency	6.0 Hz	12.5 Hz	13.1 Hz
Date	Sep 21, 2024	Sep 21, 2024	Sep 21, 2024
Time	06:10:06	09:15:06	10:25:06
Sensor Check	✓ Passed	✓ Passed	✓ Passed
Frequency	7.5 Hz	7.7 Hz	7.3 Hz
Overswing Ratio	4.1	3.8	4.3
Peak Vector Sum	0.0228 in/s at September 21, 2024 10:25:06
