DAILY FIELD REPORT

Project	Former A&A Brake Service Site	Report No.	41
BCP Site	NYSDEC BCP SITE C224372	Date	9/24/2024
Location	558 Sackett Street	File No.	0206384
Client	Sackett Heights LLC	Temperature	H: 67°F L: 60°F
Contractor	Blue Sky Builders, International Concrete	Wind Direction	NE to SW, up to 8 mph
Weather	Overcast	Personnel on Site	G. Poulton
Humidity	66%	Time on Site	6:30 am to 4:00 pm

H & A of New York Engineering and Geology, LLP (Haley & Aldrich) was present document implementation of the May 2024 NYSDEC-Approved Remedial Action Work Plan (RAWP) and Decision Document for the Former A&A Brake Service Site C224372, located at 558 Sackett Street, Brooklyn, NY. Site observations are summarized below.

WEEKLY MONITORING REPORT

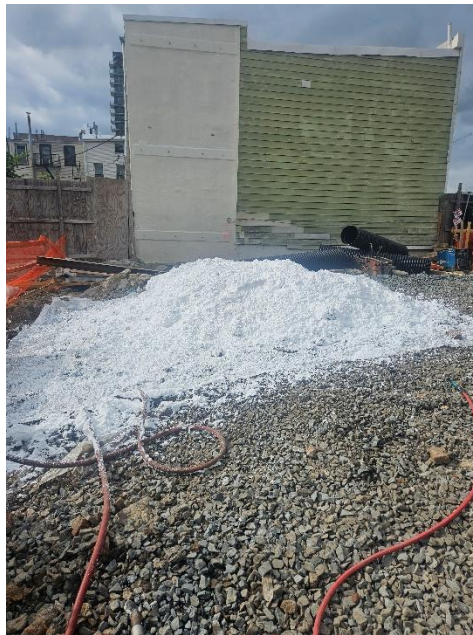
Photo 2: View of soil stockpile covered with odor control foam, facing West.
