DAILY FIELD REPORT

Project	Former A&A Brake Service Site	Report No.	43
BCP Site	NYSDEC BCP SITE C224372	Date	9/26/2024
Location	558 Sackett Street	File No.	0206384
Client	Sackett Heights LLC	Temperature	H: 75°F L: 64°F
Contractor	Blue Sky Builders, International Concrete	Wind Direction	SE to NW, up to 13 mph
Weather	Overcast	Personnel on Site	G. Poulton
Humidity	68%	Time on Site	6:30 am to 4:00 pm

H & A of New York Engineering and Geology, LLP (Haley & Aldrich) was present document implementation of the May 2024 NYSDEC-Approved Remedial Action Work Plan (RAWP) and Decision Document for the Former A&A Brake Service Site C224372, located at 558 Sackett Street, Brooklyn, NY. Site observations are summarized below.

WEEKLY MONITORING REPORT

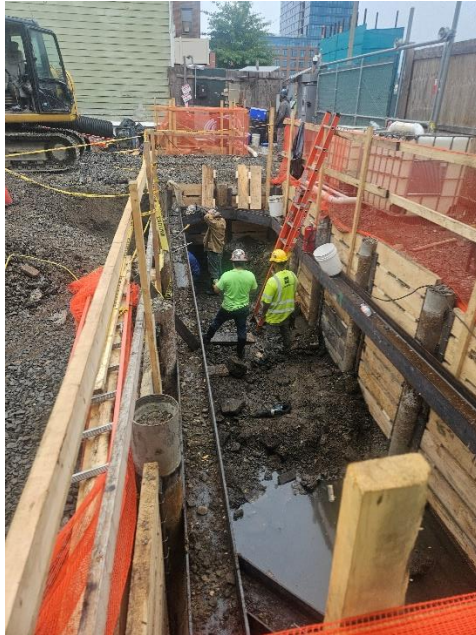
Photo 1: View of contractor welding I-beams to pilings, facing West.

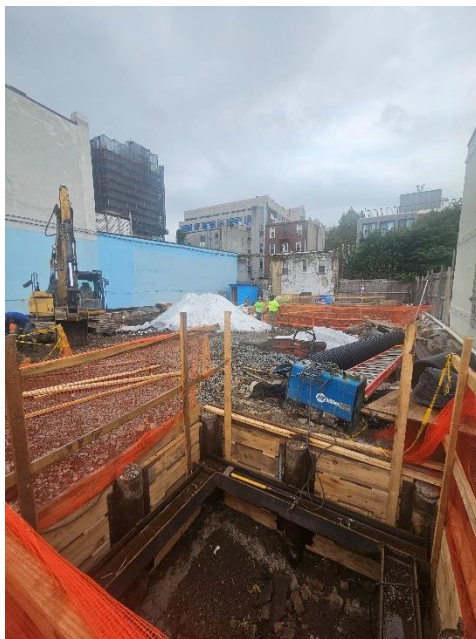
Photo 2: View of Site conditions at shift end, facing South.
