DAILY FIELD REPORT

Project	Former A&A Brake Service Site	Report No.	44
BCP Site	NYSDEC BCP SITE C224372	Date	9/27/2024
Location	558 Sackett Street	File No.	0206384
Client	Sackett Heights LLC	Temperature	H: 73°F L: 60°F
Contractor	Blue Sky Builders, International Concrete	Wind Direction	NE to SW, up to 20 mph
Weather	Overcast	Personnel on Site	G. Poulton
Humidity	52%	Time on Site	6:30 am to 3:45 pm

H & A of New York Engineering and Geology, LLP (Haley & Aldrich) was present document implementation of the May 2024 NYSDEC-Approved Remedial Action Work Plan (RAWP) and Decision Document for the Former A&A Brake Service Site C224372, located at 558 Sackett Street, Brooklyn, NY. Site observations are summarized below.

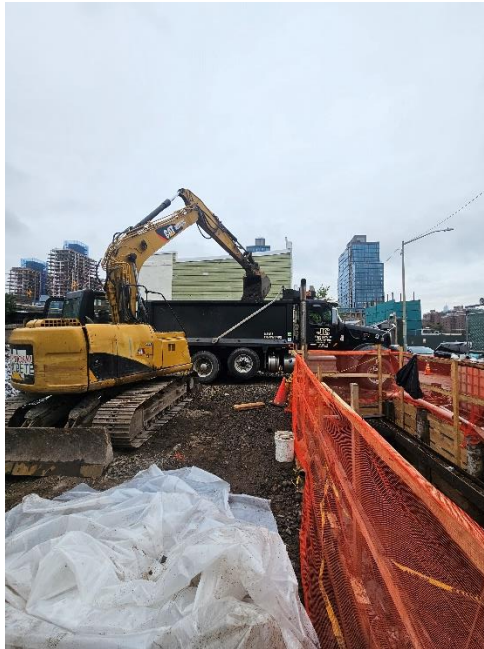
Photo 1: View of contractor loading soil for off-Site disposal, facing West.
