DAILY FIELD REPORT

Project	Former A&A Brake Service Site	Report No.	47
BCP Site	NYSDEC BCP SITE C224372	Date	10/7/2024
Location	558 Sackett Street	File No.	0206384
Client	Sackett Heights LLC	Temperature	H: 76°F L: 53°F
Contractor	Blue Sky Builders, International Concrete	Wind Direction	NW to SE, up to 9 mph
Weather	Overcast	Personnel on Site	G. Poulton
Humidity	54%	Time on Site	6:30 am to 4:00 pm

H & A of New York Engineering and Geology, LLP (Haley & Aldrich) was present document implementation of the May 2024 NYSDEC-Approved Remedial Action Work Plan (RAWP) and Decision Document for the Former A&A Brake Service Site C224372, located at 558 Sackett Street, Brooklyn, NY. Site observations are summarized below.

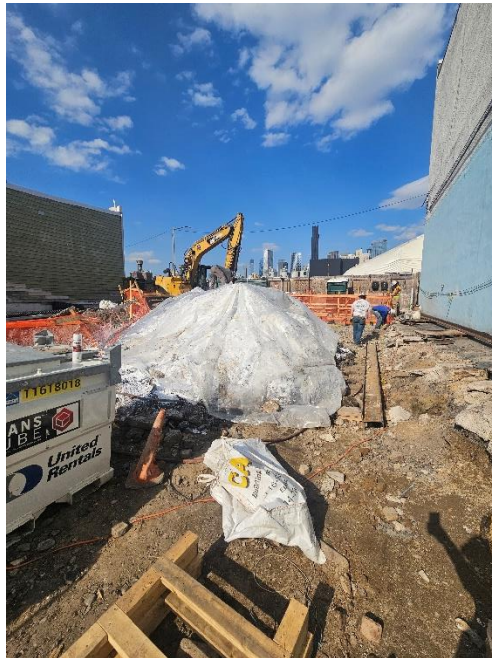
Photo 2: View of contractor covering stockpile with odor control foam and poly sheeting, facing North.
