DAILY FIELD REPORT

Project	Former A&A Brake Service Site	Report No.	49
BCP Site	NYSDEC BCP SITE C224372	Date	10/9/2024
Location	558 Sackett Street	File No.	0206384
Client	Sackett Heights LLC	Temperature	H: 68°F L: 57°F
Contractor	Blue Sky Builders, International Concrete, Nico Equipment	Wind Direction	W to E, up to 18 mph
Weather	Clear	Personnel on Site	G. Poulton
Humidity	39%	Time on Site	6:30 am to 4:00 pm

H & A of New York Engineering and Geology, LLP (Haley & Aldrich) was present document implementation of the May 2024 NYSDEC-Approved Remedial Action Work Plan (RAWP) and Decision Document for the Former A&A Brake Service Site C224372, located at 558 Sackett Street, Brooklyn, NY. Site observations are summarized below.

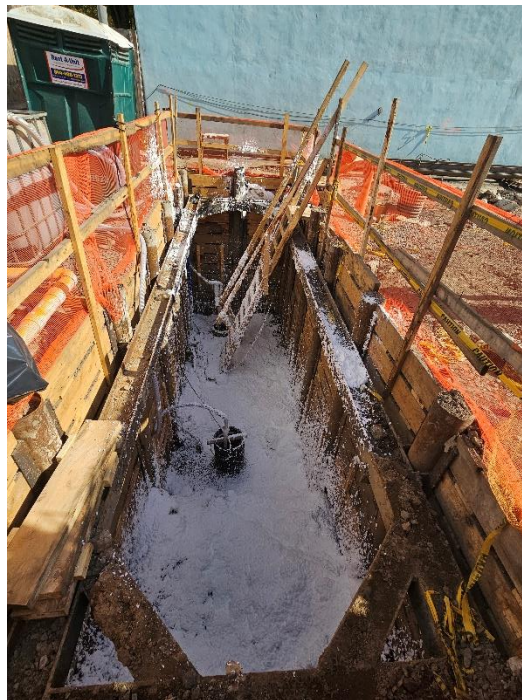
- Monica Pula from WSP, arrived on-Site to document field activities on behalf of the NYSDEC.
- Product/sheen was observed in the CS-02 hot spot excavation area when we excavated down to 14 bgs. It appears that the product originates from the 8 feet bgs level. We are currently applying sorbent socks and odor suppressant foam during intrusive work.

Photo 2: View of piling excavation covered with odor suppressant foam, facing East.
