DAILY FIELD REPORT

Project	Former A&A Brake Service Site	Report No.	50
BCP Site	NYSDEC BCP SITE C224372	Date	10/10/2024
Location	558 Sackett Street	File No.	0206384
Client	Sackett Heights LLC	Temperature	H: 68°F L: 57°F
Contractor	Blue Sky Builders, International Concrete	Wind Direction	W to E, up to 18 mph
Weather	Clear	Personnel on Site	G. Poulton
Humidity	39%	Time on Site	6:30 am to 5:00 pm

H & A of New York Engineering and Geology, LLP (Haley & Aldrich) was present document implementation of the May 2024 NYSDEC-Approved Remedial Action Work Plan (RAWP) and Decision Document for the Former A&A Brake Service Site C224372, located at 558 Sackett Street, Brooklyn, NY. Site observations are summarized below.

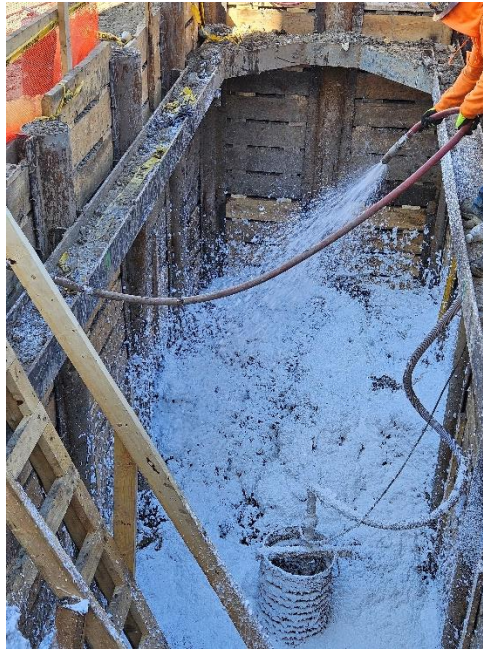
Photo 1: View of concurrent odor suppressant foam application during excavation, facing West.

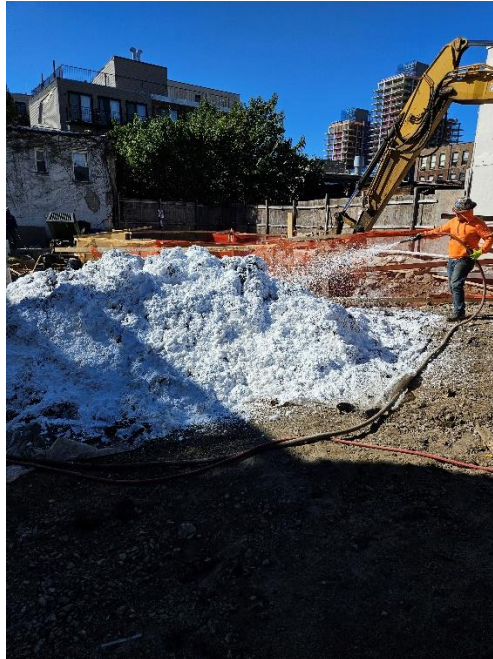
Photo 2: View of stockpile covered with odor suppressant foam, facing Southwest.
