# DAILY FIELD REPORT

<b>Project</b>	Former A&A Brake Service Site	<b>Report No.</b>	51
<b>BCP Site</b>	NYSDEC BCP SITE C224372	<b>Date</b>	10/11/2024
<b>Location</b>	558 Sackett Street	<b>File No.</b>	0206384
<b>Client</b>	Sackett Heights LLC	<b>Temperature</b>	H: 70°F L: 49°F
<b>Contractor</b>	Blue Sky Builders, International Concrete	<b>Wind Direction</b>	W to E, up to 14 mph
<b>Weather</b>	Clear	<b>Personnel on Site</b>	G. Poulton
<b>Humidity</b>	37%	<b>Time on Site</b>	6:30 am to 3:00 pm

H & A of New York Engineering and Geology, LLP (Haley & Aldrich) was present document implementation of the May 2024 NYSDEC-Approved Remedial Action Work Plan (RAWP) and Decision Document for the Former A&A Brake Service Site C224372, located at 558 Sackett Street, Brooklyn, NY. Site observations are summarized below.

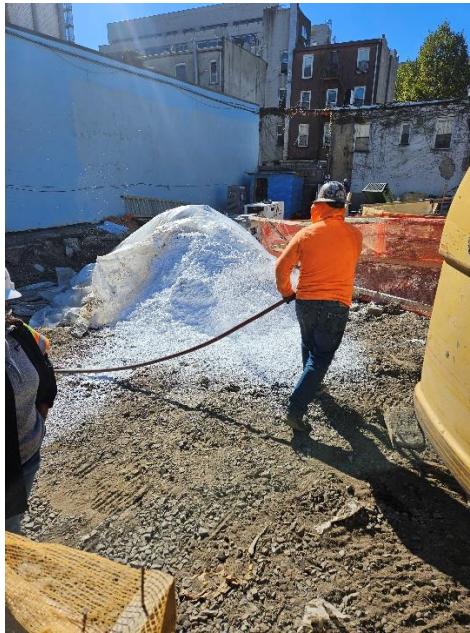
*Photo 2: View of stockpile covered with odor suppressant foam, facing Southeast.*

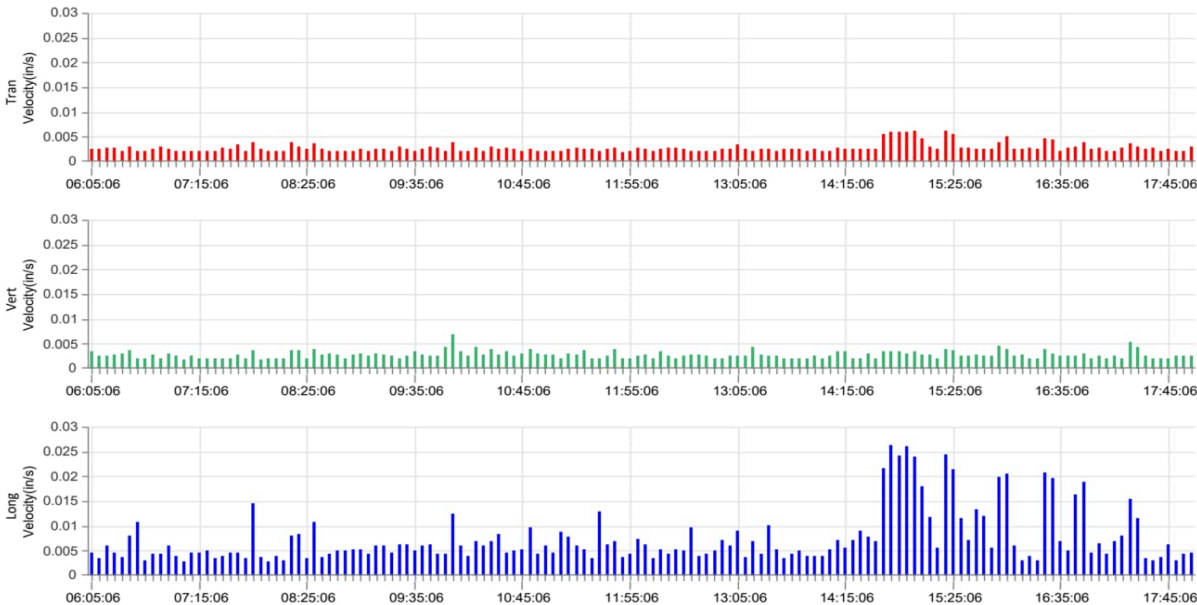
**USBM R18507 And OSMRE**  
Velocity versus Frequency (Zero Crossing)

Peak Vector Sum 0.0264 in/s at October 12, 2024 14:45:06

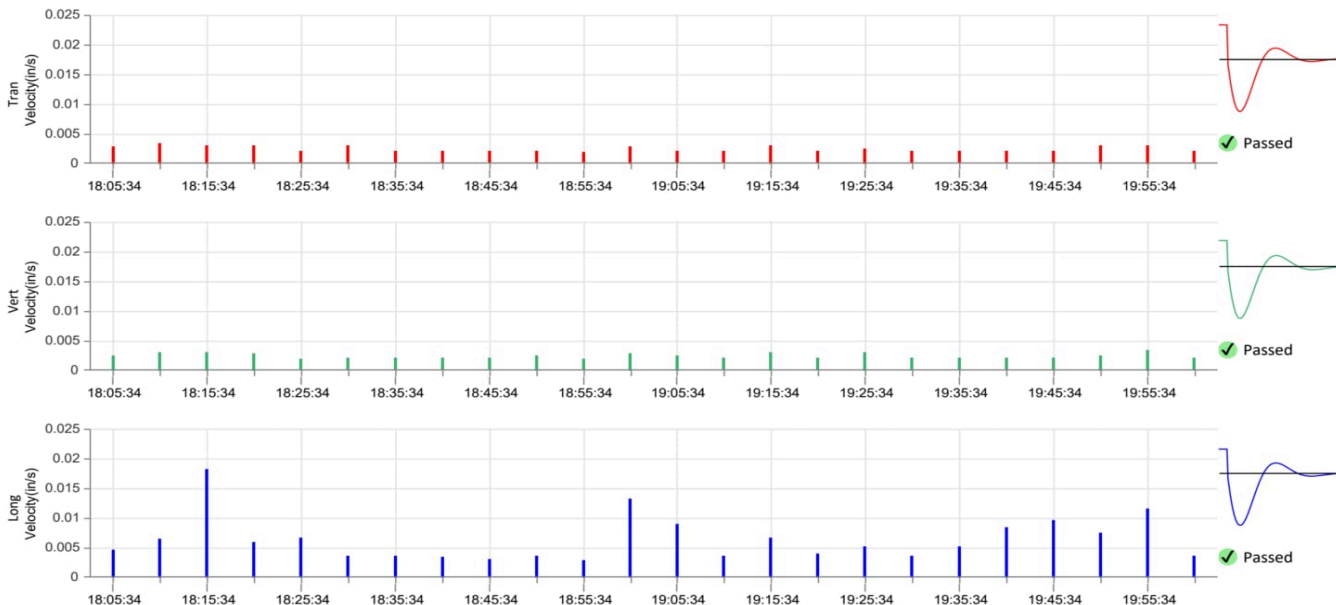
**USBM R18507 And OSMRE**  
Velocity versus Frequency (Zero Crossing)

Peak Vector Sum 0.0184 in/s at October 13, 2024 18:15:34

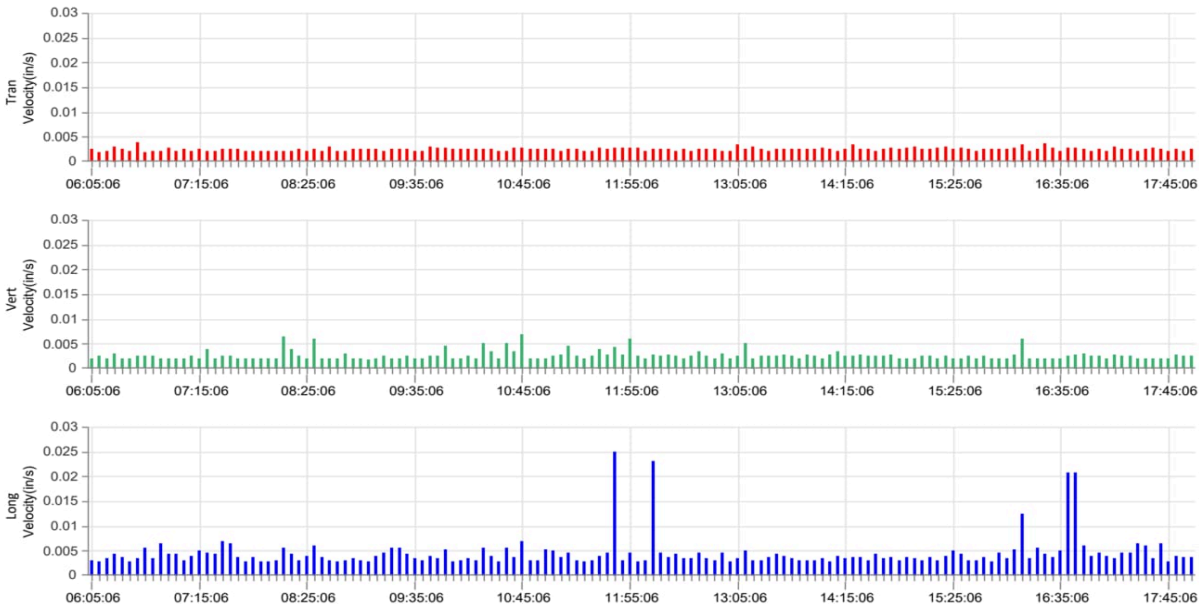
#### USBM R18507 And OSMRE Velocity versus Frequency (Zero Crossing)

Peak Vector Sum 0.0249 in/s at October 13, 2024 11:45:06
