DAILY FIELD REPORT

Project	Former A&A Brake Service Site	Report No.	52
BCP Site	NYSDEC BCP SITE C224372	Date	10/14/2024
Location	558 Sackett Street	File No.	0206384
Client	Sackett Heights LLC	Temperature	H: 67°F L: 50°F
Contractor	Blue Sky Builders, International Concrete	Wind Direction	NW to SE, up to 30 mph
Weather	Overcast	Personnel on Site	G. Poulton
Humidity	59%	Time on Site	6:30 am to 4:00 pm

H & A of New York Engineering and Geology, LLP (Haley & Aldrich) was present document implementation of the May 2024 NYSDEC-Approved Remedial Action Work Plan (RAWP) and Decision Document for the Former A&A Brake Service Site C224372, located at 558 Sackett Street, Brooklyn, NY. Site observations are summarized below.

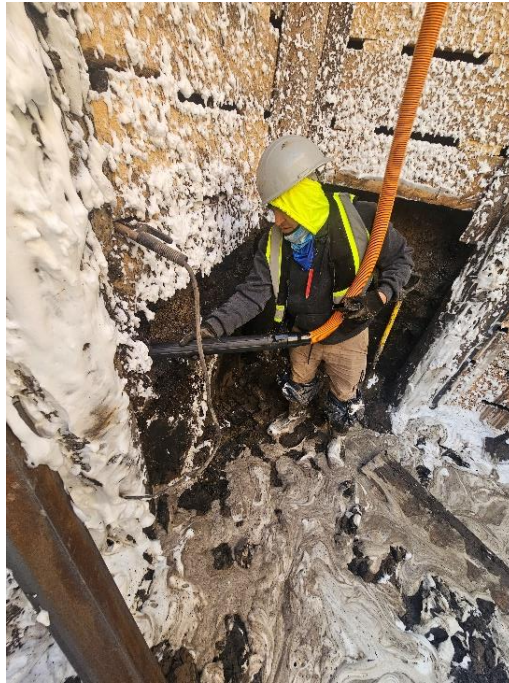
Photo 1: View of contractor using shop vac to remove observed product, facing Southwest.

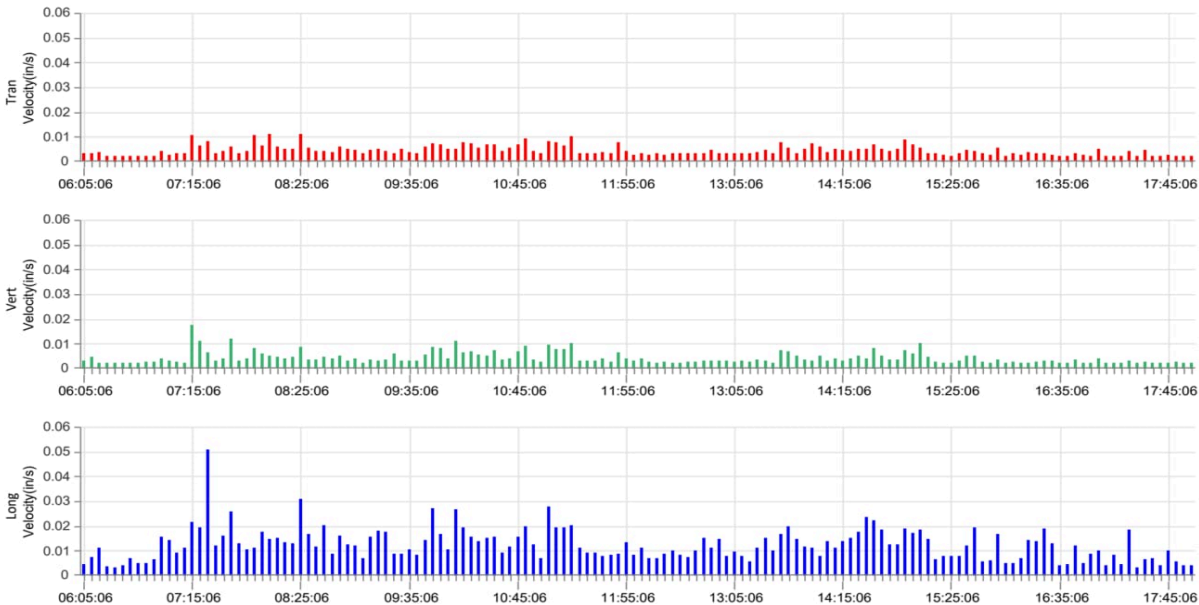
USBM RI8507 And OSMRE
Velocity versus Frequency (Zero Crossing)

Tran	Vert	Long
0.0112 in/s	0.0177 in/s	0.0509 in/s
5.0 Hz	9.7 Hz	30.1 Hz
Oct 14, 2024	Oct 14, 2024	Oct 14, 2024
08:05:06	07:15:06	07:25:06
✓ Passed	✓ Passed	✓ Passed
7.5 Hz	7.3 Hz	7.3 Hz
4.6	4.8	5.0

Peak Vector Sum 0.0514 in/s at October 14, 2024 07:25:06

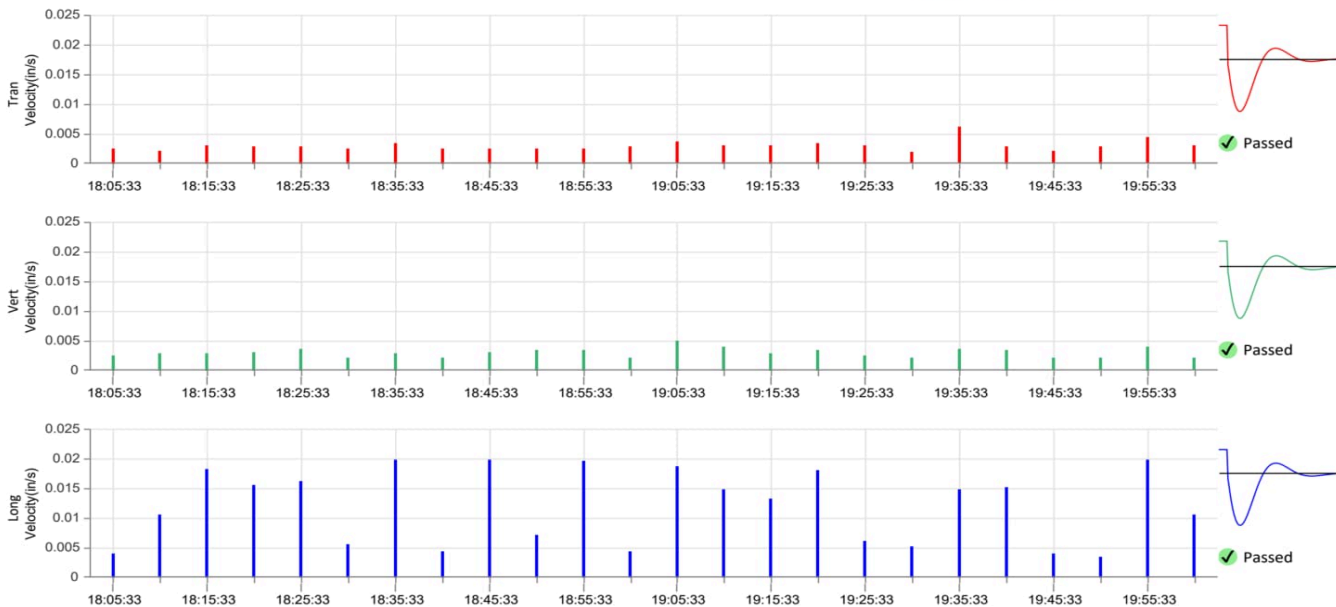
USBM RI8507 And OSMRE
Velocity versus Frequency (Zero Crossing)

0.0199 in/s at October 14, 2024 19:55:33

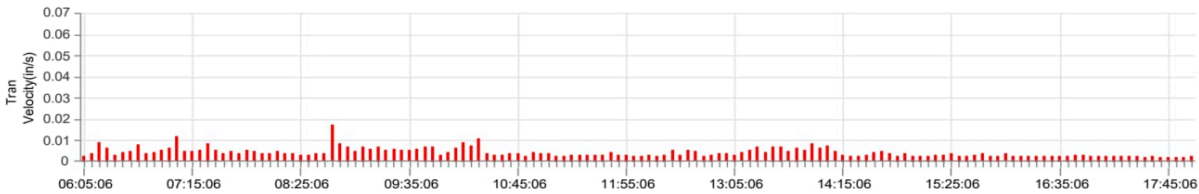
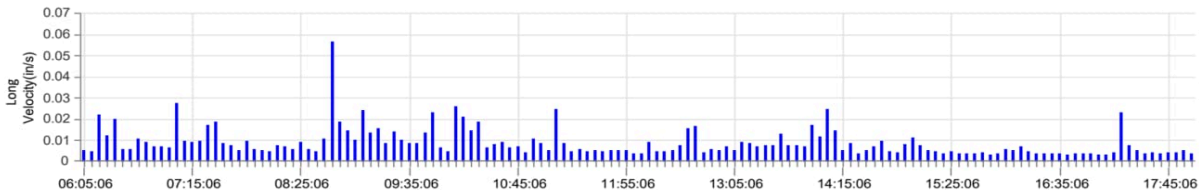
USBM R18507 And OSMRE
Velocity versus Frequency (Zero Crossing)

Peak Vector Sum 0.0573 in/s at October 14, 2024 08:45:06
