# DAILY FIELD REPORT

| <b>Project</b> | Former A&A Brake Service Site | <b>Report No.</b> | 54 |
| <b>BCP Site</b> | NYSDEC BCP SITE C224372 | <b>Date</b> | 10/16/2024 |
| <b>Location</b> | 558 Sackett Street | <b>File No.</b> | 0206384 |

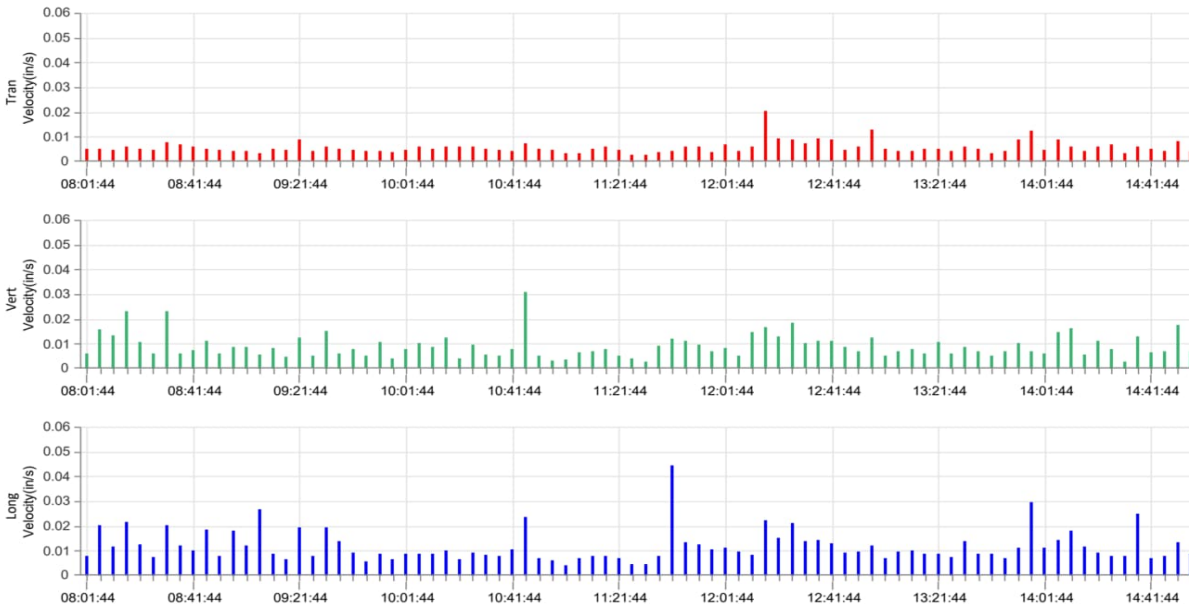
**USBM RI8507 And OSMRE**  
Velocity versus Frequency (Zero Crossing)

Peak Vector Sum 0.0446 in/s at October 16, 2024 11:41:44

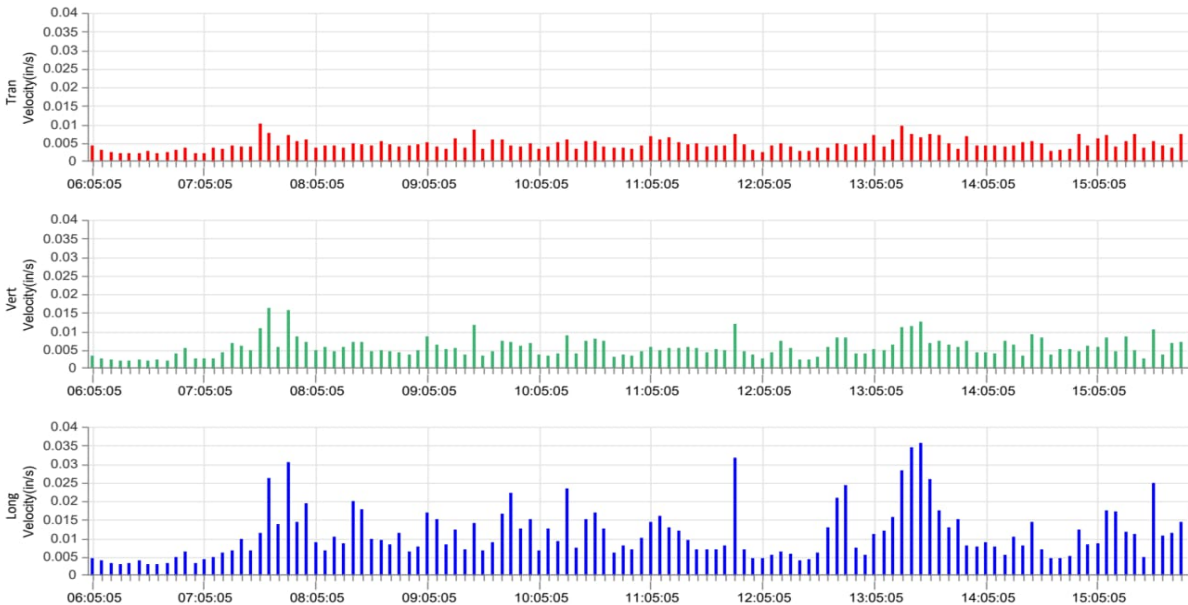
**UM22524**

Peak Vector Sum 0.0372 in/s at October 16, 2024 13:30:05

**USBM R18507 And OSMRE**  
Velocity versus Frequency (Zero Crossing)

**Extended Note** IF VIBRATIONS REACH 0.25 IN/S ALERT THE CONSTRUCTION MANAGER AND ENGINEER. IF VIBRATIONS EXCEEDED 0.50 IN/S STOP ALL VIBRATION PRODUCING ACTIVITIES AND NOTIFY THE CONSTRUCTION MANAGER AND ENGINEER. FOLLOW UP WITH OPTICAL AND CRACK GAUGE MONITORS AND SUBMIT ALL RESULTS TO THE PROJECT ENGINEER. WORK SHALL RESUME WHEN APPROVED BY CONSTRUCTION MANAGER AND ENGINEER.
