DAILY FIELD REPORT

Project	Former A&A Brake Service Site	Report No.	55
BCP Site	NYSDEC BCP SITE C224372	Date	10/28/2024
Location	558 Sackett Street	File No.	0206384
Client	Sackett Heights LLC	Temperature	H: 60°F L: 50°F
Contractor	Blue Sky Builders, International Concrete	Wind Direction	NW to SE, up to 13 mph
Weather	Clear	Personnel on Site	G. Poulton
Humidity	35%	Time on Site	6:30 am to 4:00 pm

H & A of New York Engineering and Geology, LLP (Haley & Aldrich) was present document implementation of the May 2024 NYSDEC-Approved Remedial Action Work Plan (RAWP) and Decision Document for the Former A&A Brake Service Site C224372, located at 558 Sackett Street, Brooklyn, NY. Site observations are summarized below.

WEEKLY MONITORING REPORT

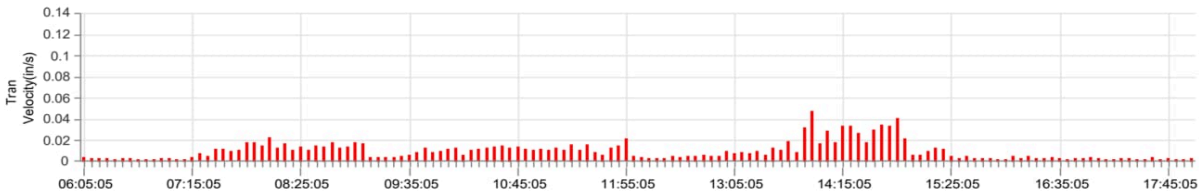
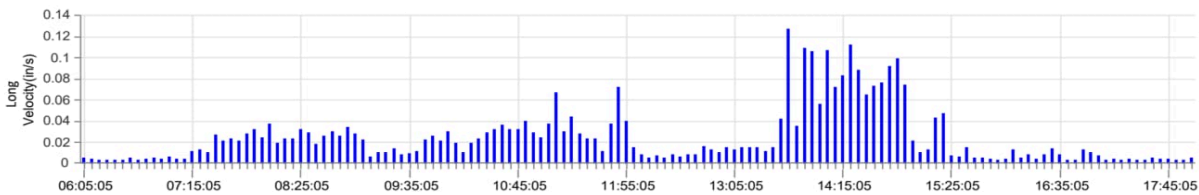
USBM R18507 And OSMRE Velocity versus Frequency (Zero Crossing)

Geophone	Tran	Vert	Long
Peak Particle Velocity	0.0475 in/s	0.1092 in/s	0.1272 in/s
Zero Crossing Frequency	10.4 Hz	15.5 Hz	17.1 Hz
Date	Oct 28, 2024	Oct 28, 2024	Oct 28, 2024
Time	13:55:05	13:55:05	13:40:05
Sensor Check	✓ Passed	✓ Passed	✓ Passed
Frequency	7.1 Hz	7.5 Hz	7.3 Hz
Overswing Ratio	4.8	4.6	4.4
Peak Vector Sum	0.1311 in/s at October 28, 2024 13:40:05

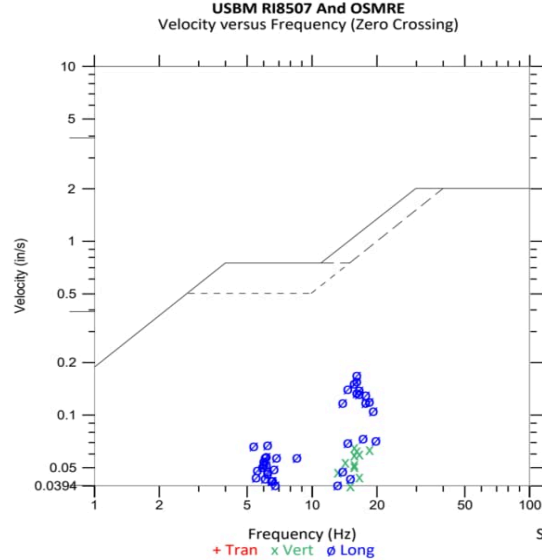
Geophone	Tran	Vert	Long
Peak Particle Velocity	0.0363 in/s	0.0658 in/s	0.1707 in/s
Zero Crossing Frequency	19.0 Hz	15.5 Hz	16.0 Hz
Date	Oct 28, 2024	Oct 28, 2024	Oct 28, 2024
Time	14:05:06	14:25:06	14:20:06
Sensor Check	✓ Passed	✓ Passed	✓ Passed
Frequency	7.3 Hz	7.3 Hz	7.3 Hz
Overswing Ratio	4.7	4.9	5.1

Peak Vector Sum 0.1710 in/s at October 28, 2024 14:20:06

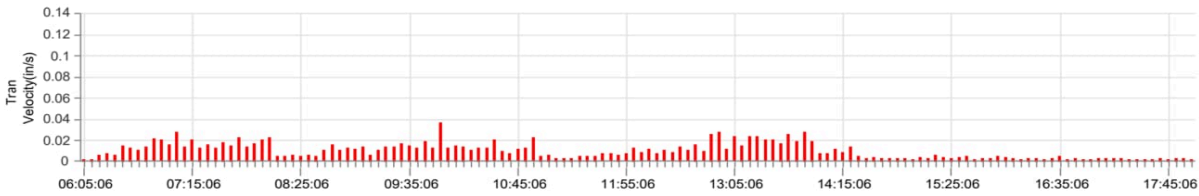
USBM R18507 And OSMRE Velocity versus Frequency (Zero Crossing)

Peak Vector Sum 0.1142 in/s at October 28, 2024 09:55:06

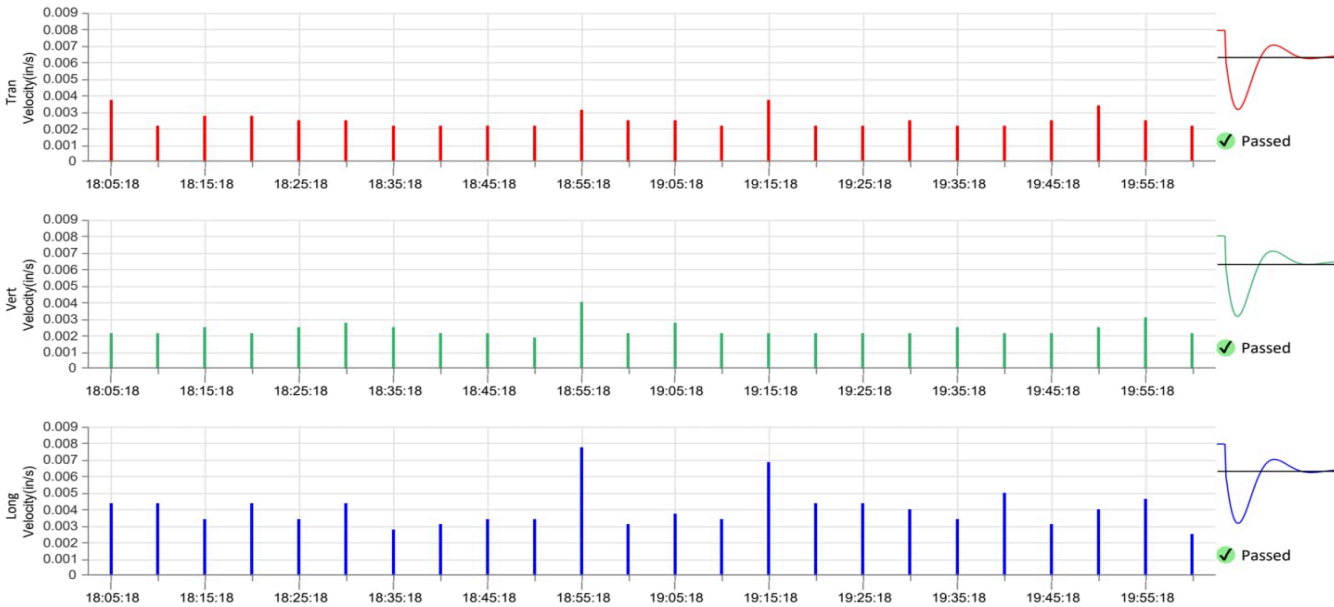
Geophone	Tran	Vert	Long
Peak Particle Velocity	<0.005 in/s	<0.005 in/s	0.0078 in/s
Zero Crossing Frequency	3.9 Hz	12.2 Hz	11.6 Hz
Date	Oct 28, 2024	Oct 28, 2024	Oct 28, 2024
Time	18:05:18	18:55:18	18:55:18
Sensor Check	✓ Passed	✓ Passed	✓ Passed
Frequency	7.5 Hz	7.7 Hz	7.3 Hz
Overswing Ratio	4.1	3.8	4.3
Peak Vector Sum	0.0079 in/s at October 28, 2024 18:55:18
