# DAILY FIELD REPORT

<b>Project</b>	Former A&A Brake Service Site	<b>Report No.</b>	58
<b>BCP Site</b>	NYSDEC BCP SITE C224372	<b>Date</b>	10/31/2024
<b>Location</b>	558 Sackett Street	<b>File No.</b>	0206384
<b>Client</b>	Sackett Heights LLC	<b>Temperature</b>	H: 82°F L: 61°F
<b>Contractor</b>	Blue Sky Builders, International Concrete	<b>Wind Direction</b>	SW to NE, up to 16 mph
<b>Weather</b>	Clear	<b>Personnel on Site</b>	G. Poulton
<b>Humidity</b>	38%	<b>Time on Site</b>	6:45 am to 4:00 pm

H & A of New York Engineering and Geology, LLP (Haley & Aldrich) was present document implementation of the May 2024 NYSDEC-Approved Remedial Action Work Plan (RAWP) and Decision Document for the Former A&A Brake Service Site C224372, located at 558 Sackett Street, Brooklyn, NY. Site observations are summarized below.

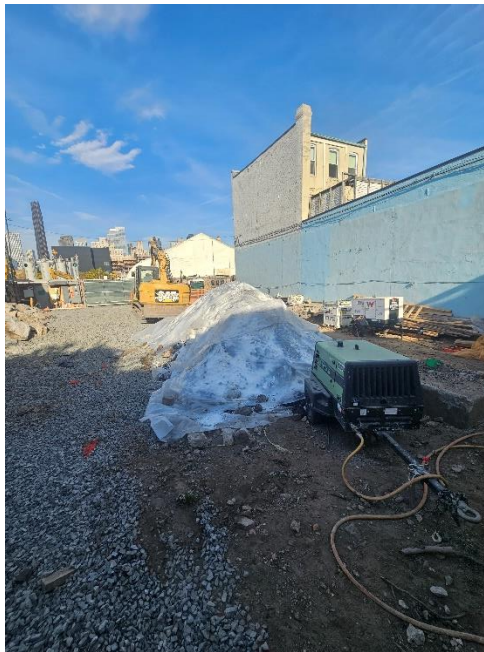
*Photo 2: View of soil stockpiles covered with odor suppressant foam and poly sheeting, facing Northeast.*
