DAILY FIELD REPORT

Project	Former A&A Brake Service Site	Report No.	59
BCP Site	NYSDEC BCP SITE C224372	Date	11/1/2024
Location	558 Sackett Street	File No.	0206384
Client	Sackett Heights LLC	Temperature	H: 80°F L: 60°F
Contractor	Blue Sky Builders, International Concrete	Wind Direction	SW to NE, up to 17 mph
Weather	Clear	Personnel on Site	G. Poulton
Humidity	34%	Time on Site	6:30 am to 3:30 pm

H & A of New York Engineering and Geology, LLP (Haley & Aldrich) was present document implementation of the May 2024 NYSDEC-Approved Remedial Action Work Plan (RAWP) and Decision Document for the Former A&A Brake Service Site C224372, located at 558 Sackett Street, Brooklyn, NY. Site observations are summarized below.

WEEKLY MONITORING REPORT

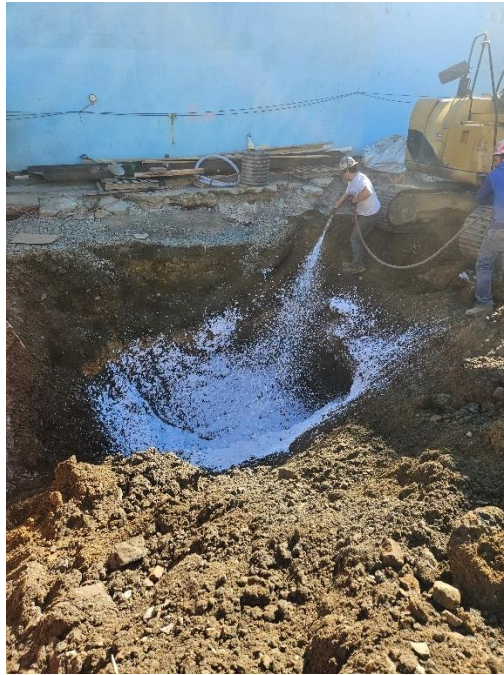
Photo 1: View of contractor applying odor suppressant foam during excavation, facing East.

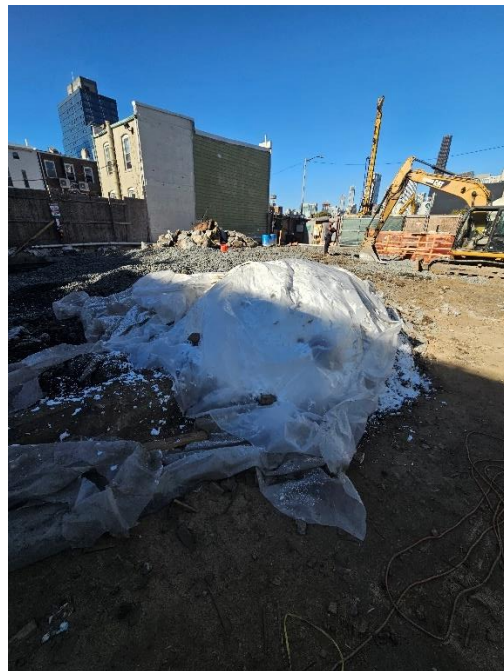
Photo 2: View of soil stockpiles covered with odor suppressant foam and poly sheeting, facing Northwest.
