DAILY FIELD REPORT

| Project | Former A&A Brake Service Site | Report No. | 60 |
| Location | 558 Sackett Street | File No. | 0206384 |

WEEKLY MONITORING REPORT

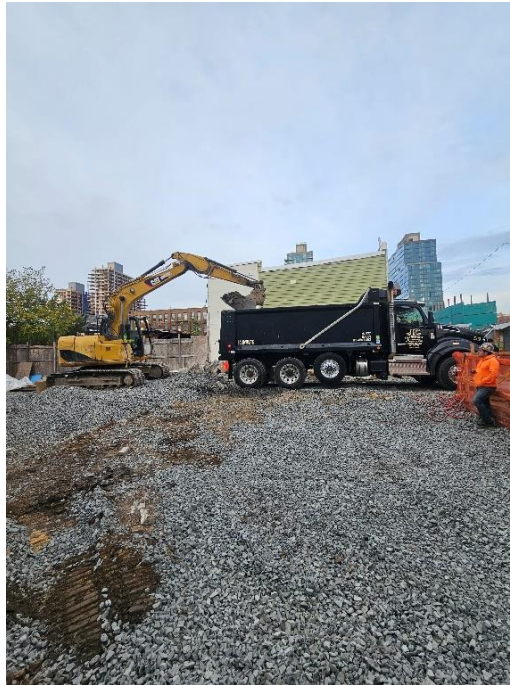
Photo 1: View of contractor loading soil for off-Site disposal, facing West.

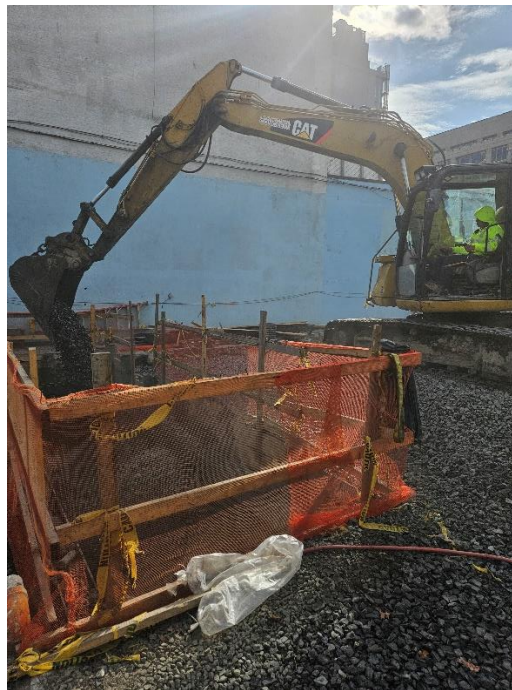
Photo 2: View of contractor backfilling CS02/CS03 excavation, facing Southeast.
