# DAILY FIELD REPORT

<b>Project</b>	Former A&A Brake Service Site	<b>Report No.</b>	61
<b>BCP Site</b>	NYSDEC BCP SITE C224372	<b>Date</b>	11/5/2024
<b>Location</b>	558 Sackett Street	<b>File No.</b>	0206384
<b>Client</b>	Sackett Heights LLC	<b>Temperature</b>	H: 57°F L: 48°F
<b>Contractor</b>	Blue Sky Builders, International Concrete, Blanco	<b>Wind Direction</b>	SW to NE, up to 15 mph
<b>Weather</b>	Clear	<b>Personnel on Site</b>	G. Poulton
<b>Humidity</b>	54%	<b>Time on Site</b>	6:30 am to 4:00 pm

## WEEKLY MONITORING REPORT

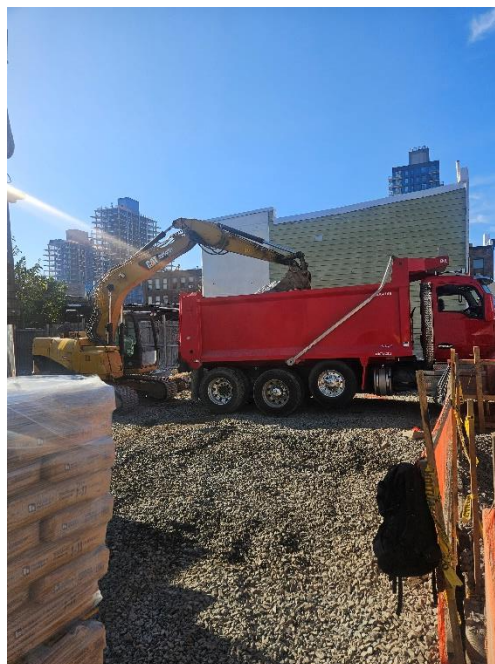
*Photo 2: View of contractor loading C&D for off-Site disposal, facing West.*

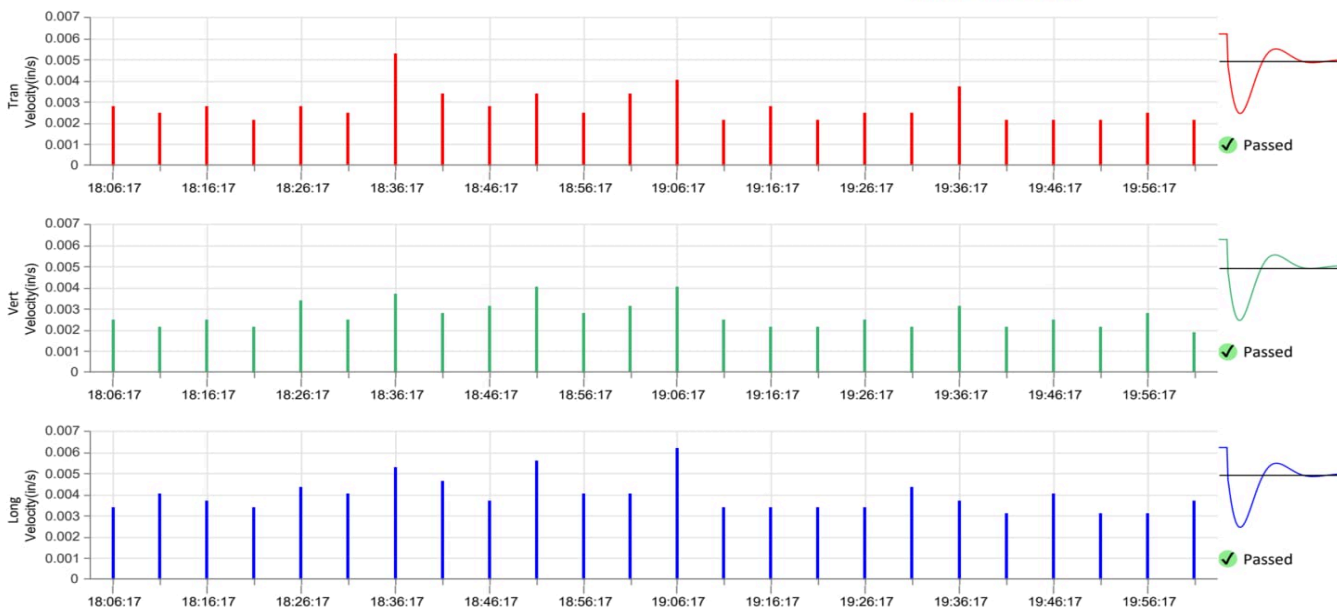
Peak Vector Sum 0.0064 in/s at November 5, 2024 19:06:17

USBM RI8507 And OSMRE  
Velocity versus Frequency (Zero Crossing)

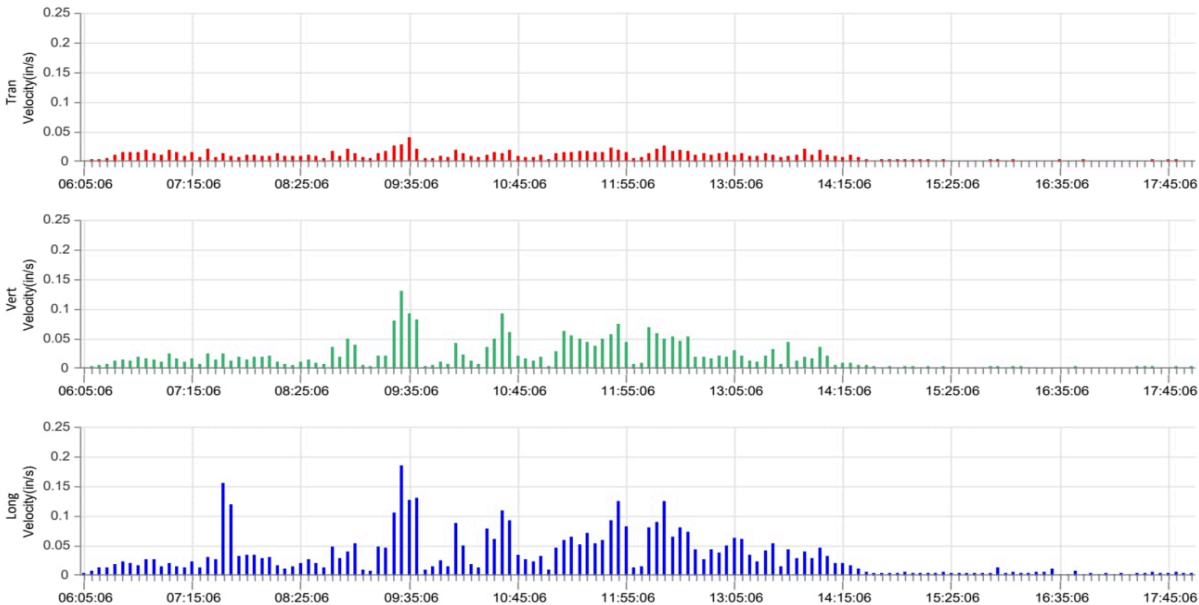
Peak Vector Sum 0.1891 in/s at November 5, 2024 09:30:06

**USBM R18507 And OSMRE**  
Velocity versus Frequency (Zero Crossing)
