DAILY FIELD REPORT

Project	Former A&A Brake Service Site	Report No.	62
BCP Site	NYSDEC BCP SITE C224372	Date	11/6/2024
Location	558 Sackett Street	File No.	0206384
Client	Sackett Heights LLC	Temperature	H: 80°F L: 65°F
Contractor	Blue Sky Builders, International Concrete, Blanco	Wind Direction	SW to NE, up to 16 mph
Weather	Clear	Personnel on Site	G. Poulton
Humidity	47%	Time on Site	6:30 am to 3:30 pm

WEEKLY MONITORING REPORT

Project Address:
558 Sackett Street,
Brooklyn,
Brooklyn NY 11215
BBL:/443/55

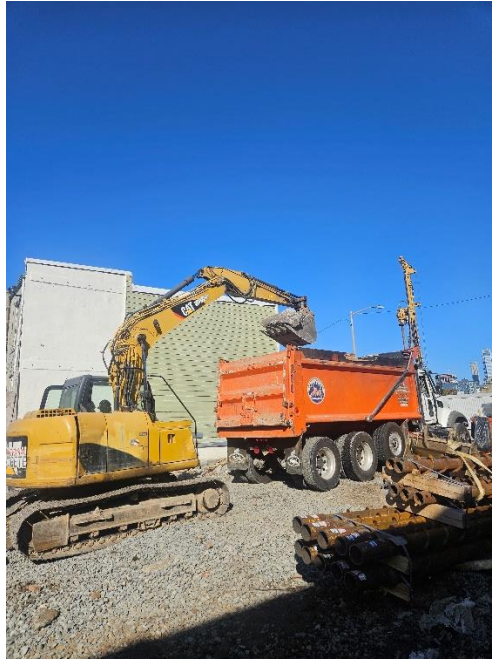
Photo 1: View of contractor loading C&D for off-Site disposal, facing Northwest.

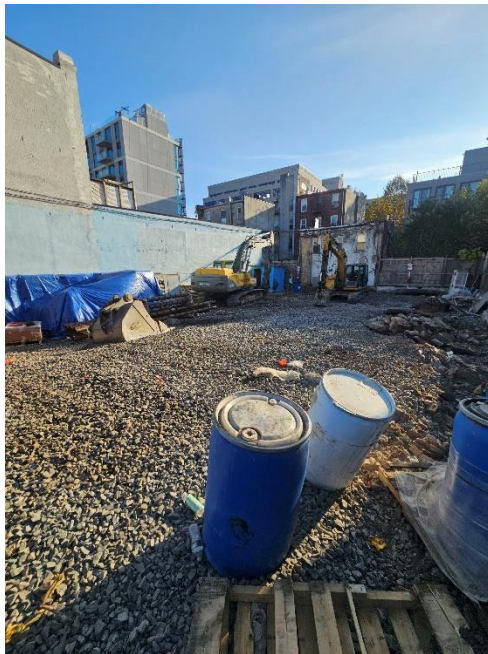
Photo 2: View of Site conditions at shift end, facing Southeast.
