DAILY FIELD REPORT

Project	Former A&A Brake Service Site	Report No.	63
BCP Site	NYSDEC BCP SITE C224372	Date	11/7/2024
Location	558 Sackett Street	File No.	0206384
Client	Sackett Heights LLC	Temperature	H: 74°F L: 56°F
Contractor	Blue Sky Builders, International Concrete, Blanco	Wind Direction	SW to NE, up to 17 mph
Weather	Clear	Personnel on Site	G. Poulton, Annelise Stewart
Humidity	38%	Time on Site	6:30 am to 3:00 pm

H & A of New York Engineering and Geology, LLP (Haley & Aldrich) was present document implementation of the May 2024 NYSDEC-Approved Remedial Action Work Plan (RAWP) and Decision Document for the Former A&A Brake Service Site C224372, located at 558 Sackett Street, Brooklyn, NY. Site observations are summarized below.

WEEKLY MONITORING REPORT

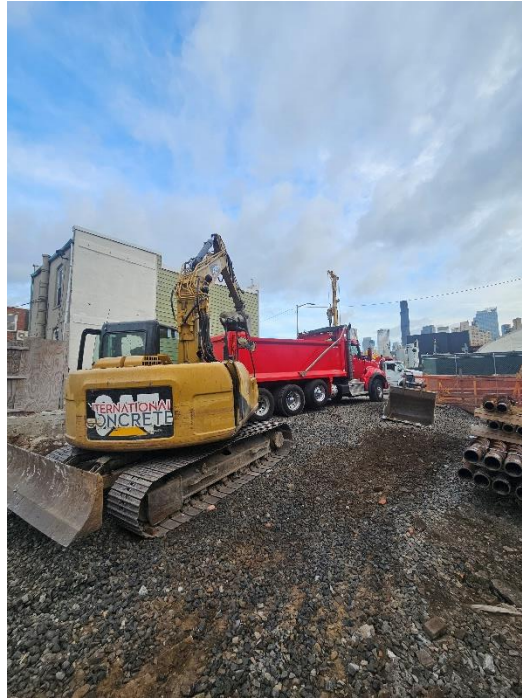
Photo 1: View of contractor loading C&D for off-Site disposal, facing Northwest.
