# DAILY FIELD REPORT

<b>Project</b>	Former A&A Brake Service Site	<b>Report No.</b>	64
<b>BCP Site</b>	NYSDEC BCP SITE C224372	<b>Date</b>	11/8/2024
<b>Location</b>	558 Sackett Street	<b>File No.</b>	0206384
<b>Client</b>	Sackett Heights LLC	<b>Temperature</b>	H: 68°F L: 51°F
<b>Contractor</b>	Blue Sky Builders, Blanco	<b>Wind Direction</b>	N to S, up to 6 mph
<b>Weather</b>	Sunny	<b>Personnel on Site</b>	Annilese Stewart
<b>Humidity</b>	46%	<b>Time on Site</b>	6:30 am to 11:30 pm

H & A of New York Engineering and Geology, LLP (Haley & Aldrich) was present document implementation of the May 2024 NYSDEC-Approved Remedial Action Work Plan (RAWP) and Decision Document for the Former A&A Brake Service Site C224372, located at 558 Sackett Street, Brooklyn, NY. Site observations are summarized below.

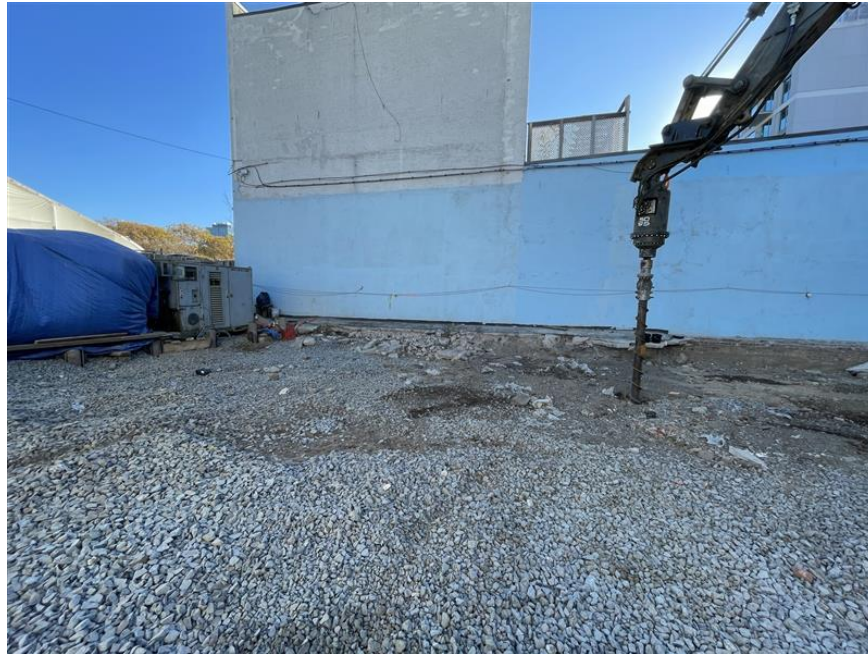
*Photo 1: View of contractor mobilizing excavator, facing East.*

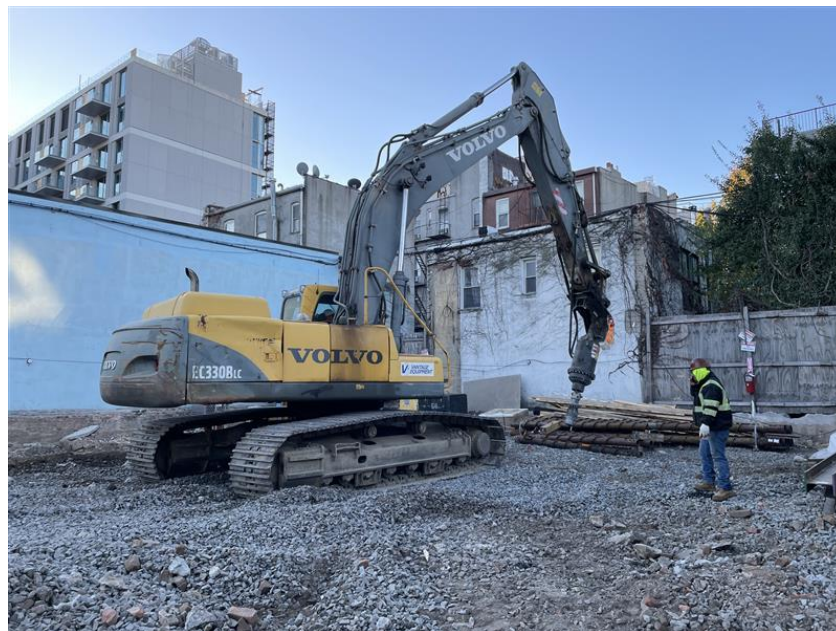
*Photo 2: View of contractor preparing for pile installation, facing Southeast.*

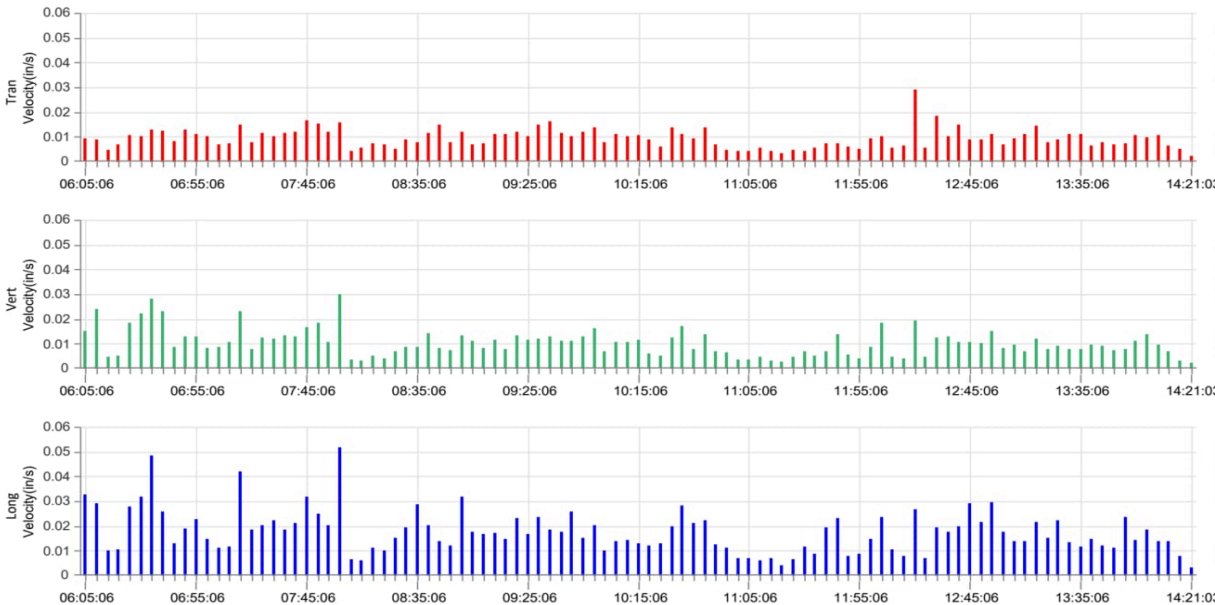
Peak Vector Sum 0.0580 in/s at November 8, 2024 08:00:06

**USBM RI8507 And OSMRE**  
Velocity versus Frequency (Zero Crossing)

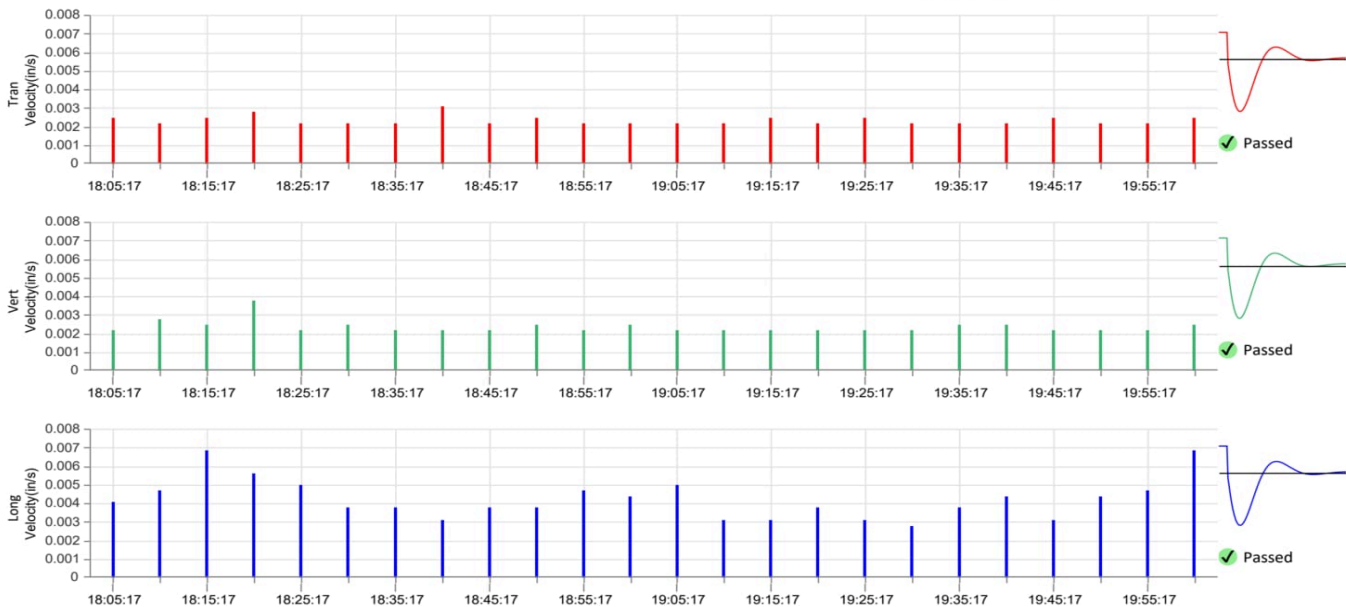
0.0069 in/s at November 10, 2024 18:15:17

USBM RI8507 And OSMRE  
Velocity versus Frequency (Zero Crossing)
