# DAILY FIELD REPORT

| <b>Project</b> | Former A&A Brake Service Site | <b>Report No.</b> | 67 |
| <b>Location</b> | 558 Sackett Street | <b>File No.</b> | 0206384 |

## WEEKLY MONITORING REPORT

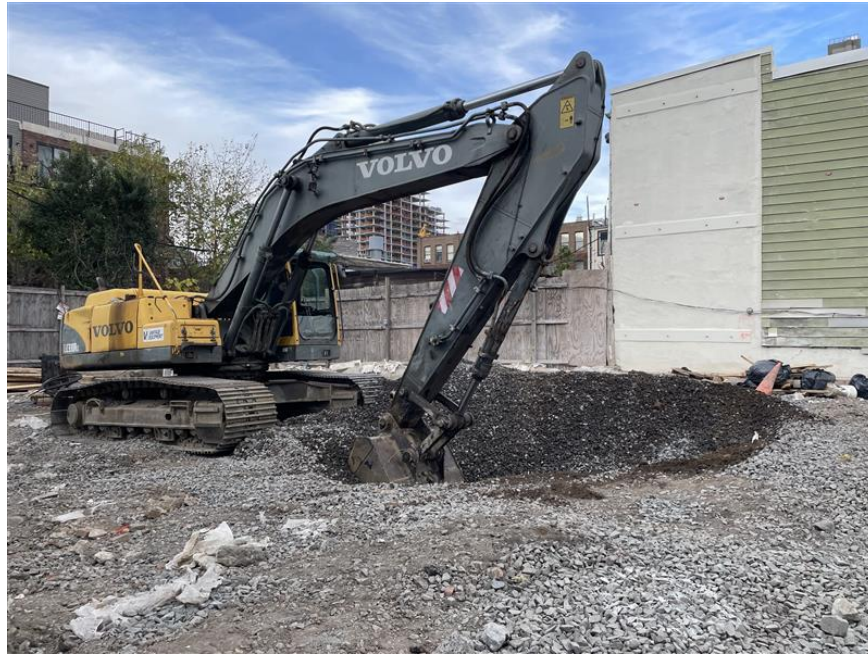
*Photo 1: View of contractor excavating for soil samples, facing Southwest.*

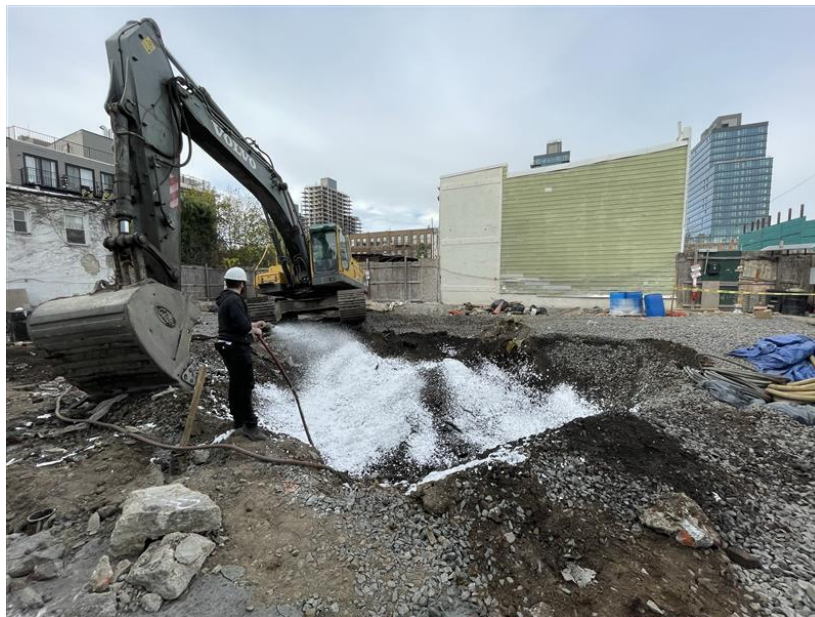
*Photo 2: View of contractor spraying odor suppressant in excavation, facing Southwest.*

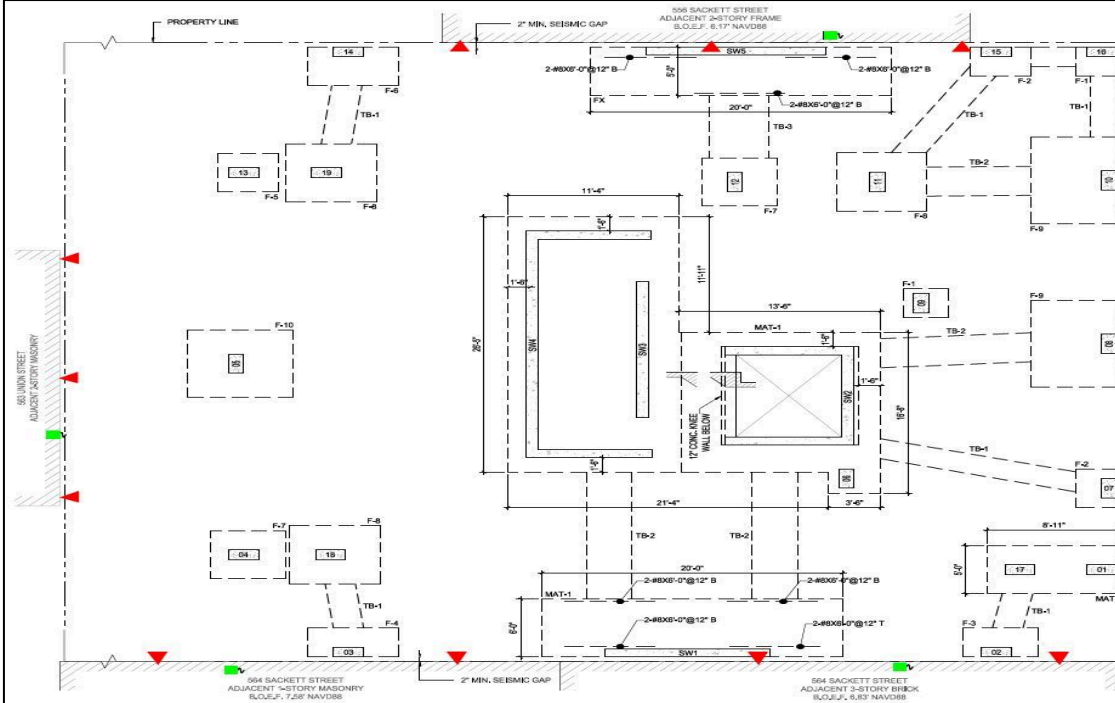
## 2 MONITORING PLAN

- ▼ OPTICAL MONITORING POINT
- LV VIBRATION MONITORING POINT

**NOTICE : this monitoring plan was drafted based on the SOE Plan of the subject property. This Monitoring Plans is intended for Monitoring Layout purpose only.**

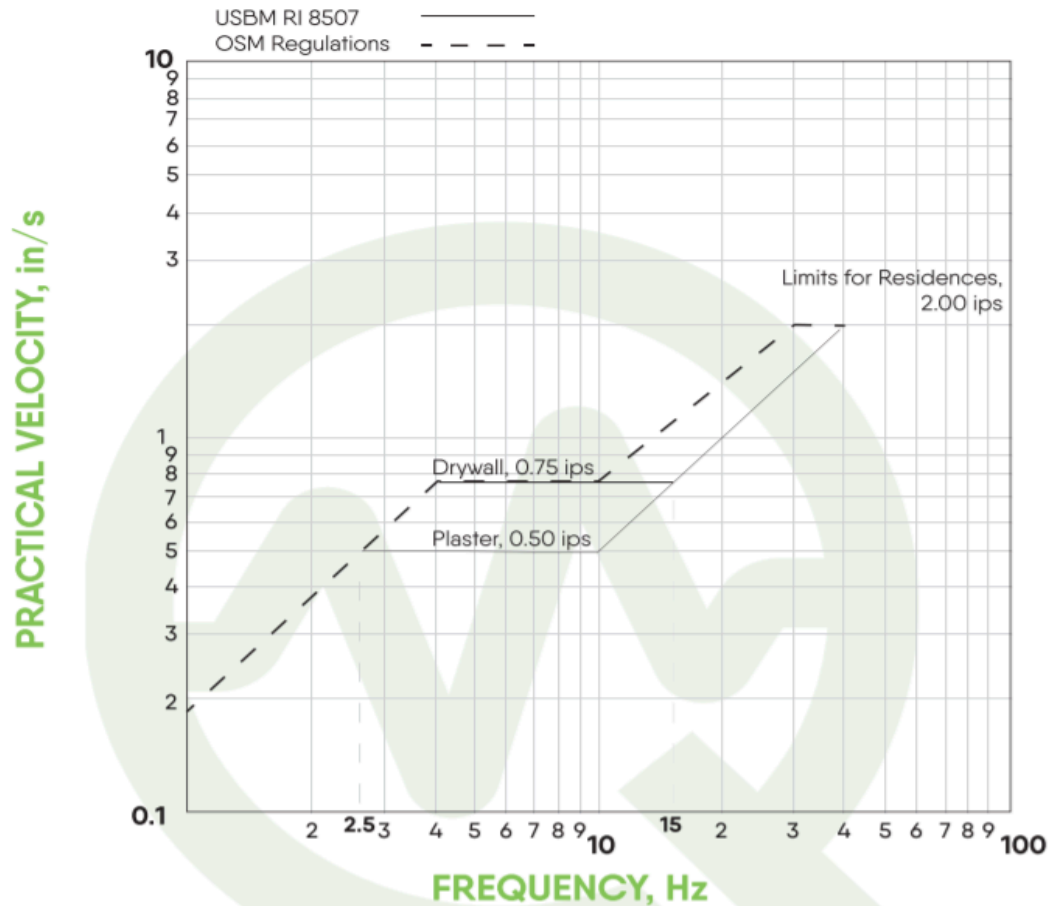
# USBM REPORT OF INVESTIGATION 8507 DIAGRAM

The USBM Report of Investigation 8507 graph is shown on the following page. Above 12 hertz, the allowable vibration intensity Increases to 2.0 inches per second as the frequency increases up to 40 hertz. Above 40 hertz, a constant 2.0 inches per second level is recommended to protect

the interior walls and ceiling of structures, regardless of construction material. With respect to vibration induced soil settlement, and underground structure and utility damage, other research has shown that vibration levels in excess of 5.0 inches per second are required for this to occur.

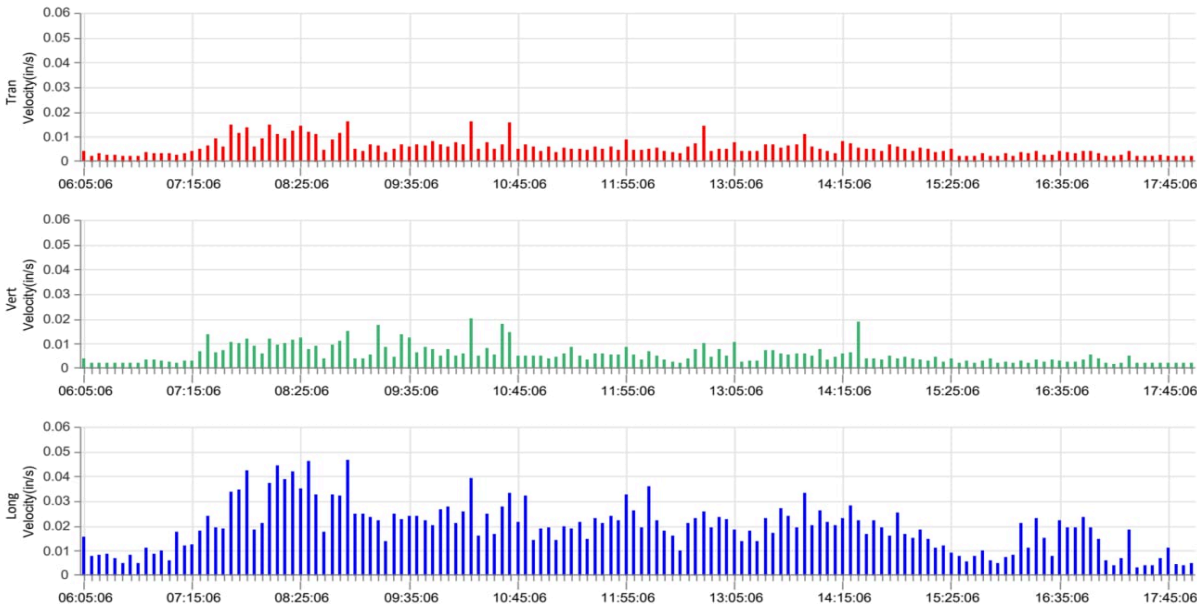
Peak Vector Sum 0.0468 in/s at November 14, 2024 08:55:06

**USBM R18507 And OSMRE**  
Velocity versus Frequency (Zero Crossing)

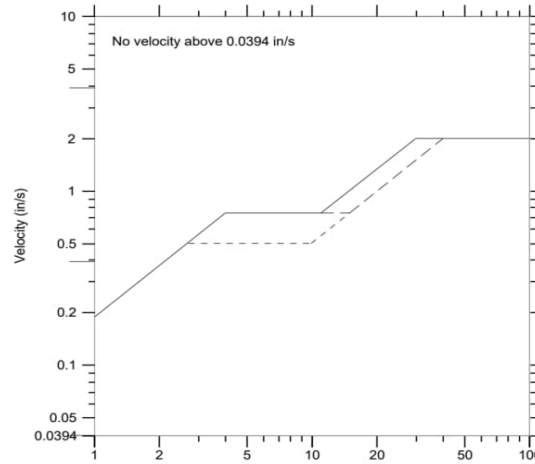
Peak Vector Sum 0.0214 in/s at November 14, 2024 20:00:31

**USBM RI8507 And OSMRE**  
Velocity versus Frequency (Zero Crossing)

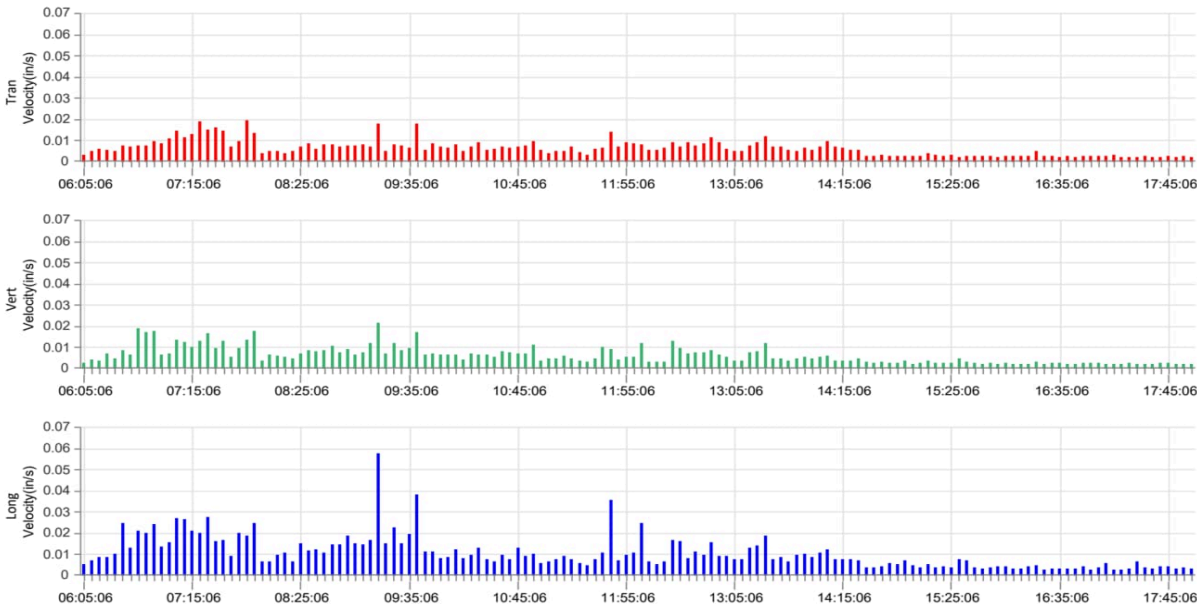
Peak Vector Sum 0.0589 in/s at November 14, 2024 09:15:06

**USBM RI8507 And OSMRE**  
Velocity versus Frequency (Zero Crossing)
