<b>Project</b>	Former A&A Brake Service Site	<b>Report No.</b>	68
<b>BCP Site</b>	NYSDEC BCP SITE C224372	<b>Date</b>	11/18/2024
<b>Location</b>	558 Sackett Street	<b>File No.</b>	0206384
<b>Client</b>	Sackett Heights LLC	<b>Temperature</b>	H: 63°F L: 48°F
<b>Contractor</b>	Blue Sky Builders, Blanco	<b>Wind Direction</b>	NW to SE, up to 9 mph
<b>Weather</b>	Sunny	<b>Personnel on Site</b>	Annilese Stewart
<b>Humidity</b>	57%	<b>Time on Site</b>	6:30 am to 1:30 pm

H & A of New York Engineering and Geology, LLP (Haley & Aldrich) was present document implementation of the May 2024 NYSDEC-Approved Remedial Action Work Plan (RAWP) and Decision Document for the Former A&A Brake Service Site C224372, located at 558 Sackett Street, Brooklyn, NY. Site observations are summarized below.

## WEEKLY MONITORING REPORT

**Project Address:**  
558 Sackett Street,  
Brooklyn,  
Brooklyn NY 11215  
BBL:/443/55

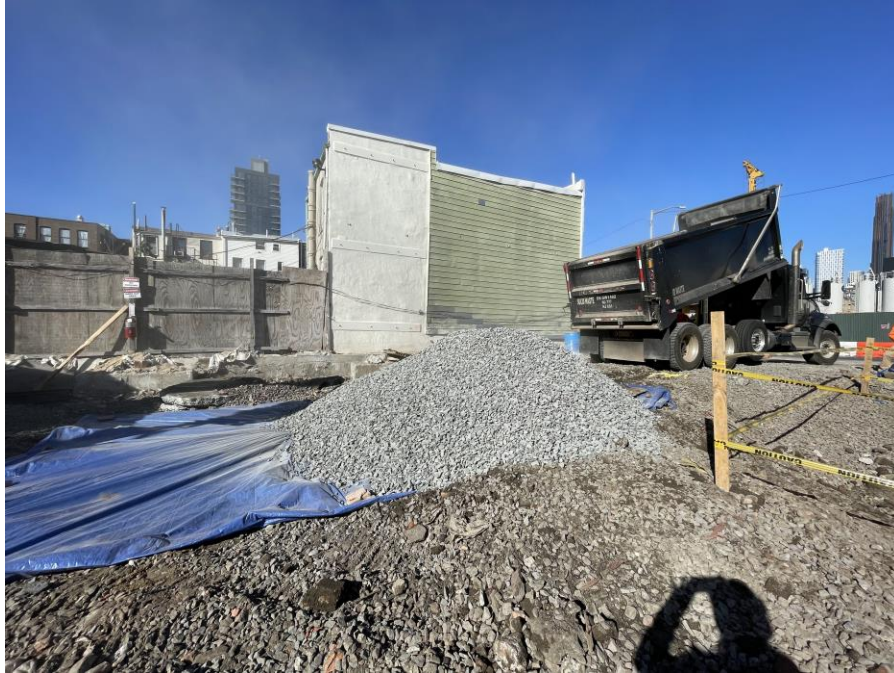
*Photo 1: View of contractor stockpiling imported clean gravel, facing Northwest.*

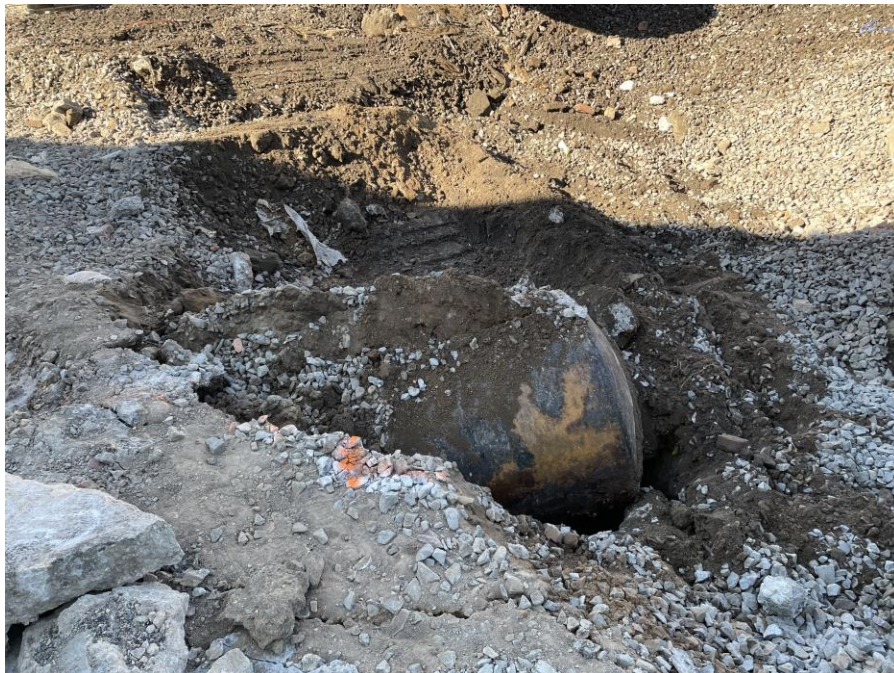
*Photo 2: View of encountered UST in eastern portion of the site, facing West.*

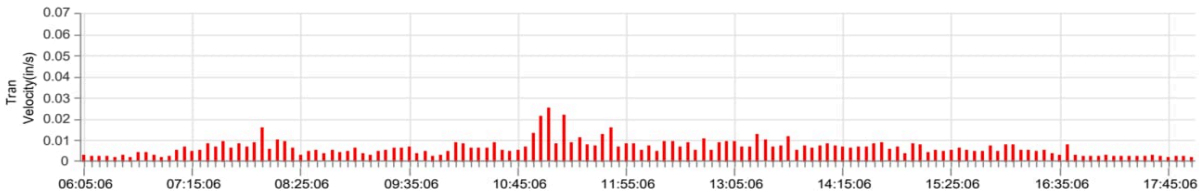
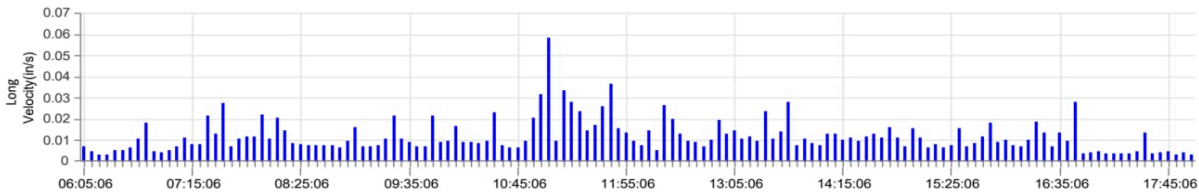
USBM R18507 And OSMRE  
Velocity versus Frequency (Zero Crossing)

Geophone	Tran	Vert	Long
Peak Particle Velocity	0.0251 in/s	0.0484 in/s	0.0580 in/s
Zero Crossing Frequency	13.8 Hz	10.0 Hz	11.4 Hz
Date	Nov 18, 2024	Nov 18, 2024	Nov 18, 2024
Time	11:05:06	11:05:06	11:05:06
Sensor Check	✓ Passed	✓ Passed	✓ Passed
Frequency	7.5 Hz	7.7 Hz	7.3 Hz
Overswing Ratio	4.2	3.9	4.4
Peak Vector Sum	0.0582 in/s at November 18, 2024 11:05:06

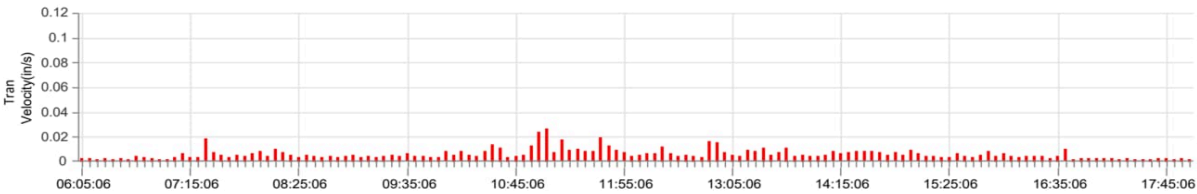
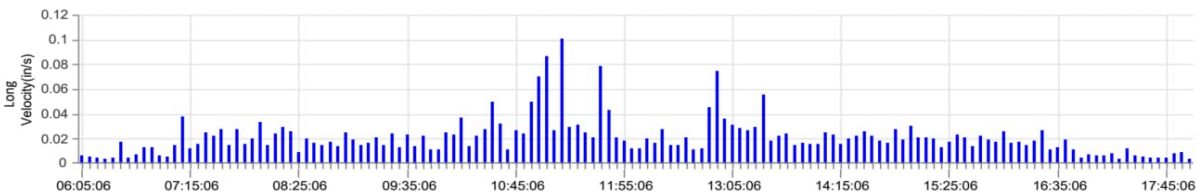
Geophone	Tran	Vert	Long
Peak Particle Velocity	0.0267 in/s	0.0338 in/s	0.1005 in/s
Zero Crossing Frequency	12.2 Hz	13.8 Hz	11.9 Hz
Date	Nov 18, 2024	Nov 18, 2024	Nov 18, 2024
Time	11:05:06	11:15:06	11:15:06
Sensor Check	✓ Passed	✓ Passed	✓ Passed
Frequency	7.5 Hz	7.3 Hz	7.3 Hz
Overswing Ratio	4.7	4.9	5.1

Peak Vector Sum 0.1008 in/s at November 18, 2024 11:15:06

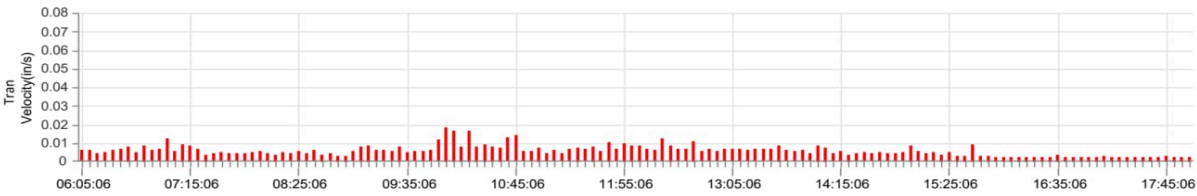
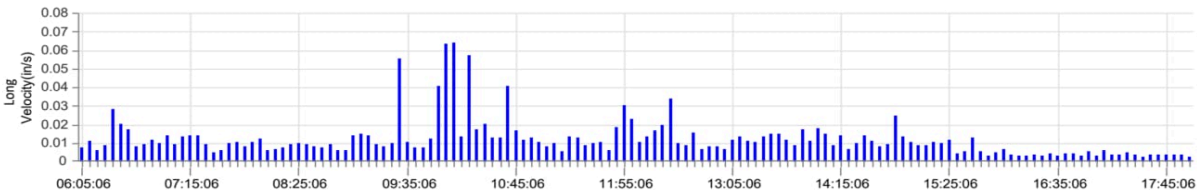
Geophone	Tran	Vert	Long
Peak Particle Velocity	0.0183 in/s	0.0509 in/s	0.0642 in/s
Zero Crossing Frequency	13.8 Hz	7.0 Hz	8.8 Hz
Date	Nov 18, 2024	Nov 18, 2024	Nov 18, 2024
Time	10:00:06	10:05:06	10:05:06
Sensor Check	✓ Passed	✓ Passed	✓ Passed
Frequency	7.1 Hz	7.5 Hz	7.3 Hz
Overswing Ratio	4.8	4.6	4.4
Peak Vector Sum	0.0651 in/s at November 18, 2024 10:05:06
