DAILY FIELD REPORT

Project	Former A&A Brake Service Site	Report No.	71
BCP Site	NYSDEC BCP SITE C224372	Date	11/21/2024
Location	558 Sackett Street	File No.	0206384
Client	Sackett Heights LLC	Temperature	H: 54°F L: 38°F
Contractor	Blue Sky Builders, Blanco	Wind Direction	NE to SW, up to 22 mph
Weather	Light to moderate rain	Personnel on Site	George Poulton
Humidity	83%	Time on Site	6:30 am to 3:00 pm

WEEKLY MONITORING REPORT

Project Address:
558 Sackett Street,
Brooklyn,
Brooklyn NY 11215
BBL:/443/55

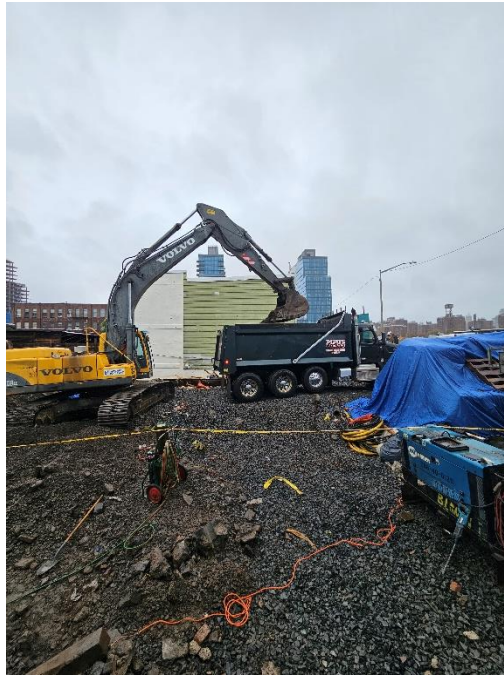
Photo 1: View of contractor loading soil for off-Site disposal, facing West.

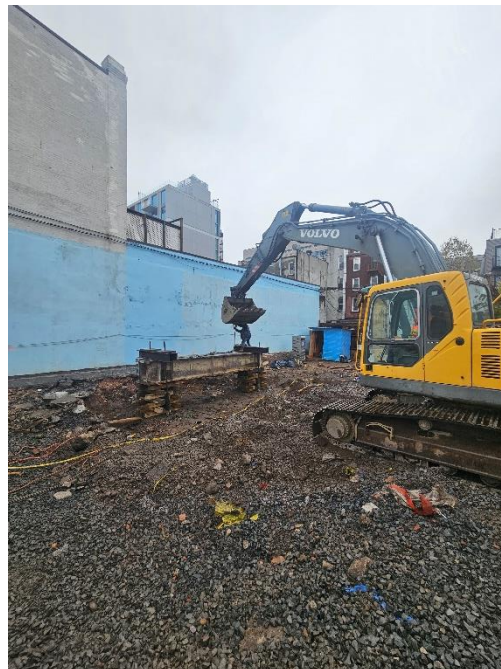
Photo 2: View of contractor constructing test pile apparatus, facing Southeast.
