DAILY FIELD REPORT

| Project | Former A&A Brake Service Site | Report No. | 72 |
| Location | 558 Sackett Street | File No. | 0206384 |

WEEKLY MONITORING REPORT

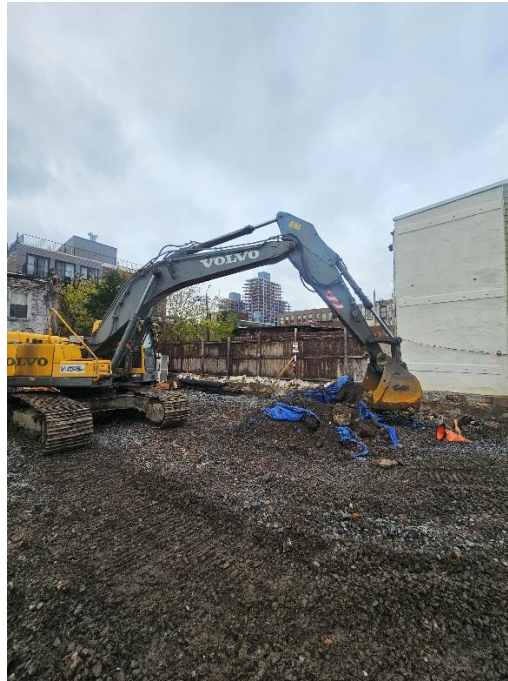
Photo 1: View of contractor moving soil stockpile, facing Southwest.

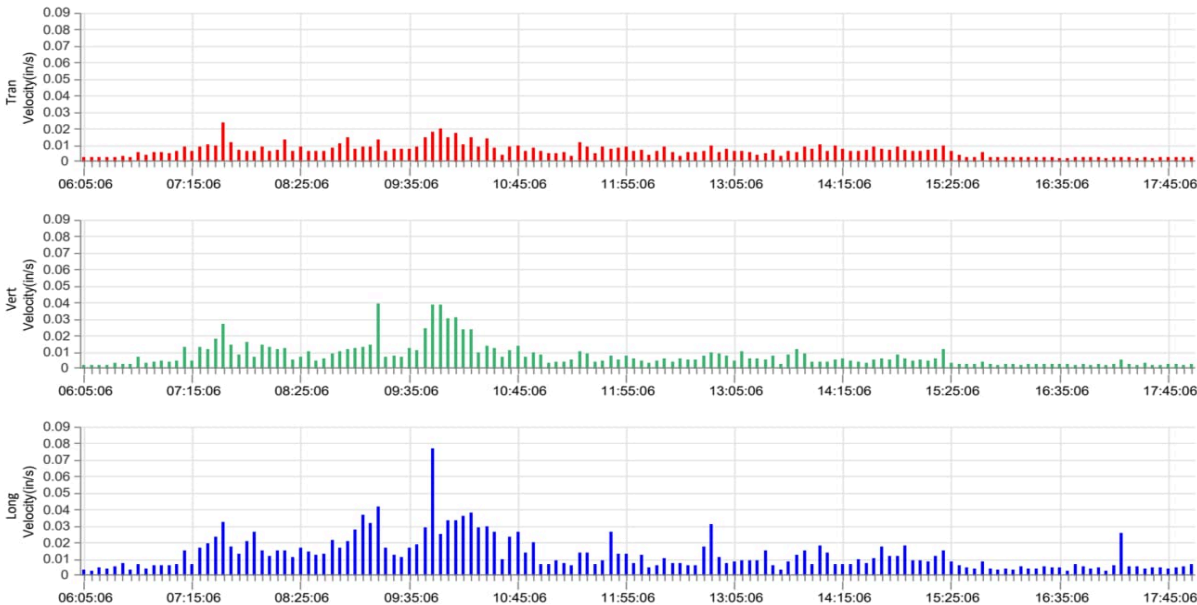
USBM RI8507 And OSMRE
Velocity versus Frequency (Zero Crossing)

0.0774 in/s at November 22, 2024 09:50:06

Extended Note IF VIBRATIONS REACH 0.25 IN/S ALERT THE CONSTRUCTION MANAGER AND ENGINEER. IF VIBRATIONS EXCEEDED 0.50 IN/S STOP ALL VIBRATION PRODUCING ACTIVITIES AND NOTIFY THE CONSTRUCTION MANAGER AND ENGINEER. FOLLOW UP WITH OPTICAL AND CRACK GAUGE MONITORS AND SUBMIT ALL RESULTS TO THE PROJECT ENGINEER. WORK SHALL RESUME WHEN APPROVED BY CONSTRUCTION MANAGER AND ENGINEER.
