DAILY FIELD REPORT

Project	Former A&A Brake Service Site	Report No.	73
BCP Site	NYSDEC BCP SITE C224372	Date	11/25/2024
Location	558 Sackett Street	File No.	0206384
Client	Sackett Heights LLC	Temperature	H: 55°F L: 43°F
Contractor	Blue Sky Builders, Blanco	Wind Direction	NW to NS, up to 15 mph
Weather	Overcast	Personnel on Site	George Poulton
Humidity	54%	Time on Site	6:30 am to 1:30 pm

WEEKLY MONITORING REPORT

Weekly Monitoring
11/25/2024 - 11/25/2024

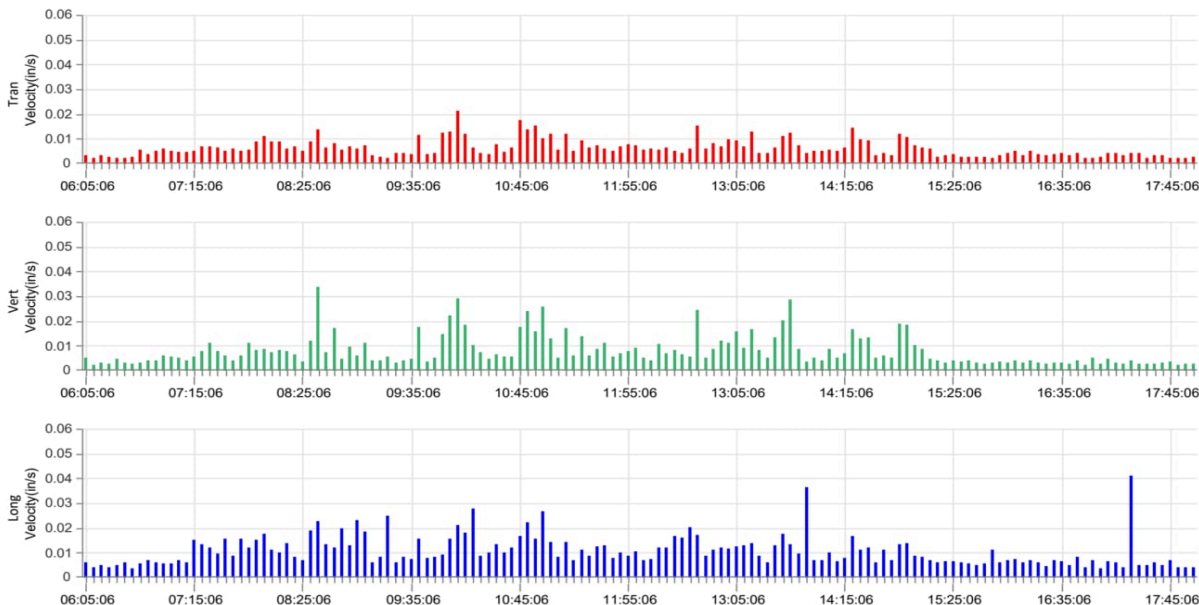
USBM R18507 And OSMRE
Velocity versus Frequency (Zero Crossing)

Tran	Vert	Long
0.0214 in/s	0.0335 in/s	0.0413 in/s
5.4 Hz	9.5 Hz	13.1 Hz
Nov 25, 2024	Nov 25, 2024	Nov 25, 2024
10:05:06	08:35:06	17:20:06
✓ Passed	✓ Passed	✓ Passed
7.5 Hz	7.7 Hz	7.3 Hz
4.2	3.9	4.4

Peak Vector Sum 0.0415 in/s at November 25, 2024 17:20:06

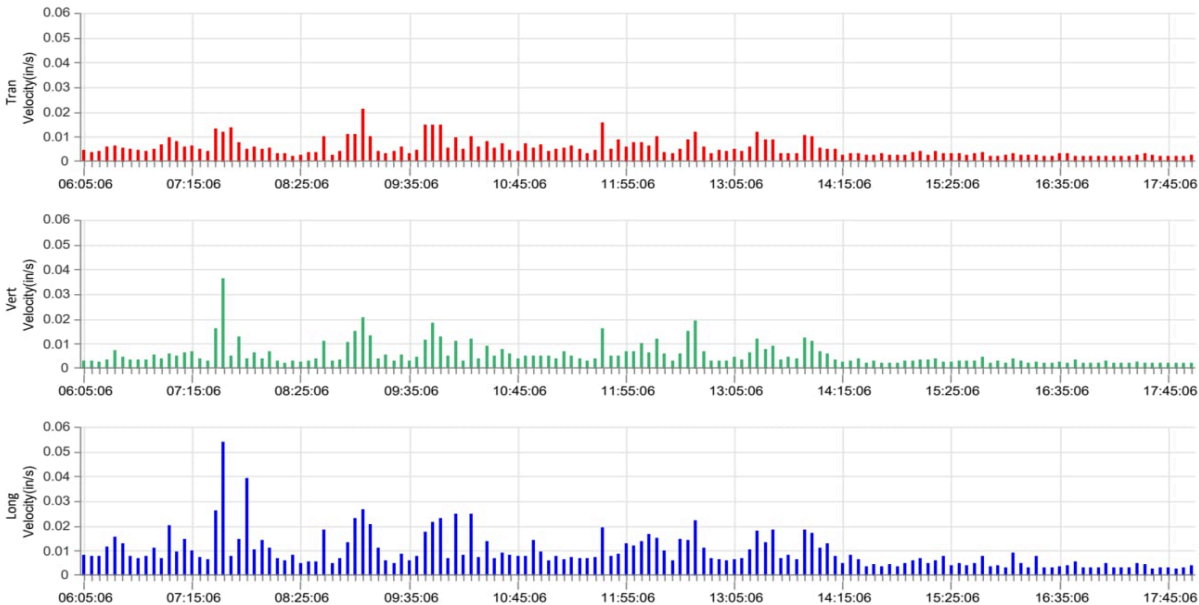
USBM R18507 And OSMRE
Velocity versus Frequency (Zero Crossing)

Peak Vector Sum 0.0650 in/s at November 25, 2024 07:35:06
