# DAILY FIELD REPORT

| <b>Project</b> | Former A&A Brake Service Site | <b>Report No.</b> | 76 |
| <b>Location</b> | 558 Sackett Street | <b>File No.</b> | 0206384 |

## WEEKLY MONITORING REPORT

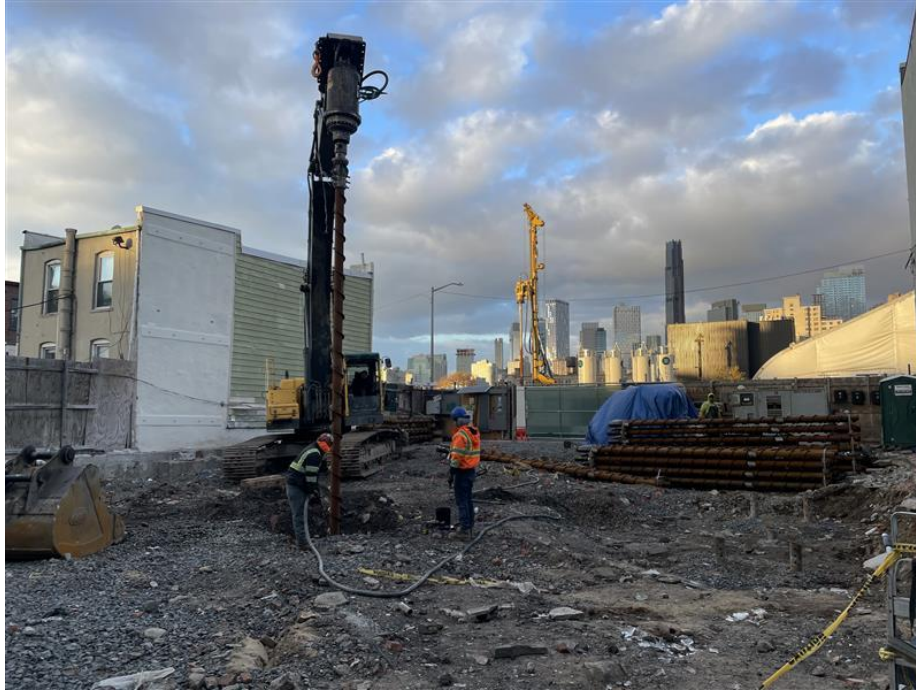
*Photo 1: View of Blanco installing structural pile, facing Northeast.*

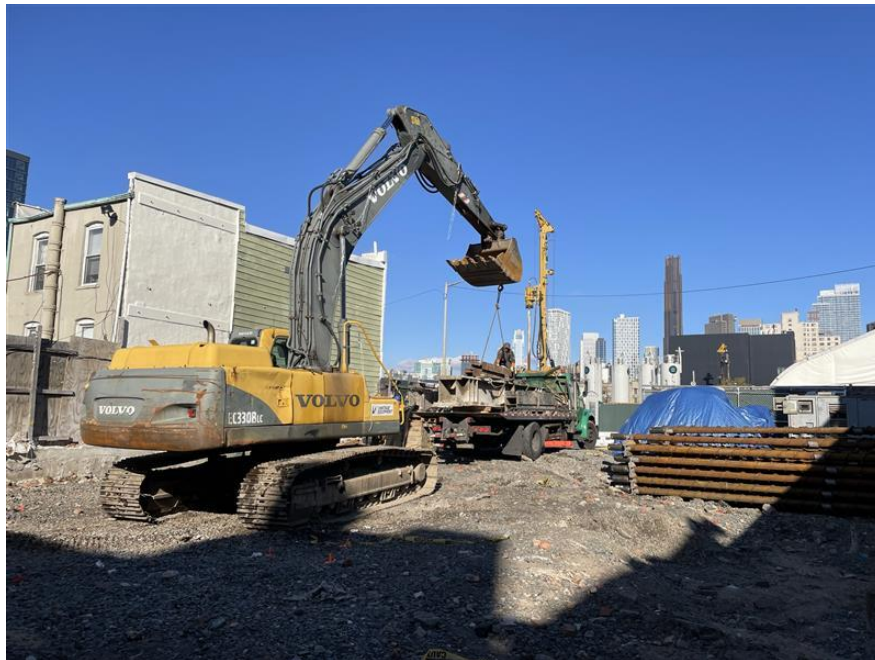
*Photo 2: View of removal of test pile apparatus, facing Northeast.*
