# DAILY FIELD REPORT

<b>Project</b>	Former A&A Brake Service Site	<b>Report No.</b>	77
<b>BCP Site</b>	NYSDEC BCP SITE C224372	<b>Date</b>	12/03/2024
<b>Location</b>	558 Sackett Street	<b>File No.</b>	0206384
<b>Client</b>	Sackett Heights LLC	<b>Temperature</b>	H: 28°F L: 40°F
<b>Contractor</b>	Blue Sky Builders, Blanco	<b>Wind Direction</b>	NW to SE, up to 7 mph
<b>Weather</b>	Partly Cloudy	<b>Personnel on Site</b>	Annilese Stewart
<b>Humidity</b>	75%	<b>Time on Site</b>	6:30 am to 3:30 pm

H & A of New York Engineering and Geology, LLP (Haley & Aldrich) was present document implementation of the May 2024 NYSDEC-Approved Remedial Action Work Plan (RAWP) and Decision Document for the Former A&A Brake Service Site C224372, located at 558 Sackett Street, Brooklyn, NY. Site observations are summarized below.

## WEEKLY MONITORING REPORT

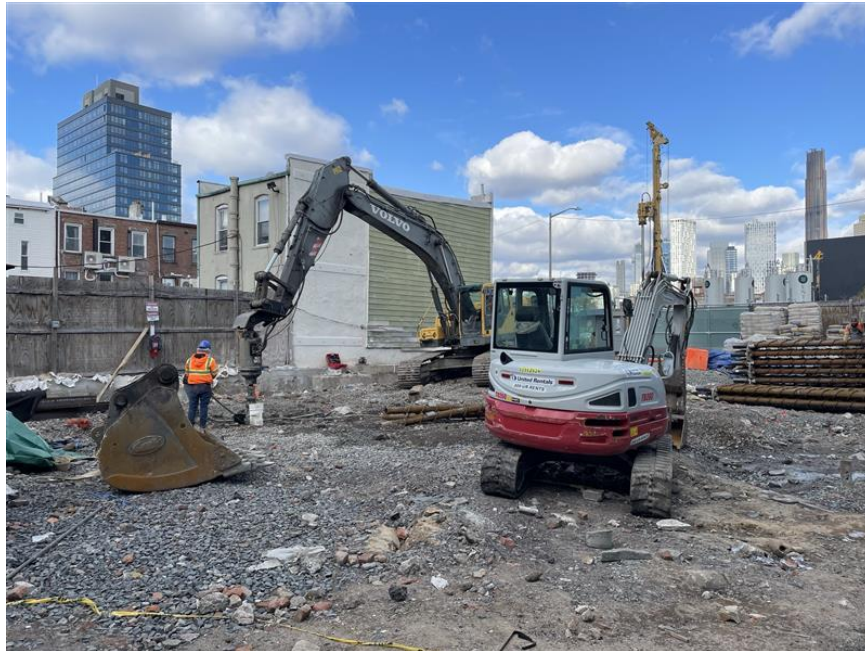
*Photo 1: View of Blanco installing structural pile, facing Northeast.*

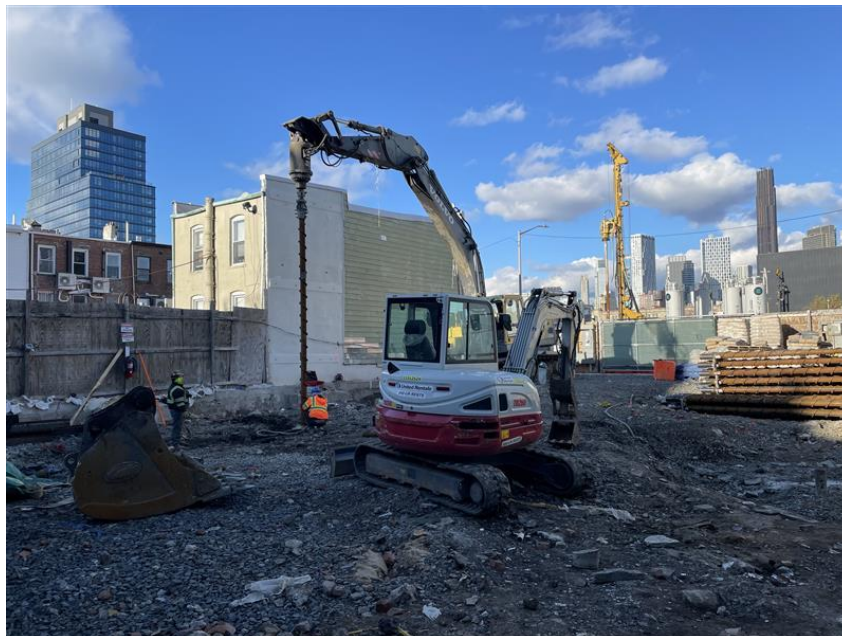
*Photo 2: View of Blanco installing structural pile, facing Northeast.*
