DAILY FIELD REPORT

Project	Former A&A Brake Service Site	Report No.	78
BCP Site	NYSDEC BCP SITE C224372	Date	12/04/2024
Location	558 Sackett Street	File No.	0206384
Client	Sackett Heights LLC	Temperature	H: 33°F L: 42°F
Contractor	Blue Sky Builders, Blanco	Wind Direction	SW to NE, up to 7 mph
Weather	Partly Cloudy	Personnel on Site	George Poulton
Humidity	41%	Time on Site	6:30 am to 5:00 pm

WEEKLY MONITORING REPORT

Weekly Monitoring
12/4/2024 - 12/4/2024

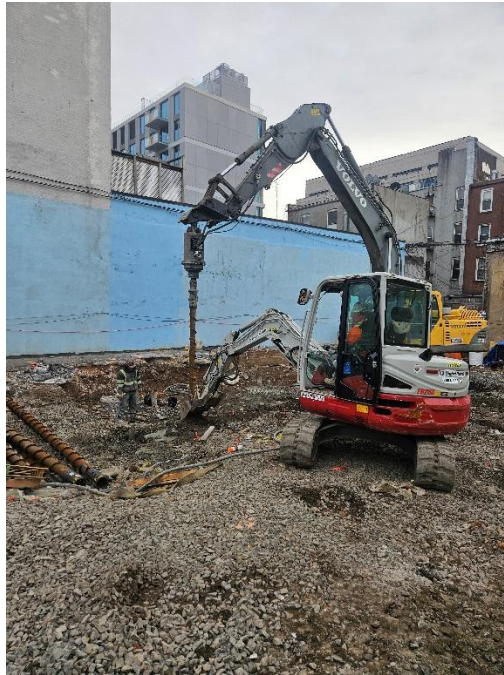
Photo 1: View of Blanco installing structural pile, facing Southeast.

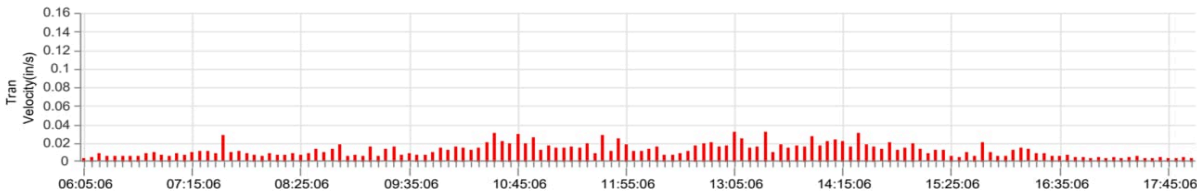
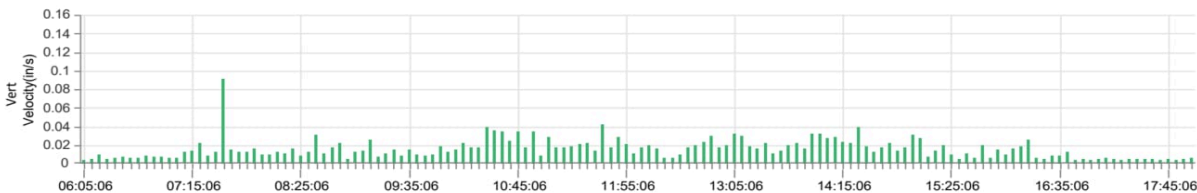
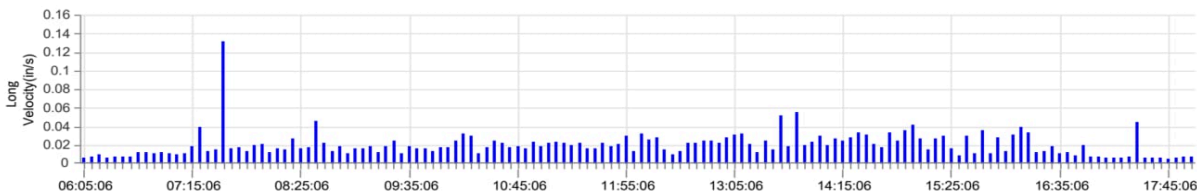
Sensor Check

✓ Passed

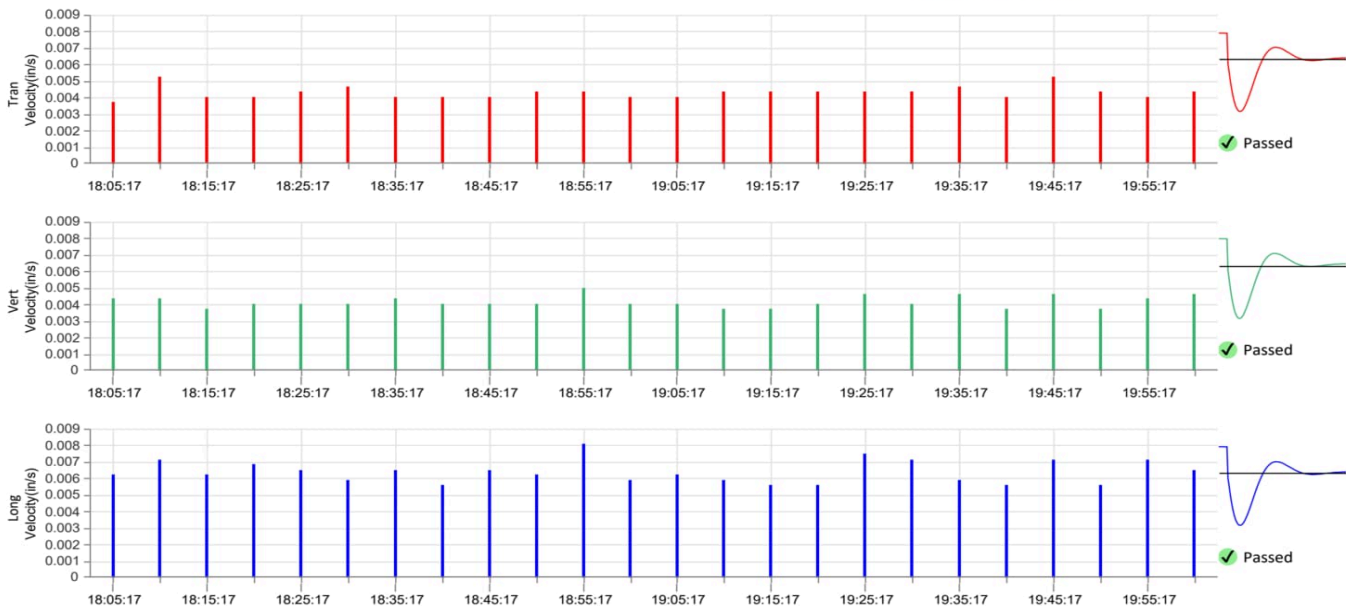
USBM R18507 And OSMRE
Velocity versus Frequency (Zero Crossing)

Peak Vector Sum 0.0089 in/s at December 4, 2024 18:55:17
