DAILY FIELD REPORT

Project	Former A&A Brake Service Site	Report No.	79
BCP Site	NYSDEC BCP SITE C224372	Date	12/05/2024
Location	558 Sackett Street	File No.	0206384
Client	Sackett Heights LLC	Temperature	H: 33°F L: 41°F
Contractor	Blue Sky Builders, Blanco	Wind Direction	SW to NE, up to 30 mph
Weather	Partly cloudy, light snow	Personnel on Site	George Poulton
Humidity	60%	Time on Site	6:30 am to 4:00 pm

WEEKLY MONITORING REPORT

Weekly Monitoring
12/5/2024 - 12/5/2024

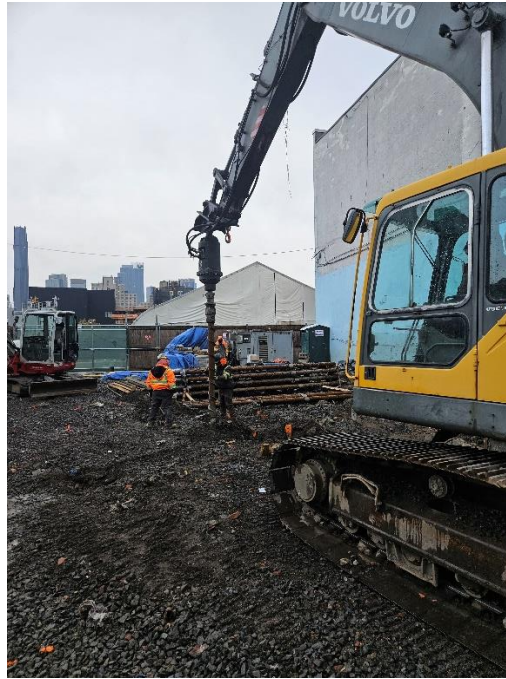
Photo 1: View of Blanco installing structural pile, facing North.

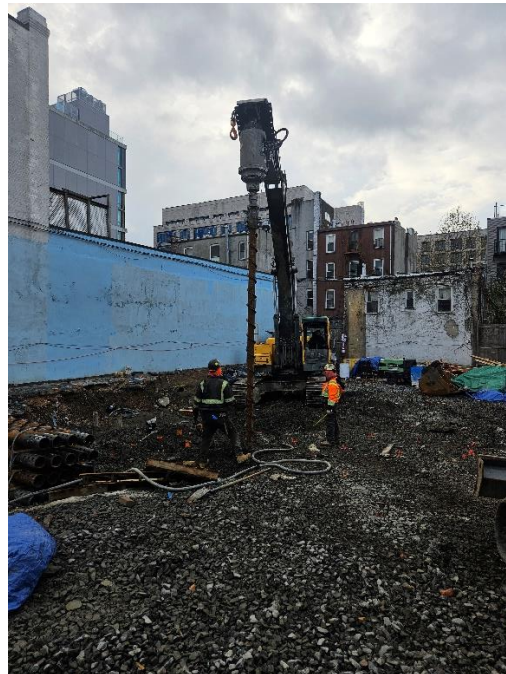
Photo 2: View of Blanco installing structural pile, facing Southeast.

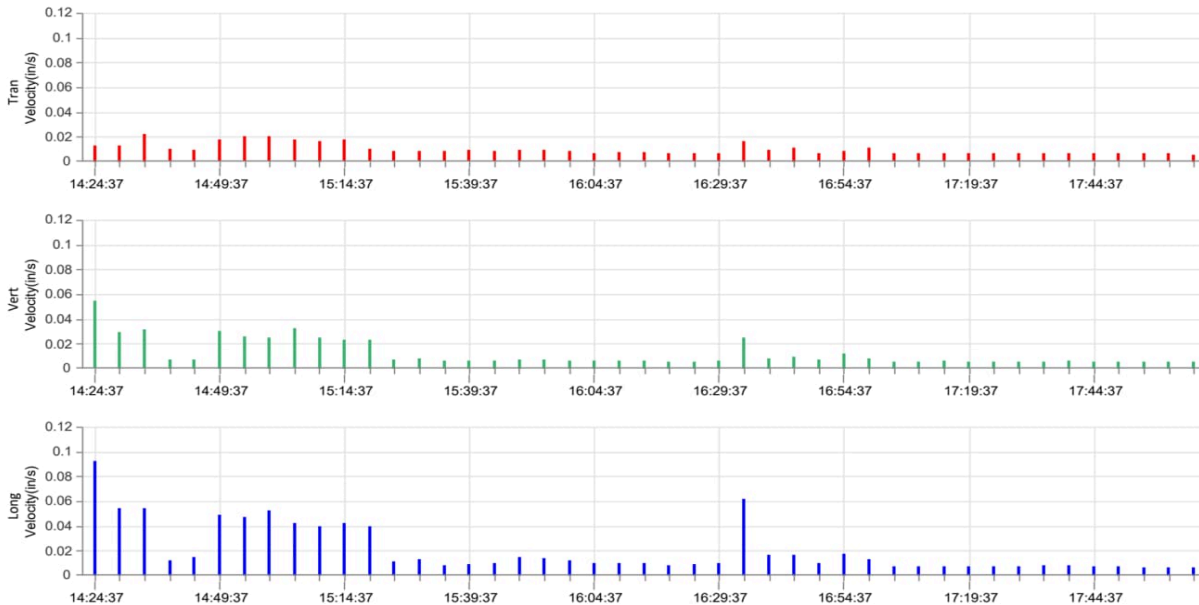
USBM R18507 And OSMRE
Velocity versus Frequency (Zero Crossing)

Peak Vector Sum 0.0928 in/s at December 5, 2024 14:24:37

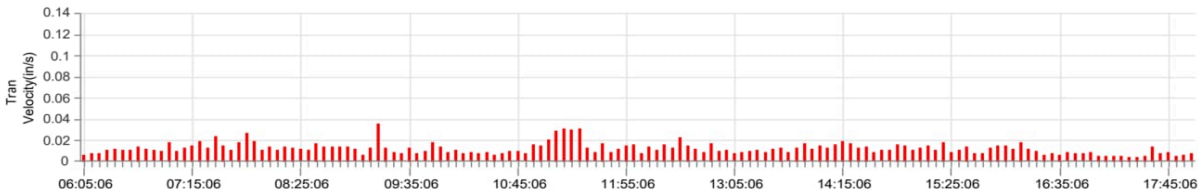
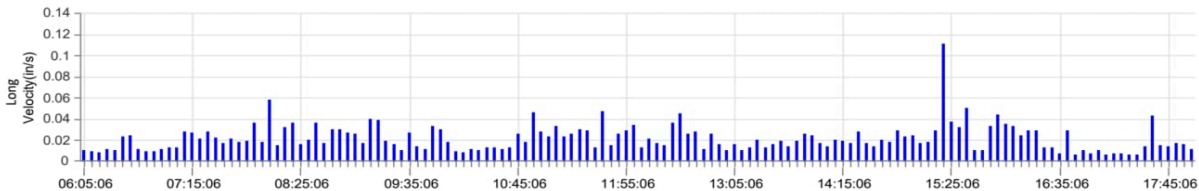
UM17486

Geophone	Tran	Vert	Long
Peak Particle Velocity	0.0351 in/s	0.0518 in/s	0.1114 in/s
Zero Crossing Frequency	6.4 Hz	5.4 Hz	30.1 Hz
Date	Dec 5, 2024	Dec 5, 2024	Dec 5, 2024
Time	09:15:06	11:15:06	15:20:06
Sensor Check	✓ Passed	✓ Passed	✓ Passed
Frequency	7.5 Hz	7.7 Hz	7.3 Hz
Overswing Ratio	4.2	4.0	4.4

Peak Vector Sum 0.1120 in/s at December 5, 2024 15:20:06
