DAILY FIELD REPORT

Project	Former A&A Brake Service Site	Report No.	82
BCP Site	NYSDEC BCP SITE C224372	Date	12/10/2024
Location	558 Sackett Street	File No.	0206384
Client	Sackett Heights LLC	Temperature	H: 58°F L: 46°F
Contractor	Blue Sky Builders, Blanco	Wind Direction	SW to NE, up to 15 mph
Weather	Light rain	Personnel on Site	George Poulton
Humidity	42%	Time on Site	6:30 am to 5:30 pm

WEEKLY MONITORING REPORT

Project Address:
558 Sackett Street,
Brooklyn,
Brooklyn NY 11215
BBL:/443/55

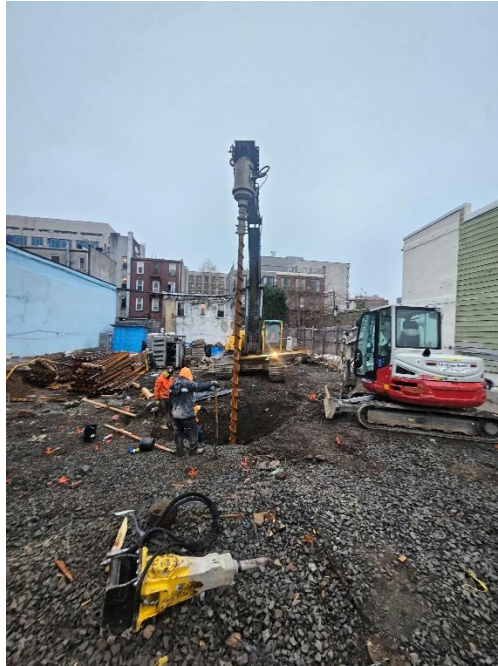
Photo 1: View of Blanco installing structural pile, facing South.

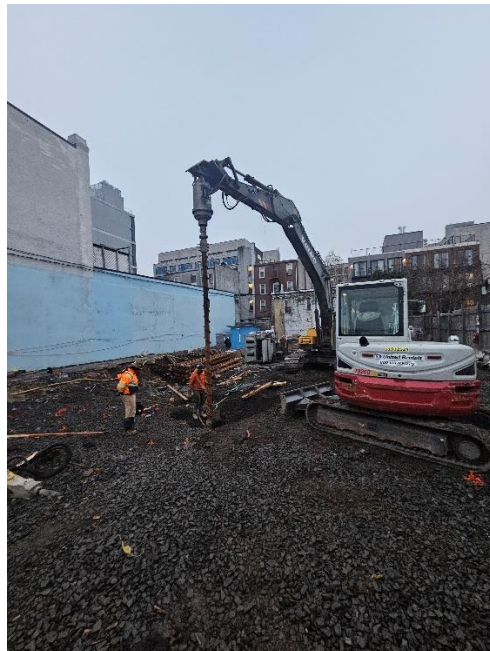
Photo 2: View of Blanco installing structural pile, facing Southeast.

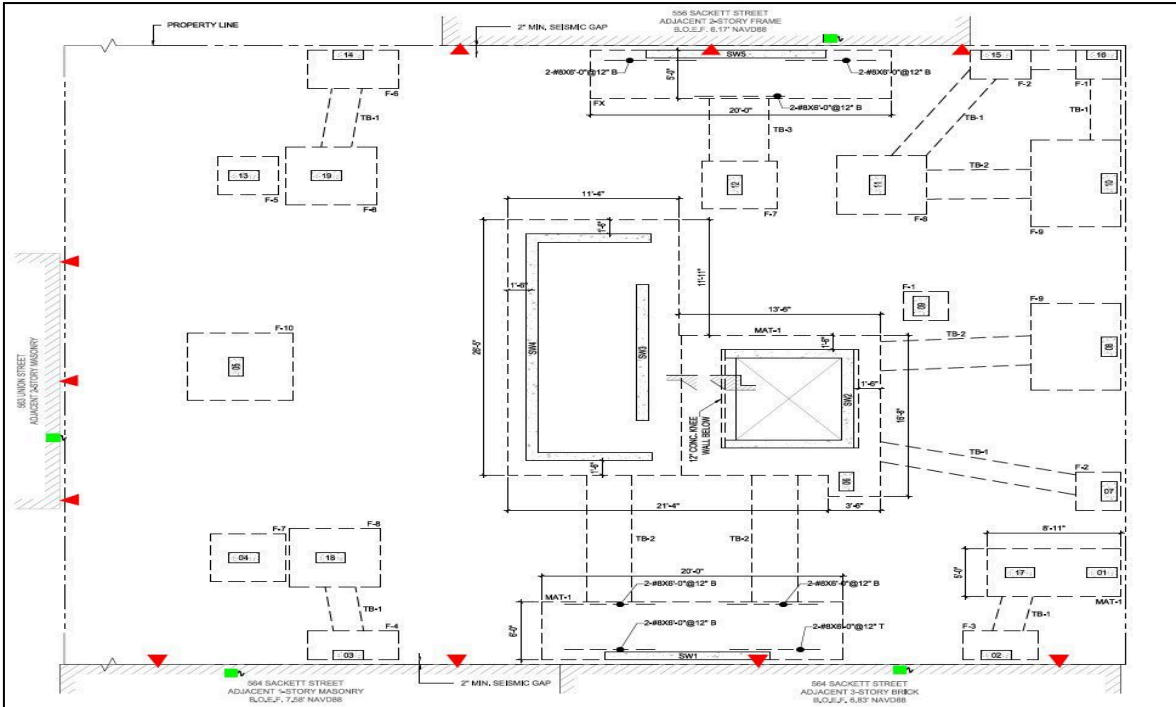
2 MONITORING PLAN

MONITORING LOCATION	THRESHOLD TYPE	
	REVIEW LEVEL	ACTION LEVEL
ADJACENT BUILDINGS	OPTICAL	
ADJACENT BUILDINGS	1/4 INCH	1/2 INCH
NYCT STRUCTURES	1/4 INCH	1/2 INCH
STREET AND SIDEWALK PAVEMENT	1/2 INCH	1 INCH
ADJACENT BUILDINGS	VIBRATION	
ADJACENT BUILDINGS	1.0 INCH/SECOND	2.0 INCH/SECOND
NYCT STRUCTURES	0.25 INCH/SECOND	0.5 INCH/SECOND
ADJACENT BUILDINGS	CRACK GAUGES	
ADJACENT BUILDINGS	3 MILLIMETERS	6 MILLIMETERS

MONITORING SUMMARY & PROTOCOL					
MONITORING TYPE	DESCRIPTION	FREQUENCY OF INSPECTION	SOFT LIMITS	THRESHOLD	REQUIRED ACTION IF THRESHOLD IS EXCEEDED
VIBRATION MONITORING	AUTOMATED REMOTE VIBRATION MONITORING WITH A THREE COMPONENT SEISMOGRAPH	REMOTE VIBRATION MONITORING DURING ALLOWANCE WORK HOURS. RECORDED EVENTS EXCEEDING THE THRESHOLD WILL BE UPLOADED TO A REMOTE SERVER AND AN EMAIL ALERT WILL BE SENT TO ALL RESPONSIBLE PARTIES.	PEAK PRACTICE VELOCITY $+1$ IN/S FOR ADJACENT STRUCTURES	PEAK PRACTICE VELOCITY $+2$ IN/S FOR ADJACENT STRUCTURES	IF VIBRATIONS EXCEED 2 IN/S FOR ADJACENT STRUCTURES STOP ALL WORK IMMEDIATELY AND TAKE ADDITIONAL OPTICAL AND CRACK GAUGE INSPECTIONS. ALL DATA MUST BE REVIEWED BY THE EOR AND MONITORING CONTRACTOR. THE WORK SHALL RESUME UPON APPROVAL BY THE CONSTRUCTION MANAGER, OWNER/ENGINEER OF APPROVED REMEDIAL MEASURES AND/OR MODIFIED CONSTRUCTION PROCEDURES.
HORIZONTAL AND VERTICAL CONTROLS	MANUAL OPTICAL SURVEYING WITH ELECTRONIC TOTAL STATION	CONDUCT OPTICAL MONITORING AT LEAST WEEKLY DURING ALL STAGES OF FOUNDATION CONSTRUCTION UNTIL COMPLETION OF FIRST FLOOR SLAB	0.25" DISPLACEMENT IN ANY DIRECTION	0.5" DISPLACEMENT IN ANY DIRECTION	IF VERTICAL OR LATERAL BUILDING MOVEMENT REACHES 0.5" IMMEDIATELY NOTIFY THE CONSTRUCTION MANAGER, OWNER, ENGINEER AND STOP WORK. THE WORK SHALL RESUME UPON APPROVAL BY THE CONSTRUCTION MANAGER, OWNER AND ENGINEER OF APPROVED REMEDIAL MEASURES AND/OR MODIFIED CONSTRUCTION PROCEDURES.

CRACK GAUGE MONITORING	MANUAL OBSERVATION AND RECORDING OF MEASUREMENT WITH THE STAMPED DIGITAL PHOTOGRAPHY	AT SAME FREQUENCY AS OPTICAL MONITORING INSPECTIONS	3mm DISPLACEMENT IN ANY DIRECTION	6mm DISPLACEMENT IN ANY DIRECTION	IF MOVEMENT REACHES 6mm IMMEDIATELY NOTIFY THE CONSTRUCTION MANAGER, OWNER, ENGINEER AND STOP WORK. THE WORK SHALL RESUME UPON APPROVAL BY THE CONSTRUCTION MANAGER, OWNER AND ENGINEER OF APPROVED REMEDIAL MEASURES AND/OR MODIFIED CONSTRUCTION PROCEDURES.

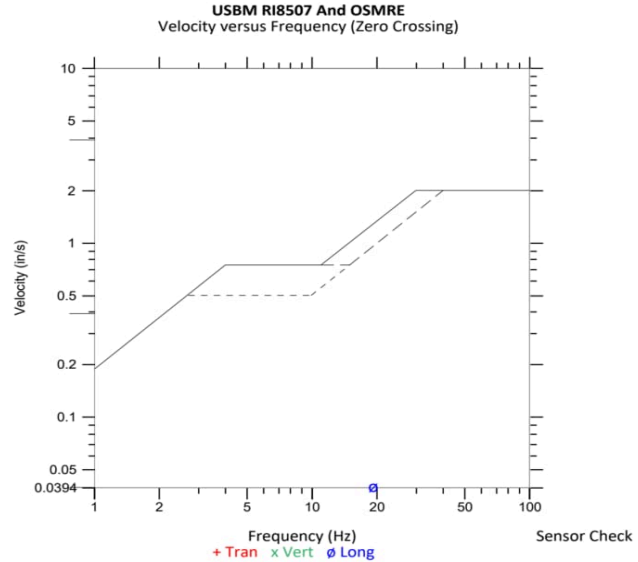
Geophone	Tran	Vert	Long
Peak Particle Velocity	0.0115 in/s	0.0127 in/s	0.0397 in/s
Zero Crossing Frequency	32.0 Hz	15.5 Hz	19.0 Hz
Date	Dec 10, 2024	Dec 10, 2024	Dec 10, 2024
Time	18:05:30	18:05:30	18:05:30
Sensor Check	✓ Passed	✓ Passed	✓ Passed
Frequency	7.3 Hz	7.3 Hz	7.3 Hz
Overswing Ratio	4.6	4.8	5.1
Peak Vector Sum	0.0398 in/s at December 10, 2024 18:05:30
