# DAILY FIELD REPORT

<b>Project</b>	Former A&A Brake Service Site	<b>Report No.</b>	84
<b>BCP Site</b>	NYSDEC BCP SITE C224372	<b>Date</b>	12/12/2024
<b>Location</b>	558 Sackett Street	<b>File No.</b>	0206384
<b>Client</b>	Sackett Heights LLC	<b>Temperature</b>	H: 42°F L: 30°F
<b>Contractor</b>	Blue Sky Builders, Blanco	<b>Wind Direction</b>	NW to SE, up to 25 mph
<b>Weather</b>	Overcast	<b>Personnel on Site</b>	George Poulton
<b>Humidity</b>	39%	<b>Time on Site</b>	6:30 am to 6:00 pm

H & A of New York Engineering and Geology, LLP (Haley & Aldrich) was present document implementation of the May 2024 NYSDEC-Approved Remedial Action Work Plan (RAWP) and Decision Document for the Former A&A Brake Service Site C224372, located at 558 Sackett Street, Brooklyn, NY. Site observations are summarized below.

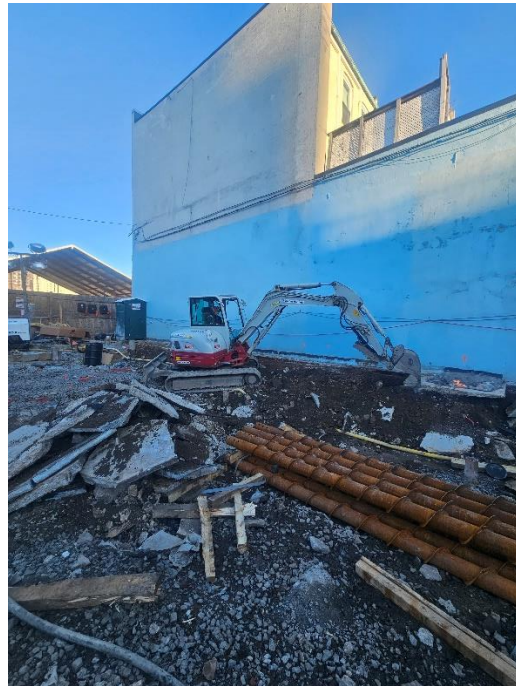
*Photo 2: View of Blanco removing concrete slab in the eastern portion of the site, facing Northeast.*

- Chris DiScafani from WSP arrived on-site to document field activities on behalf of the NYSDEC, no complaints were noted.
- Contractor (Blanco) continued installation of structural piles.
- A vibration exceedance of 1.7932 in/s was observed at 14:31 pm, which may have been caused by the movement of a concrete slab on-site.

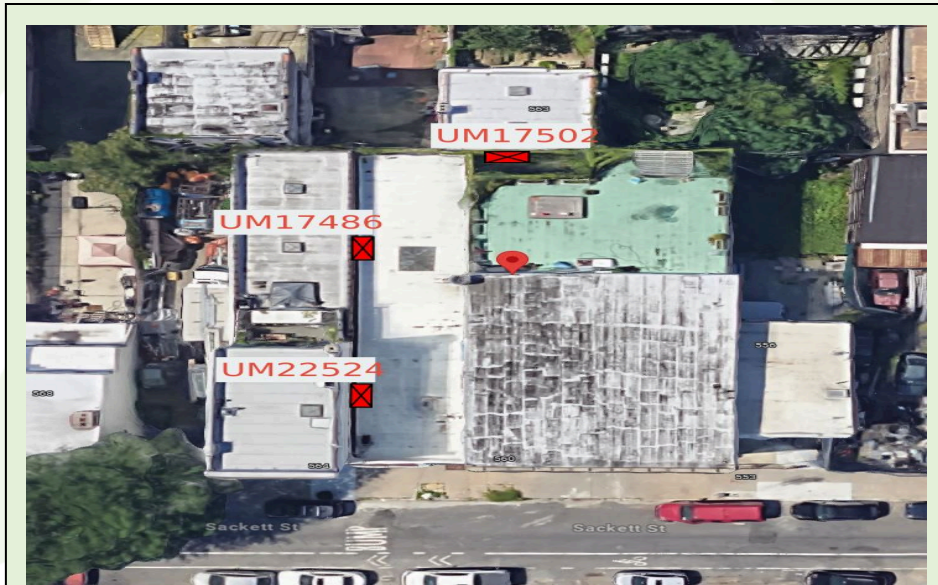
<p><b>QUIVER</b> MONITORING</p>	<p>Vibration Monitoring Layout 558 Sackett Street, Brooklyn Brooklyn NY 11215</p>	<p>Date of Installation MM/DD/YY 06/24/24</p>
---	---	---

Quiver Monitoring recommends the following vibration monitoring layout.

1. **UM17486:** Is installed at the 564 Sackett Street Exterior, front.
2. **UM17502:** Is installed at the 563 Union Street Exterior.
3. **UM22524:** Is installed at the 564 Sackett Street Exterior, rear.

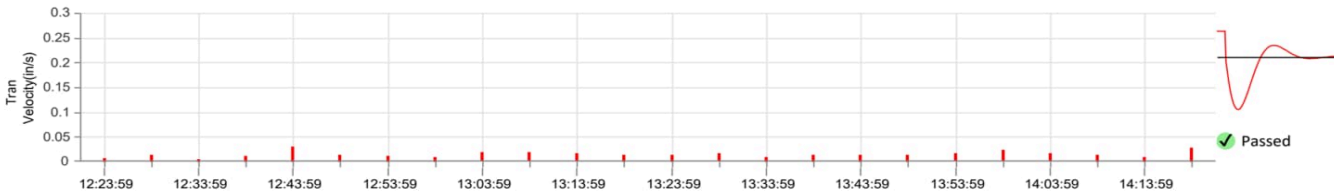
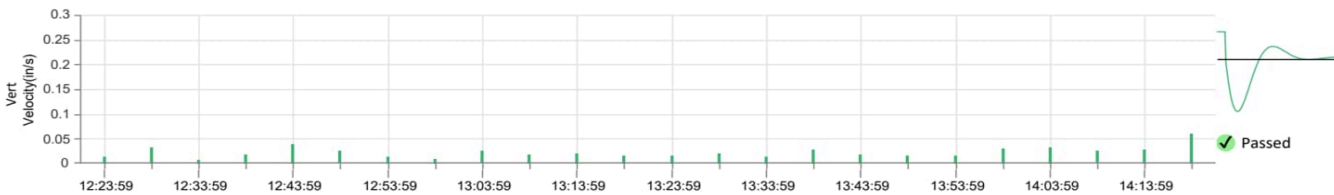
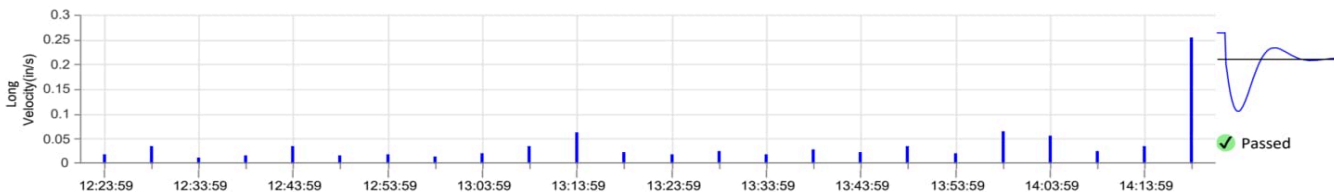
Geophone	Tran	Vert	Long
Peak Particle Velocity	0.0292 in/s	0.0605 in/s	0.2548 in/s
Zero Crossing Frequency	6.0 Hz	>100 Hz	>100 Hz
Date	Dec 12, 2024	Dec 12, 2024	Dec 12, 2024
Time	12:43:59	14:18:47	14:18:47
Sensor Check	✓ Passed	✓ Passed	✓ Passed
Frequency	7.5 Hz	7.7 Hz	7.3 Hz
Overswing Ratio	4.2	3.9	4.5

Peak Vector Sum 0.2566 in/s at December 12, 2024 14:18:59
