# DAILY FIELD REPORT

| <b>Project</b> | Former A&A Brake Service Site | <b>Report No.</b> | 86 |
| <b>Location</b> | 558 Sackett Street | <b>File No.</b> | 0206384 |

## WEEKLY MONITORING REPORT

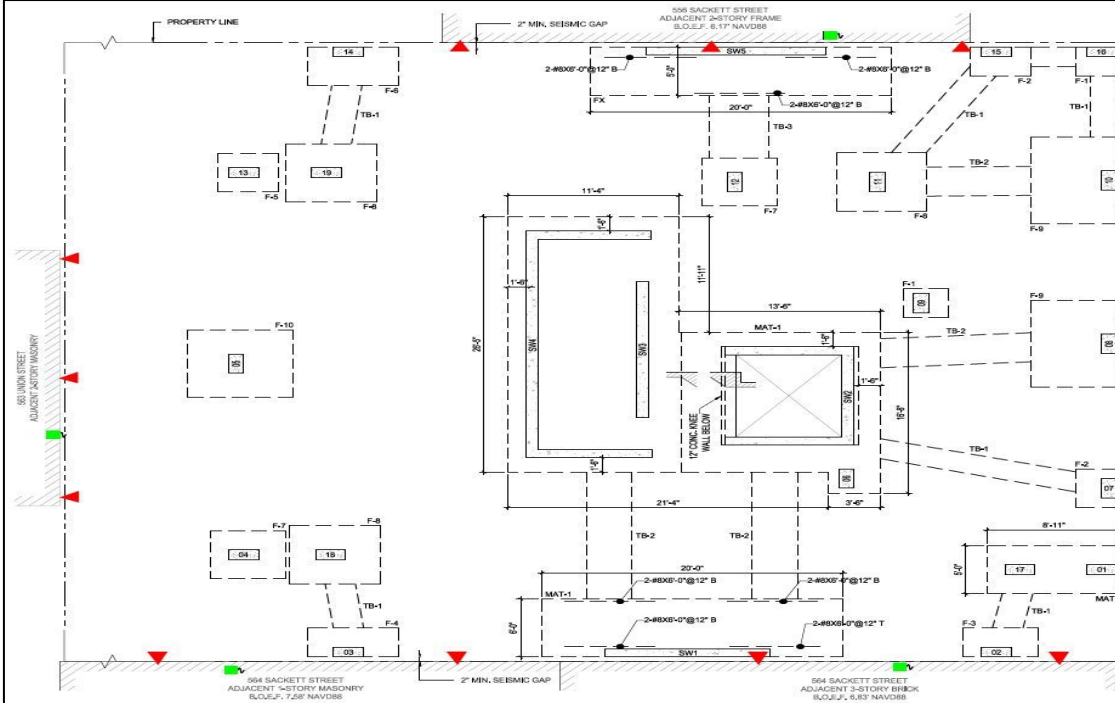
## 2 MONITORING PLAN

1. FOR ALL FOUNDATION AND FOOTING INFORMATION, SEE FO-101.
2. ALL MONITORING REPORT MUST BE SENT TO [MONITORING@ELEVATEDENGINEERINGNYC.COM](mailto:MONITORING@ELEVATEDENGINEERINGNYC.COM)
3. REFER TO MONITORING NOTES ON FC-001 FOR DETAILS.
4. VIBRATION MONITORING SHALL BE PLACED BEFORE EXCAVATION AND PROVIDE REALTIME ALERT TO ENGINEER OF RECORD.
5. OPTICAL MONITORING SHALL BE PLACED PRIOR TO EXCAVATION AND READING IS REQUIRED ONCE A WEEK DURING EXCAVATION WORK
6. THE FOLLOWING ARE THE MONITORING LIMITS:

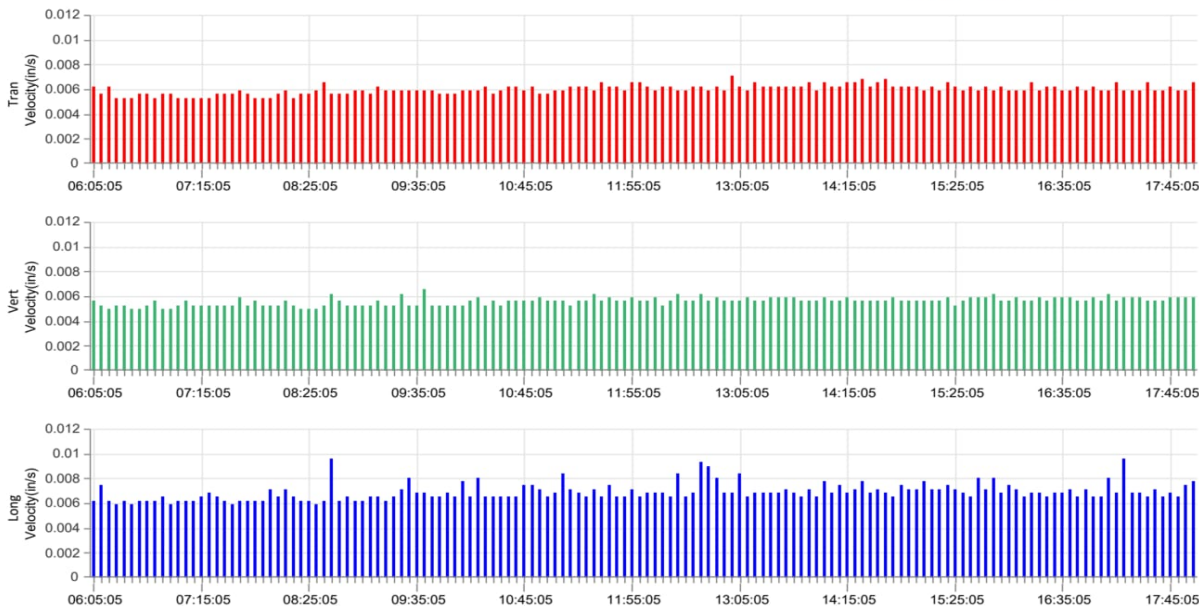
**USBM R18507 And OSMRE**  
Velocity versus Frequency (Zero Crossing)

Peak Vector Sum 0.0109 in/s at December 15, 2024 12:40:05
