DAILY FIELD REPORT

| Project | Former A&A Brake Service Site | Report No. | 87 |
| Location | 558 Sackett Street | File No. | 0206384 |

H & A of New York Engineering and Geology, LLP (Haley & Aldrich) was present document implementation of the May 2024 NYSDEC-Approved Remedial Action Work Plan (RAWP) and Decision Document for the Former A&A Brake Service Site C224372, located at 558 Sackett Street, Brooklyn, NY. Site observations are summarized below.

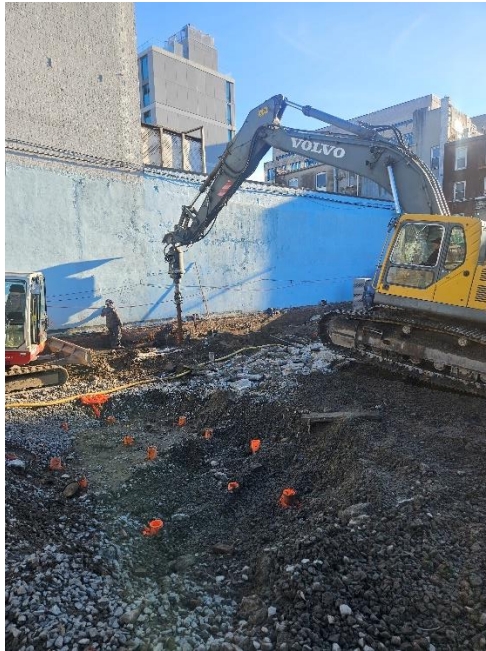
Photo 1: View of Blanco installing structural pile, facing Southeast.

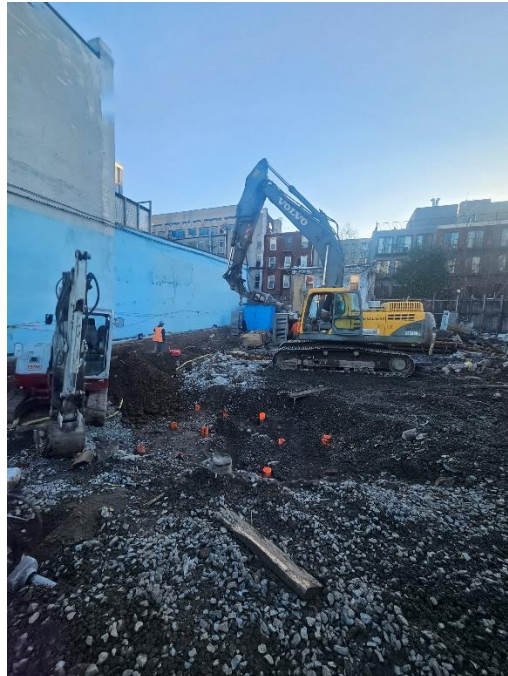
Photo 2: View of Site conditions at shift end, facing Southeast.

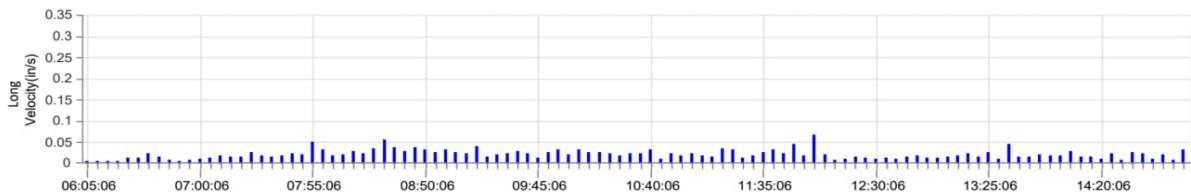
Peak Vector Sum 0.3028 in/s at December 17, 2024 15:05:06

Serial Number UM17486
Model Number Micromate ISEE 10.90GC
Battery Level 3.8 volts
Unit Calibration March 22, 2023 by InstanTel
Event File Name UM17486_20241217060006.IDFH
USB Sensor Support Disabled

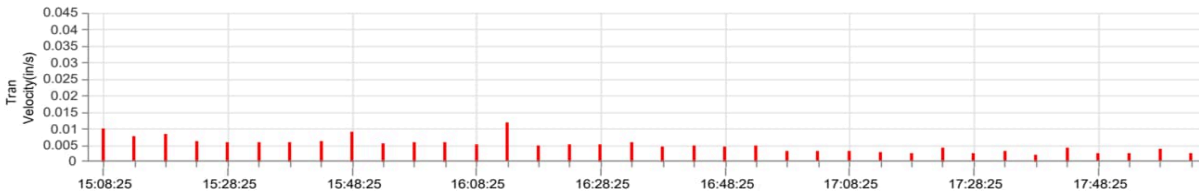
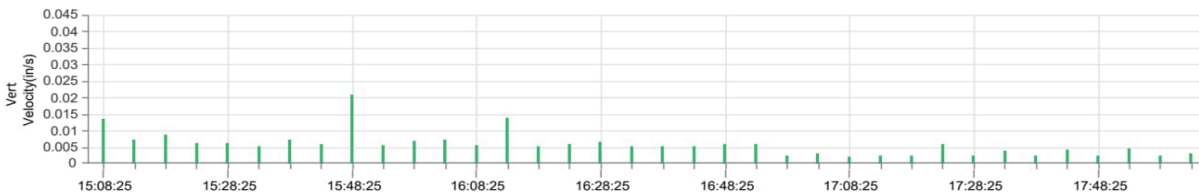
USBM RI8507 And OSMRE
Velocity versus Frequency (Zero Crossing)

Peak Vector Sum 0.0393 in/s at December 17, 2024 17:43:25
