# DAILY FIELD REPORT

<b>Project</b>	Former A&A Brake Service Site	<b>Report No.</b>	88
<b>BCP Site</b>	NYSDEC BCP SITE C224372	<b>Date</b>	12/18/2024
<b>Location</b>	558 Sackett Street	<b>File No.</b>	0206384
<b>Client</b>	Sackett Heights LLC	<b>Temperature</b>	H: 53°F L: 43°F
<b>Contractor</b>	Blue Sky Builders, Blanco	<b>Wind Direction</b>	SE to NW, up to 14 mph
<b>Weather</b>	Overcast	<b>Personnel on Site</b>	George Poulton
<b>Humidity</b>	45%	<b>Time on Site</b>	6:30 am to 6:30 pm

H & A of New York Engineering and Geology, LLP (Haley & Aldrich) was present document implementation of the May 2024 NYSDEC-Approved Remedial Action Work Plan (RAWP) and Decision Document for the Former A&A Brake Service Site C224372, located at 558 Sackett Street, Brooklyn, NY. Site observations are summarized below.

## WEEKLY MONITORING REPORT

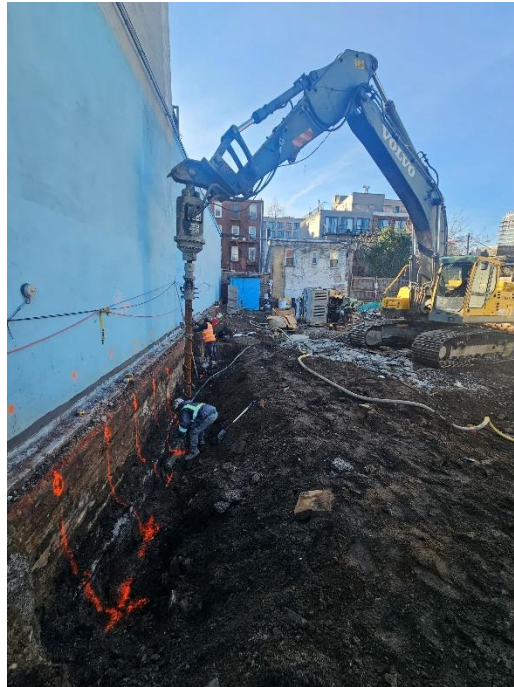
*Photo 1: View of Blanco installing structural pile, facing South.*

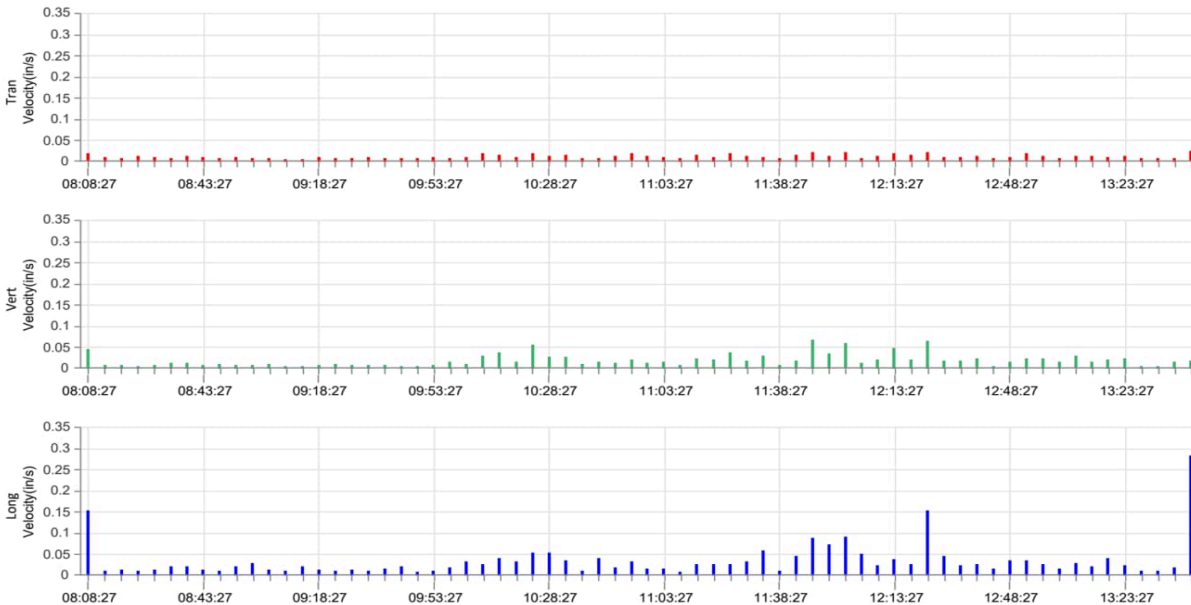
USBM R18507 And OSMRE  
Velocity versus Frequency (Zero Crossing)

December 18, 2024 08:03:27  
December 18, 2024 13:41:59  
67.71/300 sec  
1024 sps  
558 Sackett Street S4.mmb  
Quiver League

Geophone	Tran	Vert	Long
Peak Particle Velocity	0.0248 in/s	0.0680 in/s	0.2818 in/s
Zero Crossing Frequency	28.4 Hz	10.4 Hz	23.3 Hz
Date	Dec 18, 2024	Dec 18, 2024	Dec 18, 2024
Time	13:41:59	11:48:27	13:41:59
Sensor Check	✓ Passed	✓ Passed	✓ Passed
Frequency	7.5 Hz	7.7 Hz	7.3 Hz
Overswing Ratio	4.2	3.9	4.4
Peak Vector Sum	0.2828 in/s at December 18, 2024 13:43:27
