# DAILY FIELD REPORT

<b>Project</b>	Former A&A Brake Service Site	<b>Report No.</b>	89
<b>BCP Site</b>	NYSDEC BCP SITE C224372	<b>Date</b>	12/19/2024
<b>Location</b>	558 Sackett Street	<b>File No.</b>	0206384
<b>Client</b>	Sackett Heights LLC	<b>Temperature</b>	H: 45°F L: 37°F
<b>Contractor</b>	Blue Sky Builders, Blanco, A1 Waterproofing	<b>Wind Direction</b>	SE to NW, up to 23 mph
<b>Weather</b>	Overcast	<b>Personnel on Site</b>	George Poulton
<b>Humidity</b>	58%	<b>Time on Site</b>	6:30 am to 5:30 pm

## WEEKLY MONITORING REPORT

**Weekly Monitoring**  
12/19/2024 - 12/20/2024

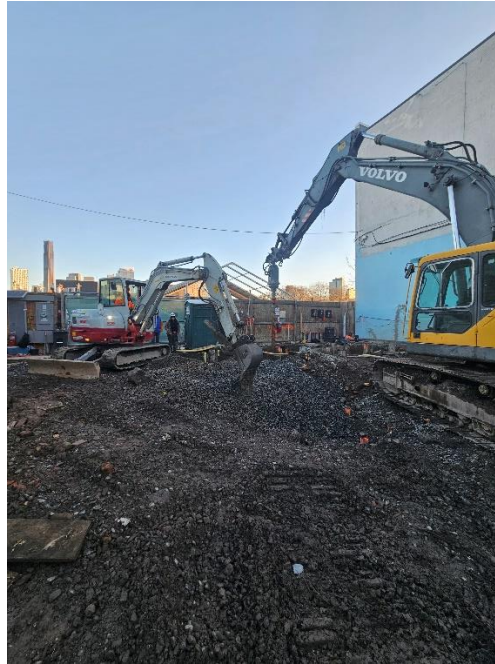
*Photo 1: View of Blanco installing structural pile, facing North.*

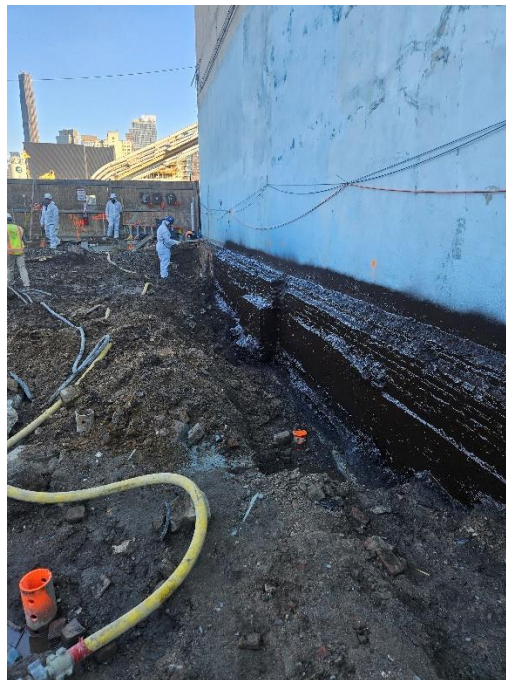
*Photo 2: View of A1 applying waterproofing to East boundary foundation wall, facing North.*

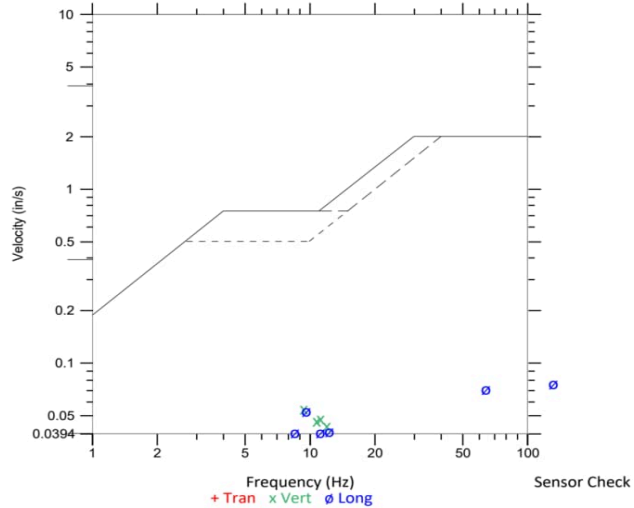
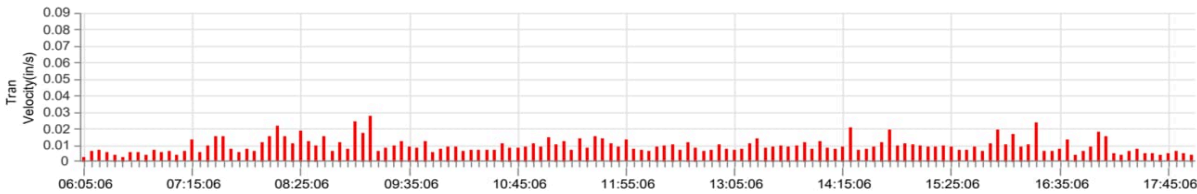
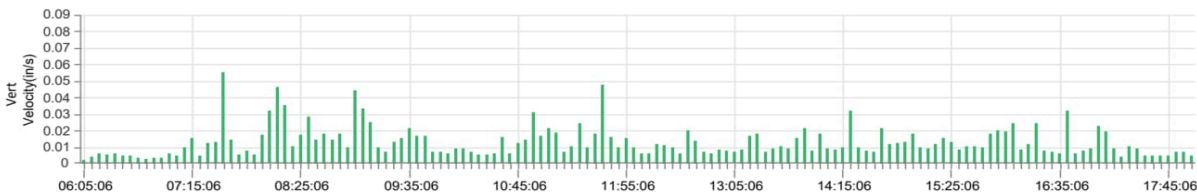
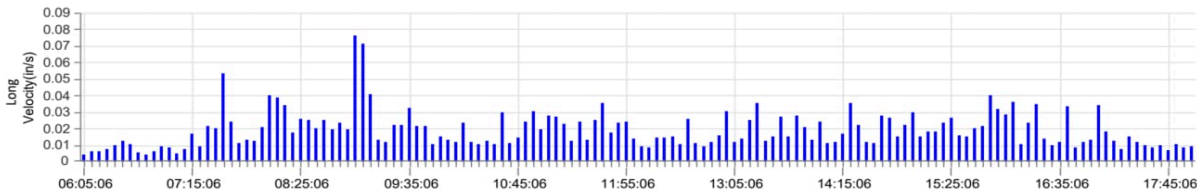
Peak Vector Sum 0.0765 in/s at December 19, 2024 09:00:06

**USBM R18507 And OSMRE**  
 Velocity versus Frequency (Zero Crossing)

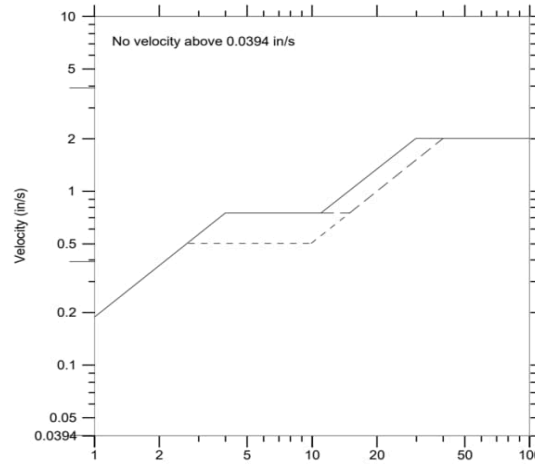
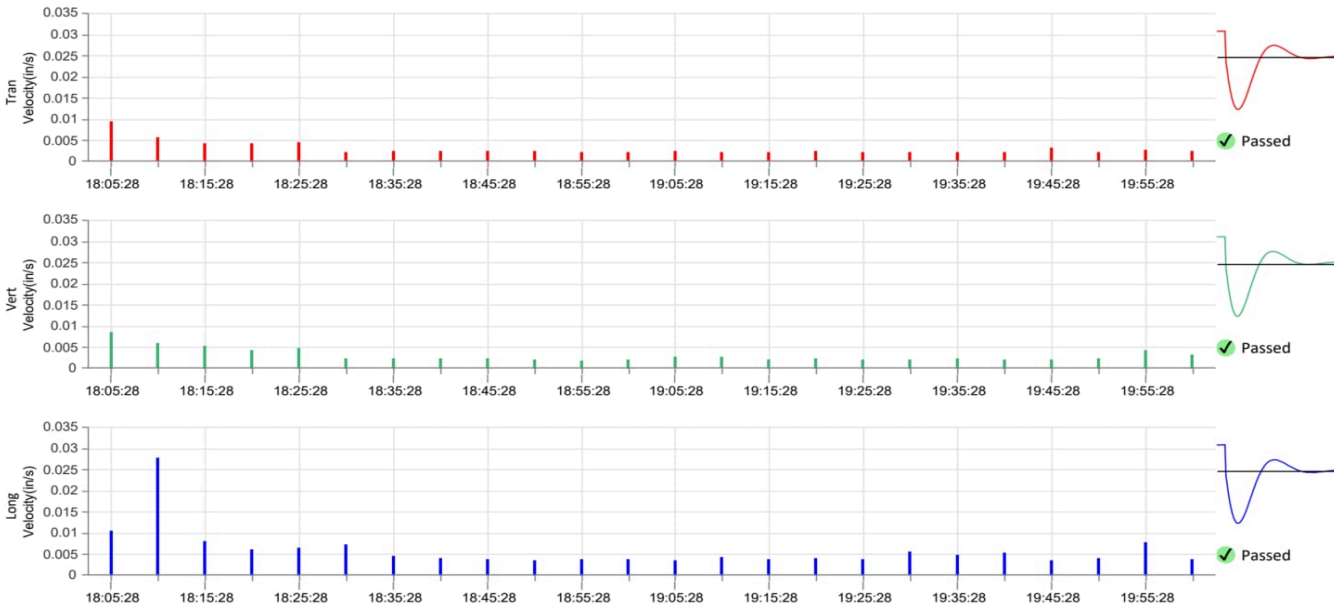
Peak Vector Sum 0.0277 in/s at December 19, 2024 18:10:28

**USBM RI8507 And OSMRE**  
Velocity versus Frequency (Zero Crossing)

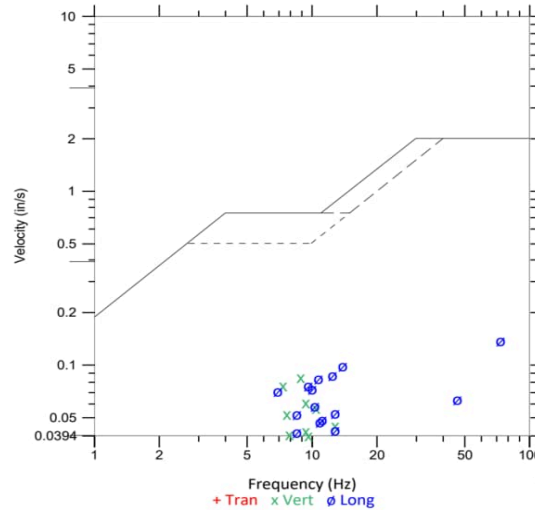
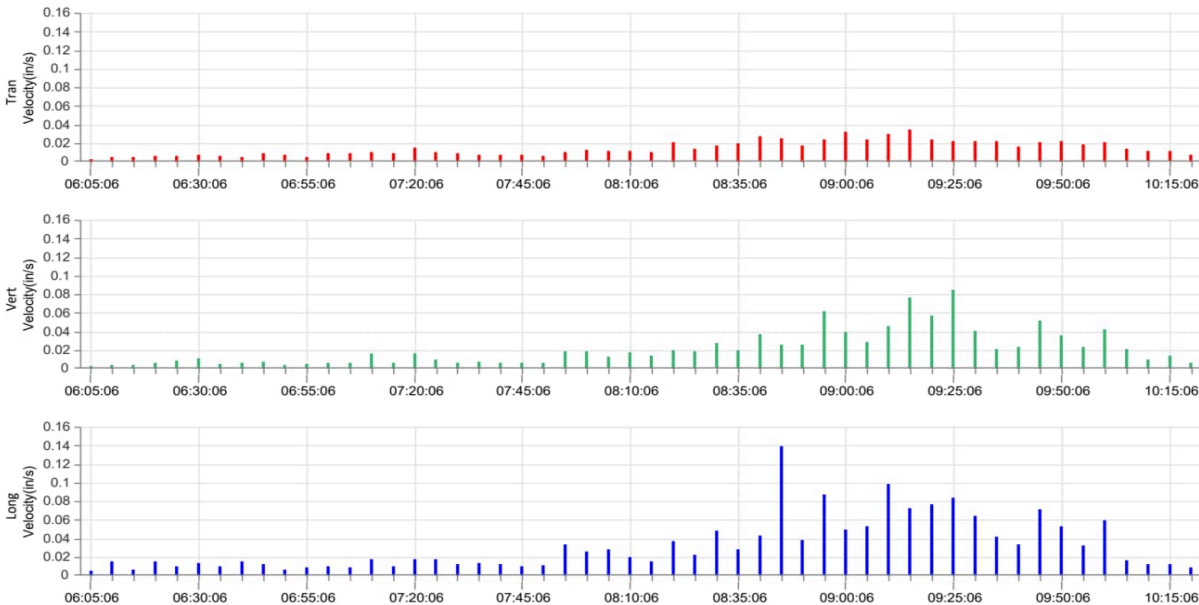
Geophone	Tran	Vert	Long
Peak Particle Velocity	0.0344 in/s	0.0847 in/s	0.1387 in/s
Zero Crossing Frequency	4.5 Hz	8.8 Hz	73.1 Hz
Date	Dec 20, 2024	Dec 20, 2024	Dec 20, 2024
Time	09:15:06	09:25:06	08:45:06
Sensor Check	✓ Passed	✓ Passed	✓ Passed
Frequency	7.5 Hz	7.7 Hz	7.3 Hz
Overswing Ratio	4.2	4.0	4.5
Peak Vector Sum	0.1401 in/s at December 20, 2024 08:45:06

**USBM RI8507 And OSMRE**  
 Velocity versus Frequency (Zero Crossing)

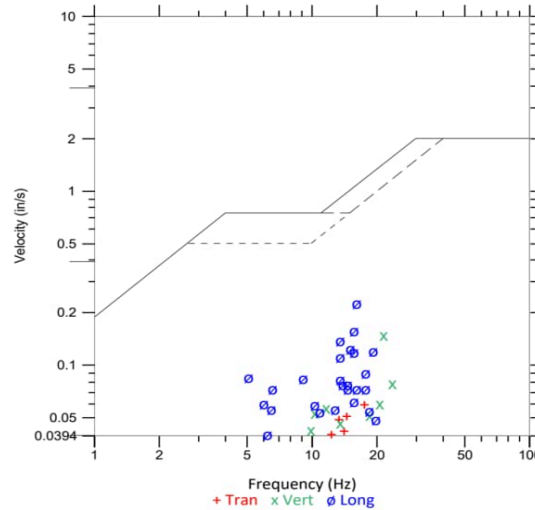
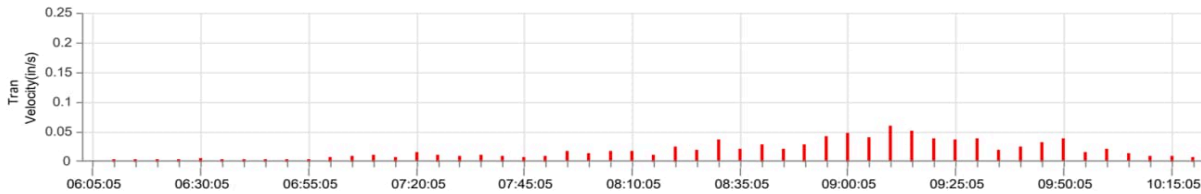
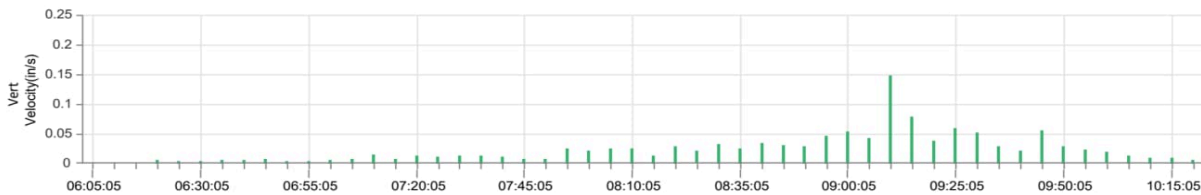
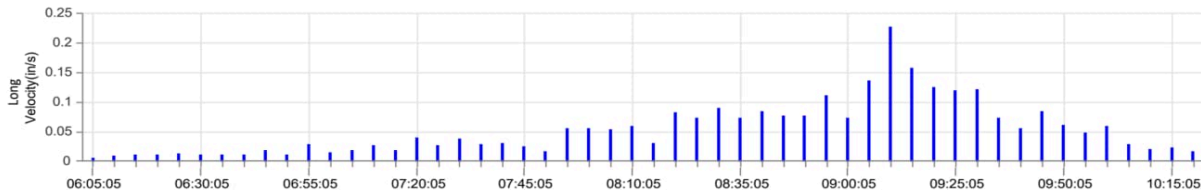
Peak Vector Sum 0.2312 in/s at December 20, 2024 09:10:05

USBM R18507 And OSMRE  
Velocity versus Frequency (Zero Crossing)
