DAILY FIELD REPORT

Project	Former A&A Brake Service Site	Report No.	90
BCP Site	NYSDEC BCP SITE C224372	Date	12/20/2024
Location	558 Sackett Street	File No.	0206384
Client	Sackett Heights LLC	Temperature	H: 38°F L: 34°F
Contractor	Blue Sky Builders, Blanco	Wind Direction	NE to SW, up to 22 mph
Weather	Light snow	Personnel on Site	George Poulton
Humidity	78%	Time on Site	6:30 am to 5:00 pm

WEEKLY MONITORING REPORT

Weekly Monitoring
12/19/2024 - 12/20/2024

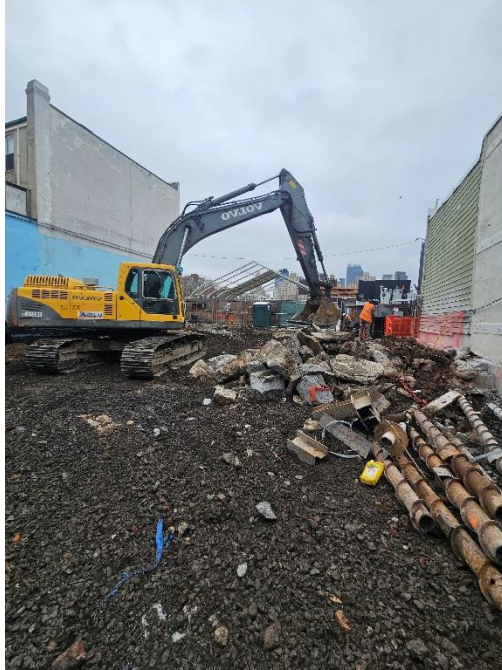
Photo 1: View of Blanco stockpiling C&D for removal, facing North.

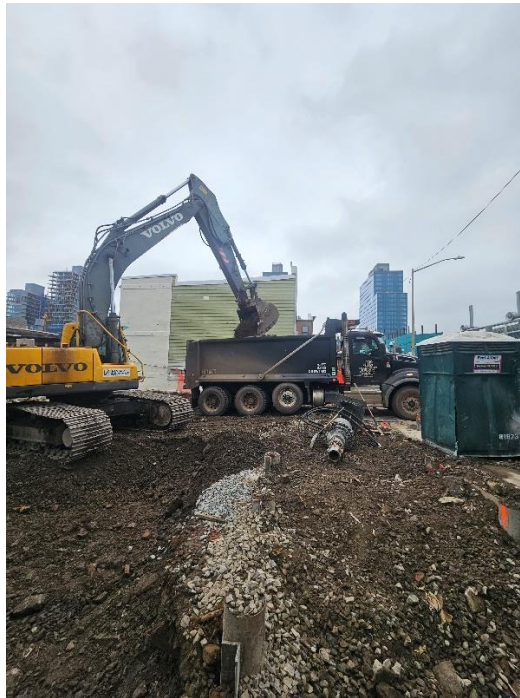
Photo 2: View of contractor loading soil for off-Site disposal, facing West.

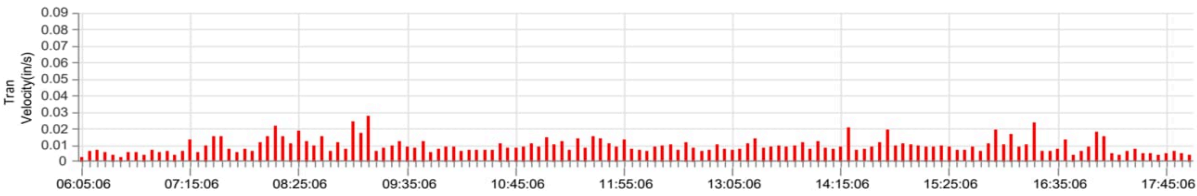
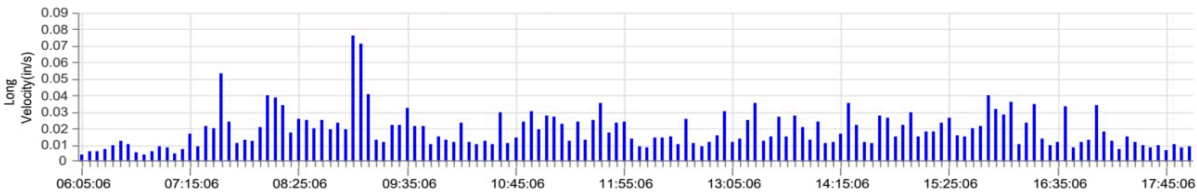
Geophone	Tran	Vert	Long
Peak Particle Velocity	0.0279 in/s	0.0552 in/s	0.0760 in/s
Zero Crossing Frequency	8.7 Hz	9.3 Hz	>100 Hz
Date	Dec 19, 2024	Dec 19, 2024	Dec 19, 2024
Time	09:10:06	07:35:06	09:00:06
Sensor Check	✓ Passed	✓ Passed	✓ Passed
Frequency	7.5 Hz	7.7 Hz	7.3 Hz
Overswing Ratio	4.2	3.9	4.4
Peak Vector Sum	0.0765 in/s at December 19, 2024 09:00:06

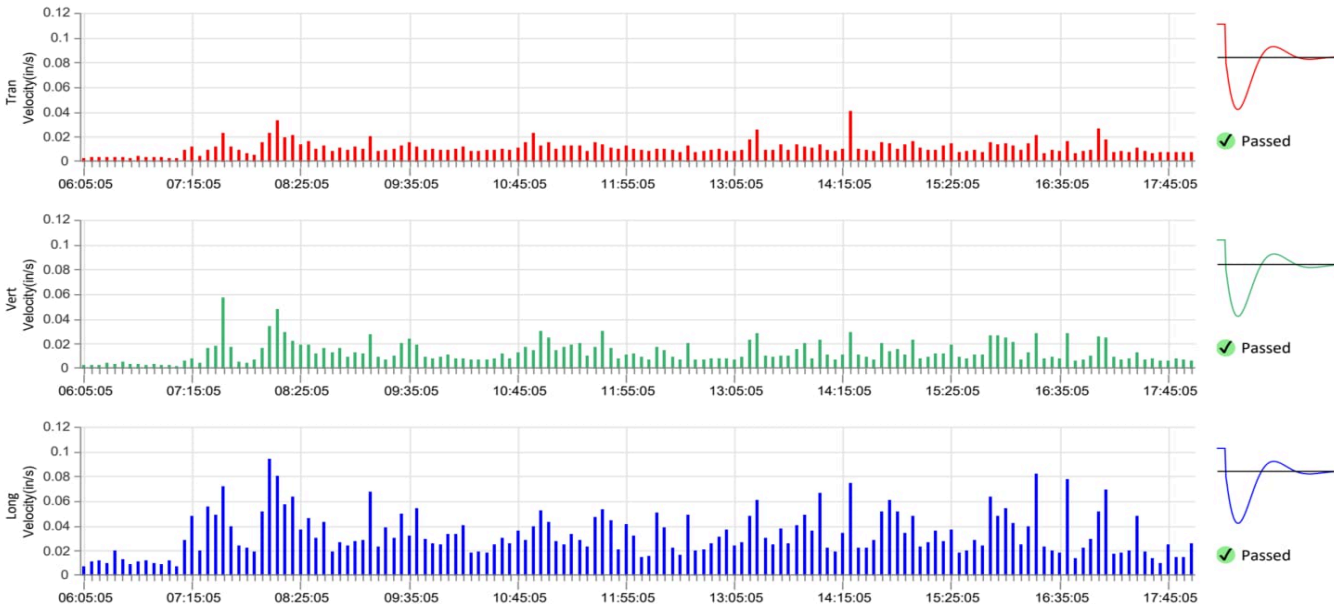
Geophone	Tran	Vert	Long
Peak Particle Velocity	0.0407 in/s	0.0568 in/s	0.0940 in/s
Zero Crossing Frequency	15.1 Hz	10.2 Hz	6.4 Hz
Date	Dec 19, 2024	Dec 19, 2024	Dec 19, 2024
Time	14:20:05	07:35:05	08:05:05
Sensor Check	✓ Passed	✓ Passed	✓ Passed
Frequency	7.5 Hz	7.3 Hz	7.3 Hz
Overswing Ratio	4.7	4.9	5.2

Peak Vector Sum 0.0942 in/s at December 19, 2024 08:05:05
