DAILY FIELD REPORT

Project	Former A&A Brake Service Site	Report No.	95
BCP Site	NYSDEC BCP SITE C224372	Date	1/7/2025
Location	558 Sackett Street	File No.	0206384
Client	Sackett Heights LLC	Temperature	H: 34°F L: 20°F
Contractor	Blue Sky Builders, International Concrete, Worldwide Concrete Cutting	Wind Direction	NW to SE, up to 30 mph
Weather	Overcast, light snow	Personnel on Site	George Poulton
Humidity	44%	Time on Site	6:30 am to 5:30 pm

H & A of New York Engineering and Geology, LLP (Haley & Aldrich) was present document implementation of the May 2024 NYSDEC-Approved Remedial Action Work Plan (RAWP) and Decision Document for the Former A&A Brake Service Site C224372, located at 558 Sackett Street, Brooklyn, NY. Site observations are summarized below.

WEEKLY MONITORING REPORT

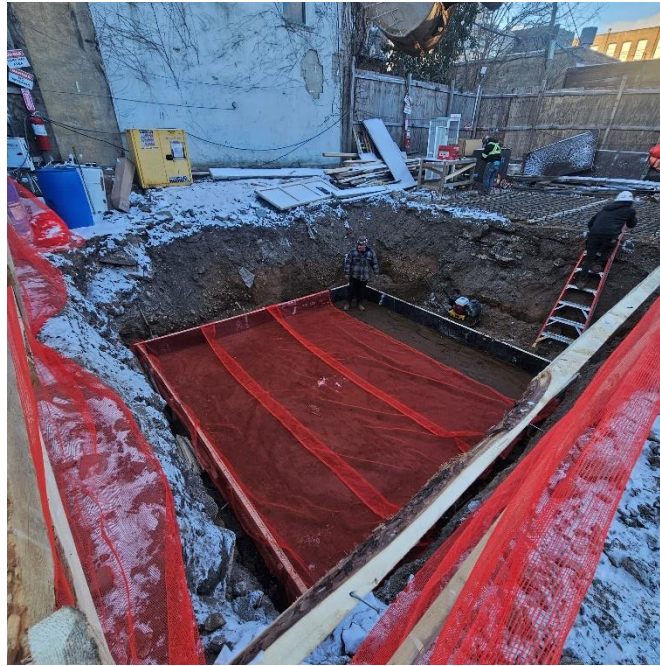
Photo 1: View of contractor laying red snow fencing as a demarcation barrier, facing Southwest.

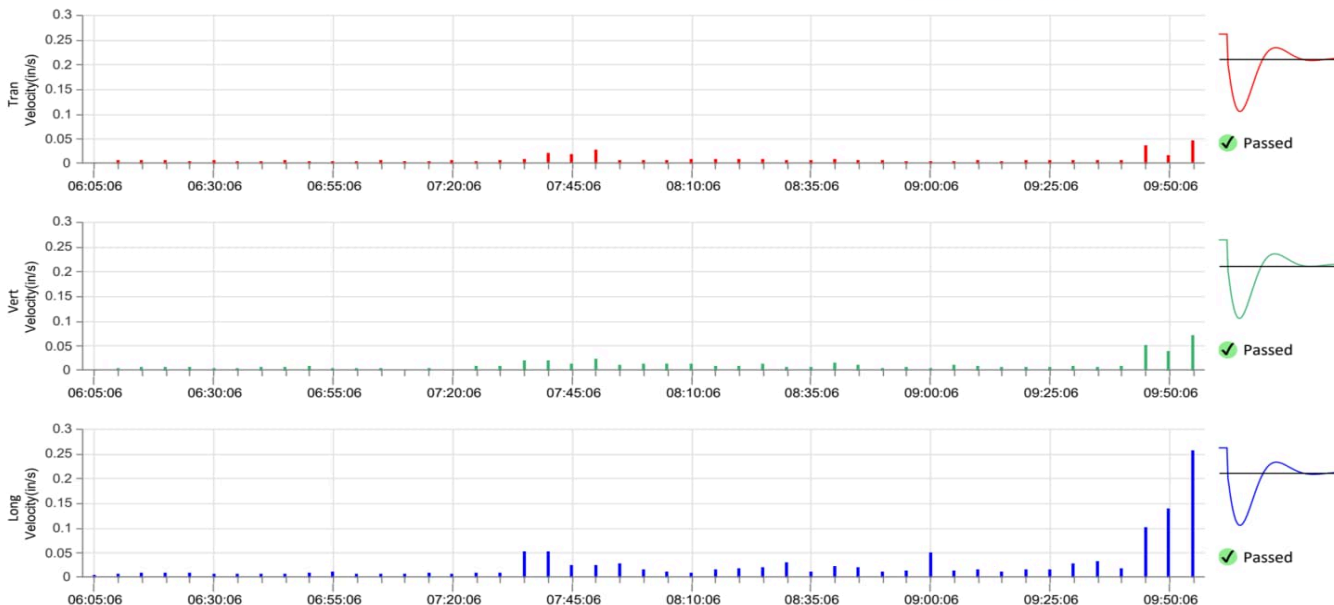
USBM R18507 And OSMRE
Velocity versus Frequency (Zero Crossing)

0.2606 in/s at January 7, 2025 09:55:06

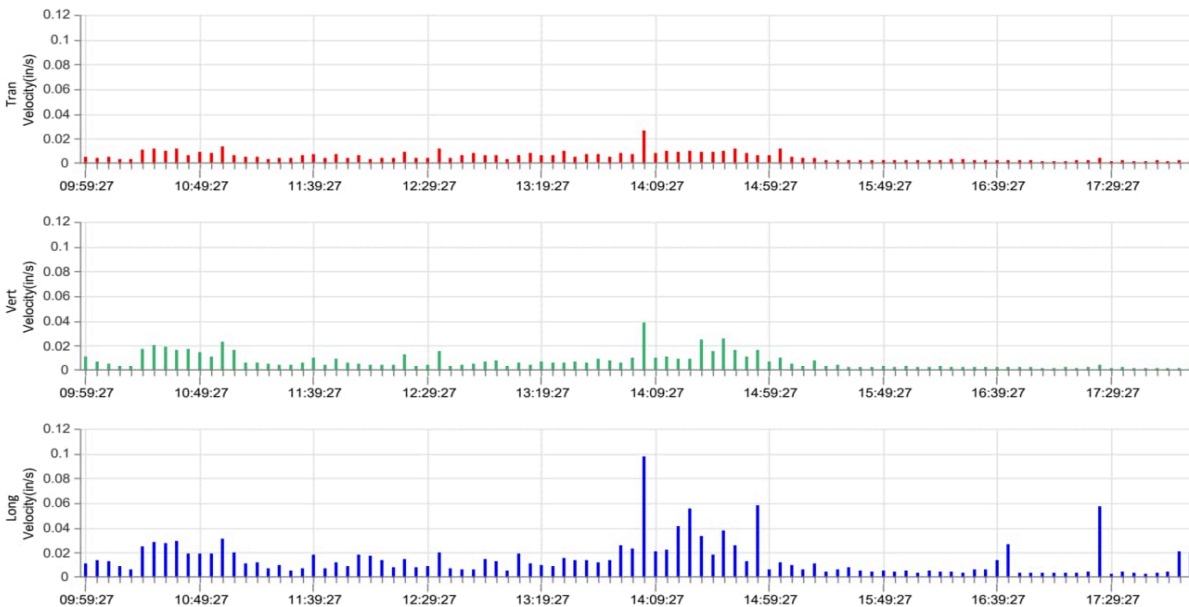
Tran	Vert	Long
0.0267 in/s	0.0388 in/s	0.0974 in/s
>100 Hz	22.3 Hz	>100 Hz
Jan 7, 2025	Jan 7, 2025	Jan 7, 2025
14:04:27	14:04:27	14:04:27
✓ Passed	✗ Check	✓ Passed
7.3 Hz	7.7 Hz	7.3 Hz
4.3	2068.8	4.5

Peak Vector Sum
0.0974 in/s at January 7, 2025 14:04:27
