DAILY FIELD REPORT

Project	Former A&A Brake Service Site	Report No.	96
BCP Site	NYSDEC BCP SITE C224372	Date	1/8/2025
Location	558 Sackett Street	File No.	0206384
Client	Sackett Heights LLC	Temperature	H: 30°F L: 24°F
Contractor	Blue Sky Builders, International Concrete, Worldwide Concrete Cutting	Wind Direction	NW to SE, up to 29 mph
Weather	Overcast	Personnel on Site	George Poulton, Annilese Stewart
Humidity	32%	Time on Site	6:30 am to 3:30 pm

WEEKLY MONITORING REPORT

Project Address:
558 Sackett Street,
Brooklyn,
Brooklyn NY 11215
BBL:/443/55

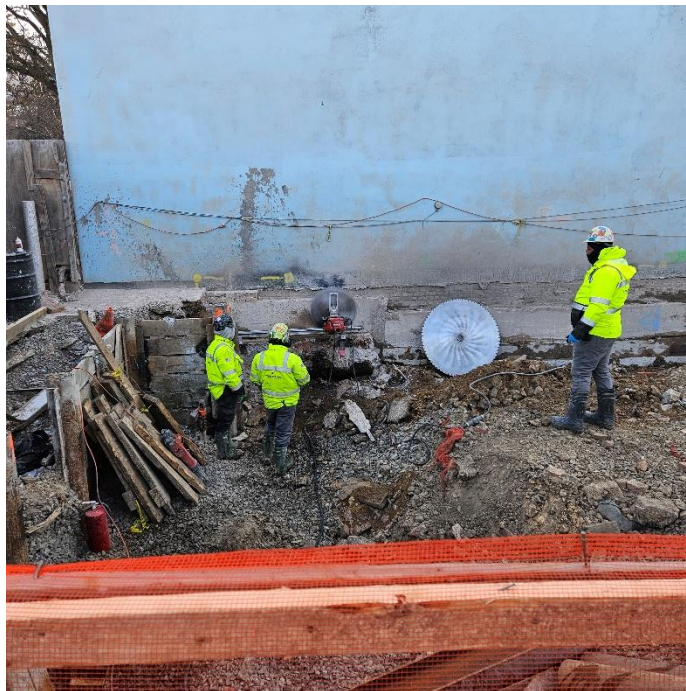
Photo 2: View of contractor saw cutting adjoining building footings, facing East.

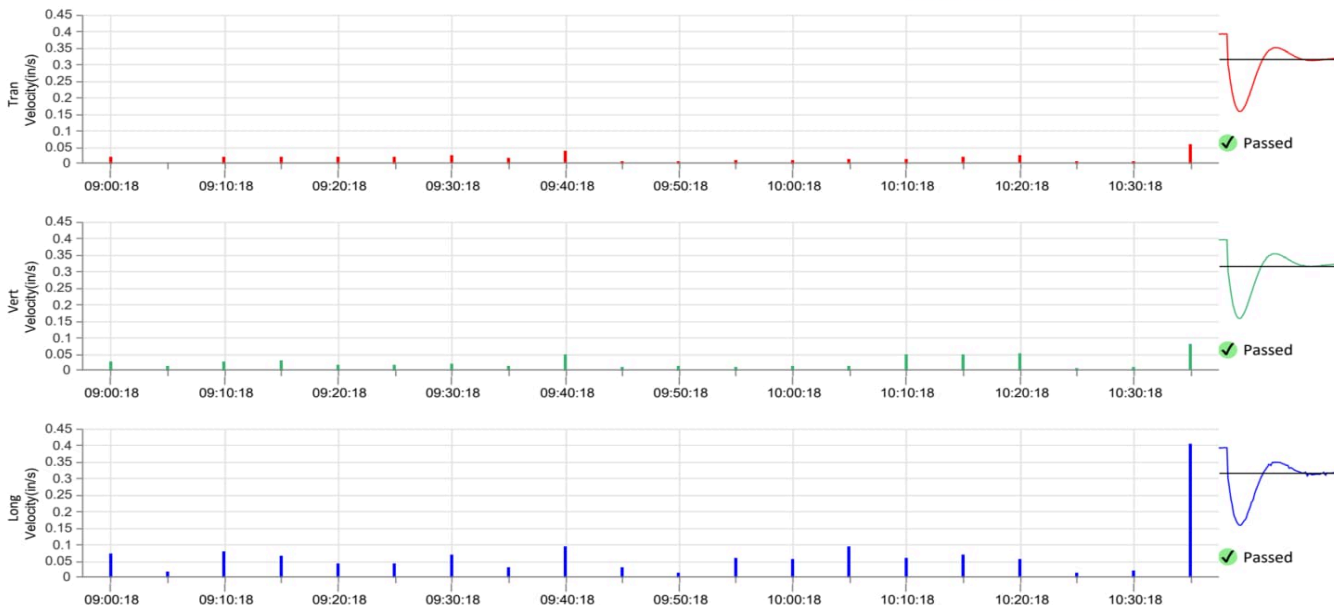
USBM R18507 And OSMRE
Velocity versus Frequency (Zero Crossing)

Peak Vector Sum 0.4109 in/s at January 8, 2025 10:35:18

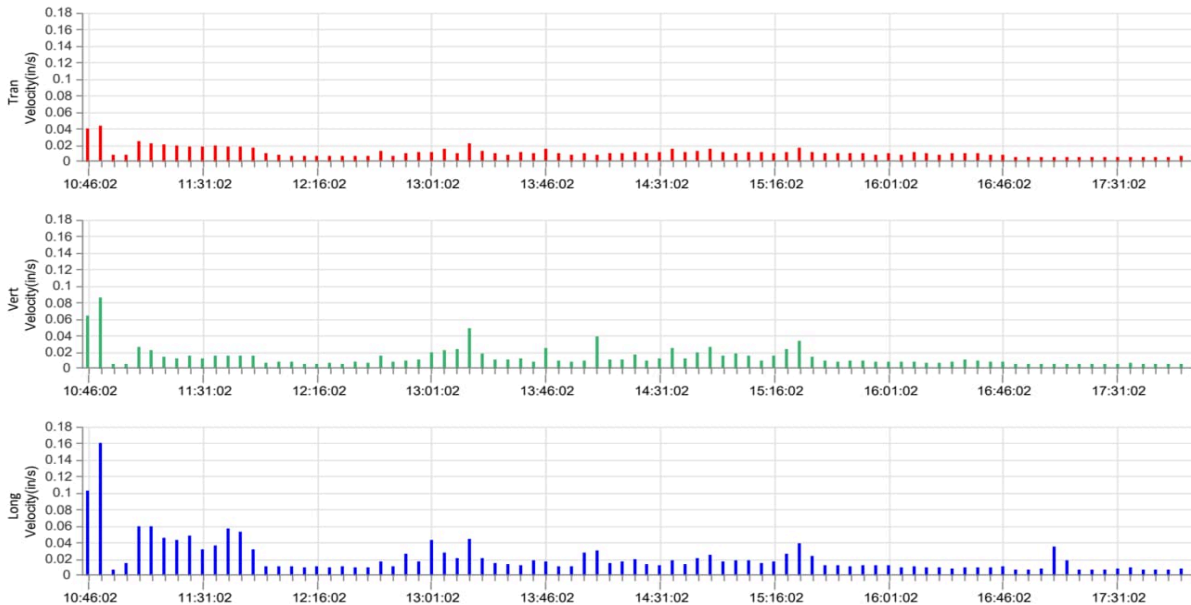
USBM R18507 And OSMRE
Velocity versus Frequency (Zero Crossing)

Peak Vector Sum 0.1626 in/s at January 8, 2025 10:51:02
