DAILY FIELD REPORT

Project	Former A&A Brake Service Site	Report No.	97
BCP Site	NYSDEC BCP SITE C224372	Date	1/9/2025
Location	558 Sackett Street	File No.	0206384
Client	Sackett Heights LLC	Temperature	H: 33°F L: 23°F
Contractor	Blue Sky Builders, International Concrete, Worldwide Concrete Cutting, A1 Waterproofing	Wind Direction	NW to SE, up to 20 mph
Weather	Sunny	Personnel on Site	Annilese Stewart
Humidity	53%	Time on Site	6:30 am to 3:30 pm

WEEKLY MONITORING REPORT

Weekly Monitoring
1/9/2025 - 1/9/2025

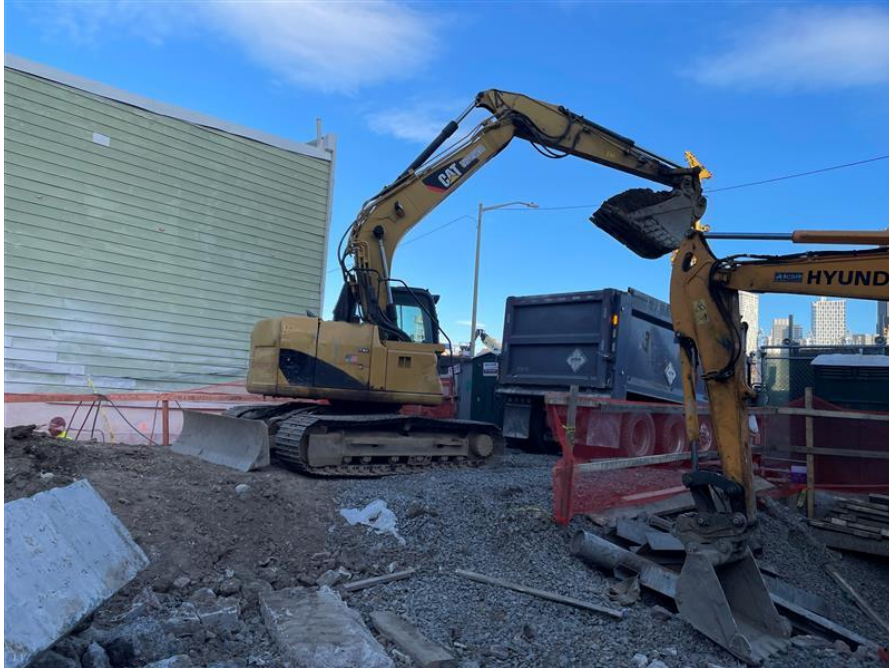
Photo 1: View of contractor loading soil for off-Site disposal, facing Northwest.

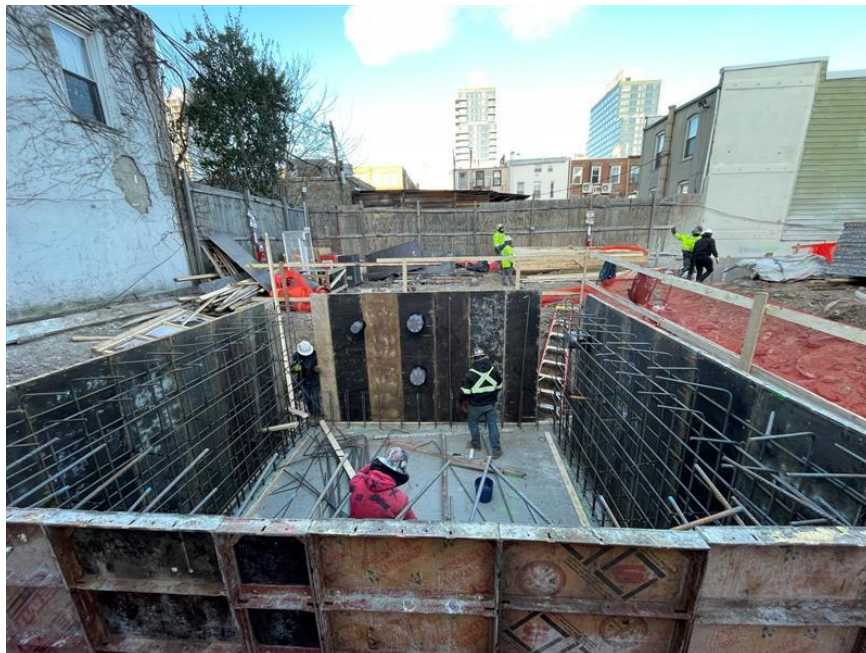
Photo 2: View of contractor installing foundation wall frames, facing West.
