# DAILY FIELD REPORT

| <b>Project</b> | Former A&A Brake Service Site | <b>Report No.</b> | 98 |
| <b>Location</b> | 558 Sackett Street | <b>File No.</b> | 0206384 |

## WEEKLY MONITORING REPORT

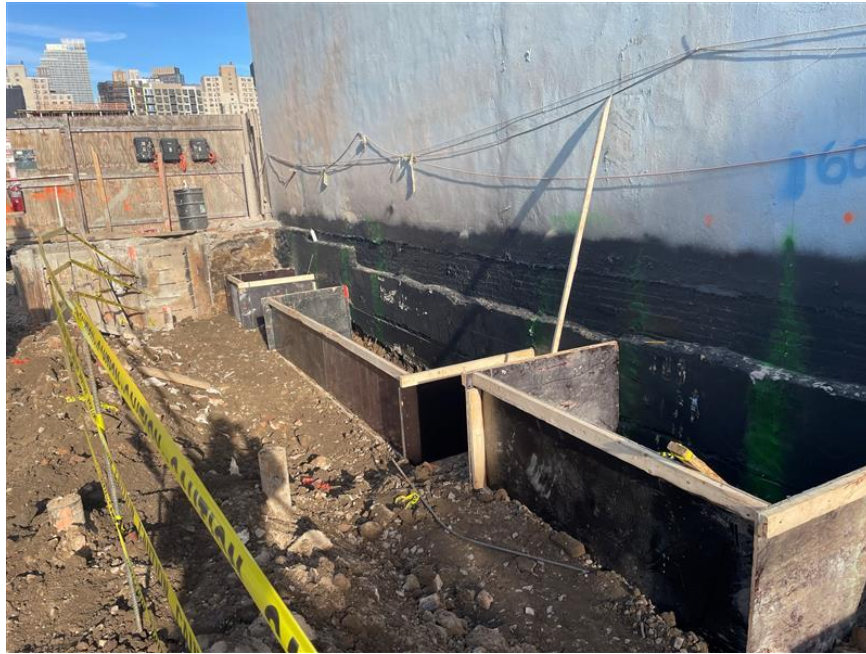
*Photo 1: View of prepped footing frames, facing Northeast.*

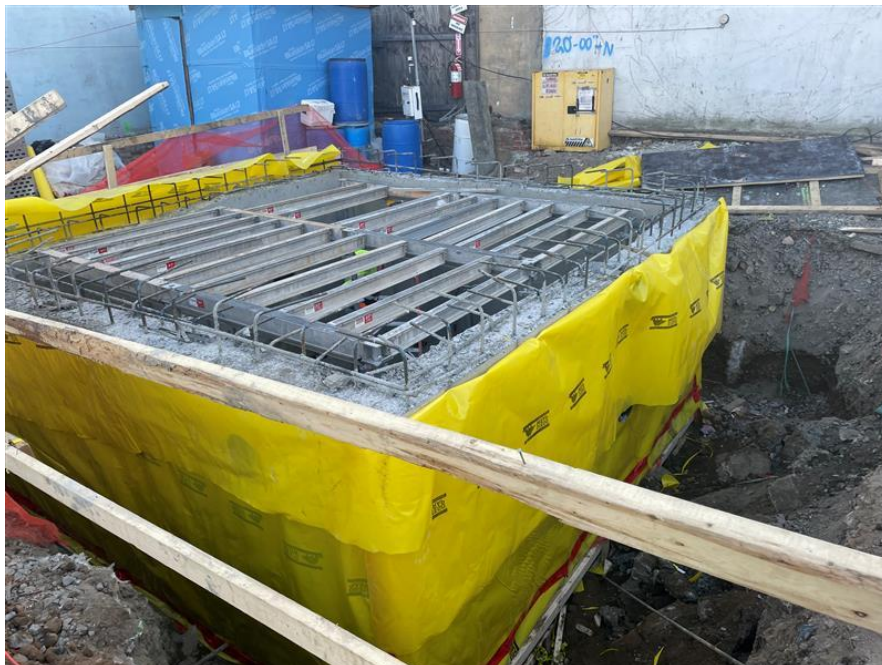
*Photo 2: View of contractor installing vapor barrier to the water tank, facing southeast.*

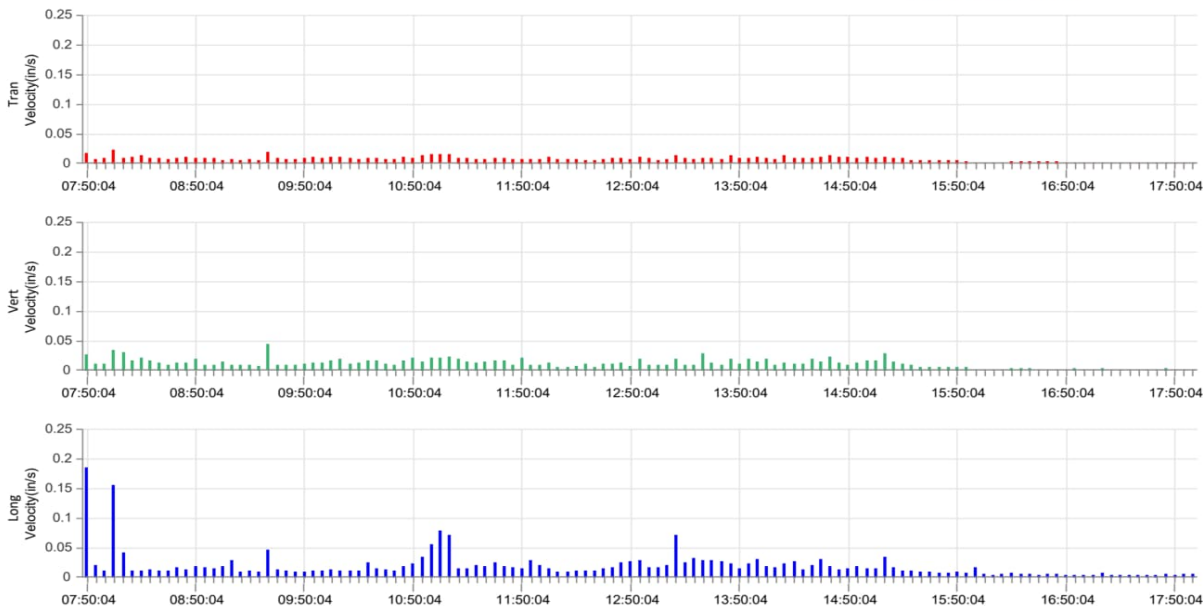
**USBM R18507 And OSMRE**  
Velocity versus Frequency (Zero Crossing)

Peak Vector Sum 0.1854 in/s at January 10, 2025 07:50:04

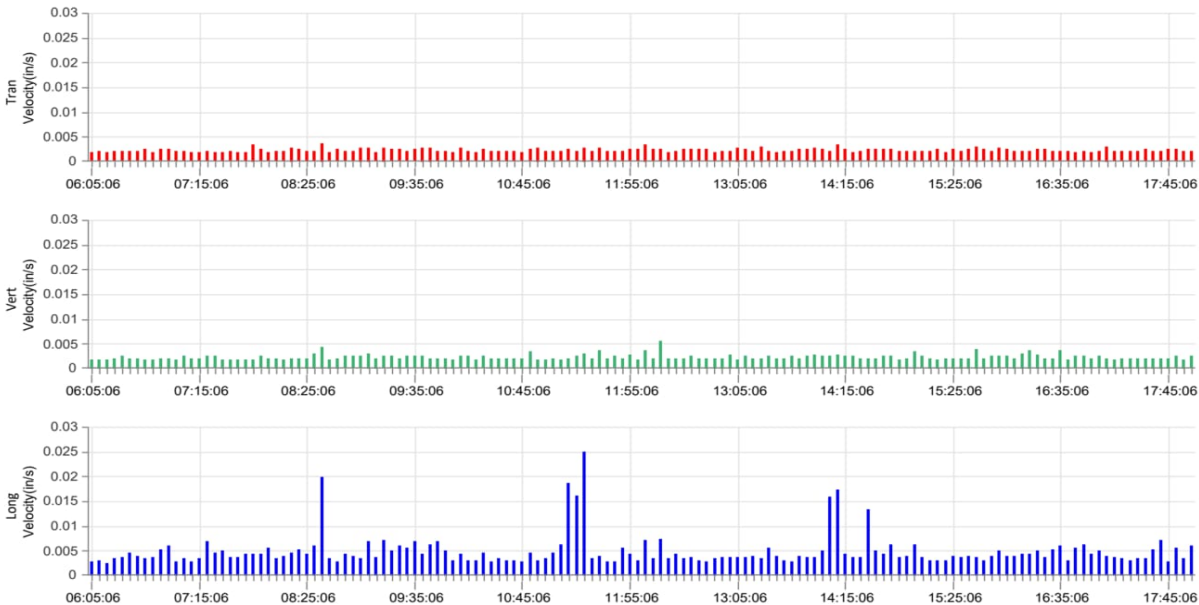
**USBM R18507 And OSMRE**  
Velocity versus Frequency (Zero Crossing)

Peak Vector Sum 0.0249 in/s at January 12, 2025 11:25:06

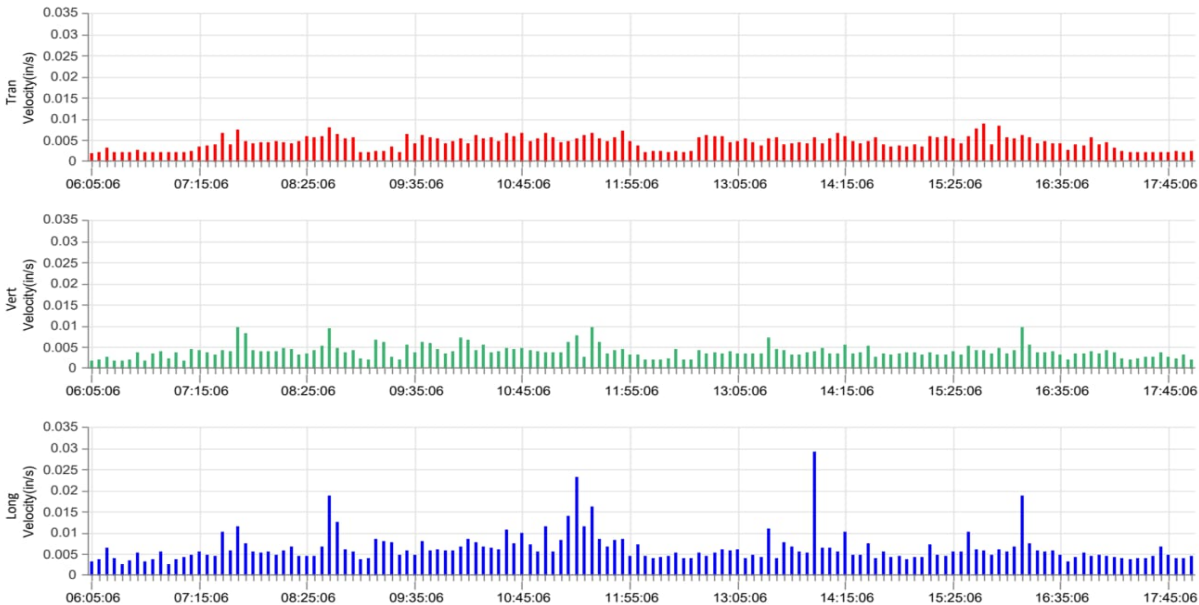
**USBM R18507 And OSMRE**  
Velocity versus Frequency (Zero Crossing)

Peak Vector Sum 0.0293 in/s at January 11, 2025 13:55:06

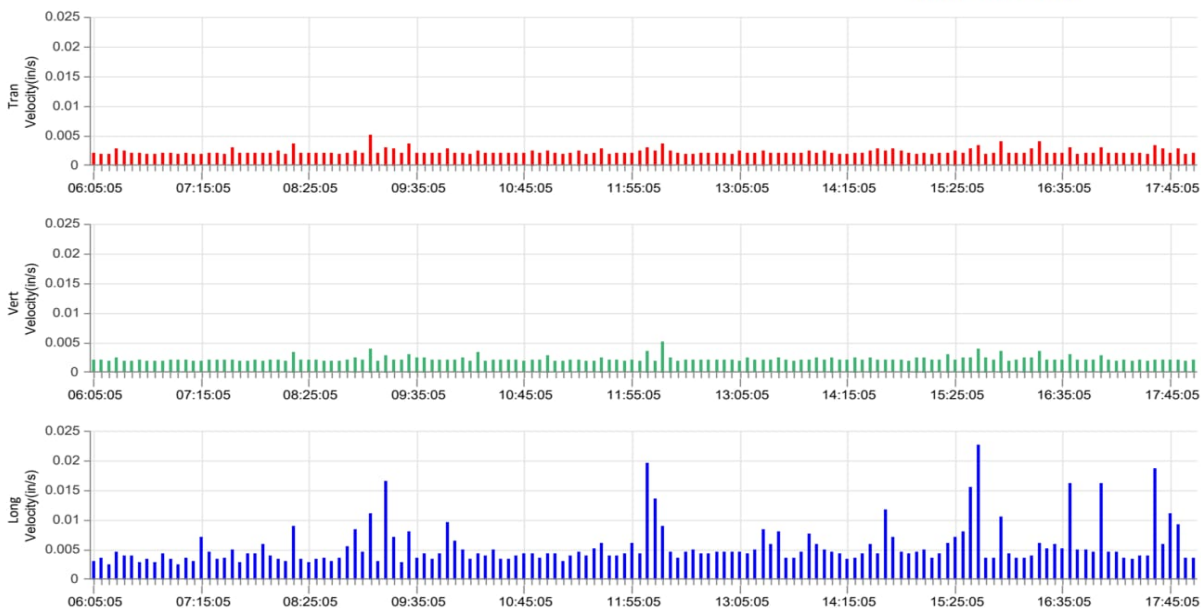
**USBM R18507 And OSMRE**  
Velocity versus Frequency (Zero Crossing)

Peak Vector Sum 0.0227 in/s at January 12, 2025 15:40:05

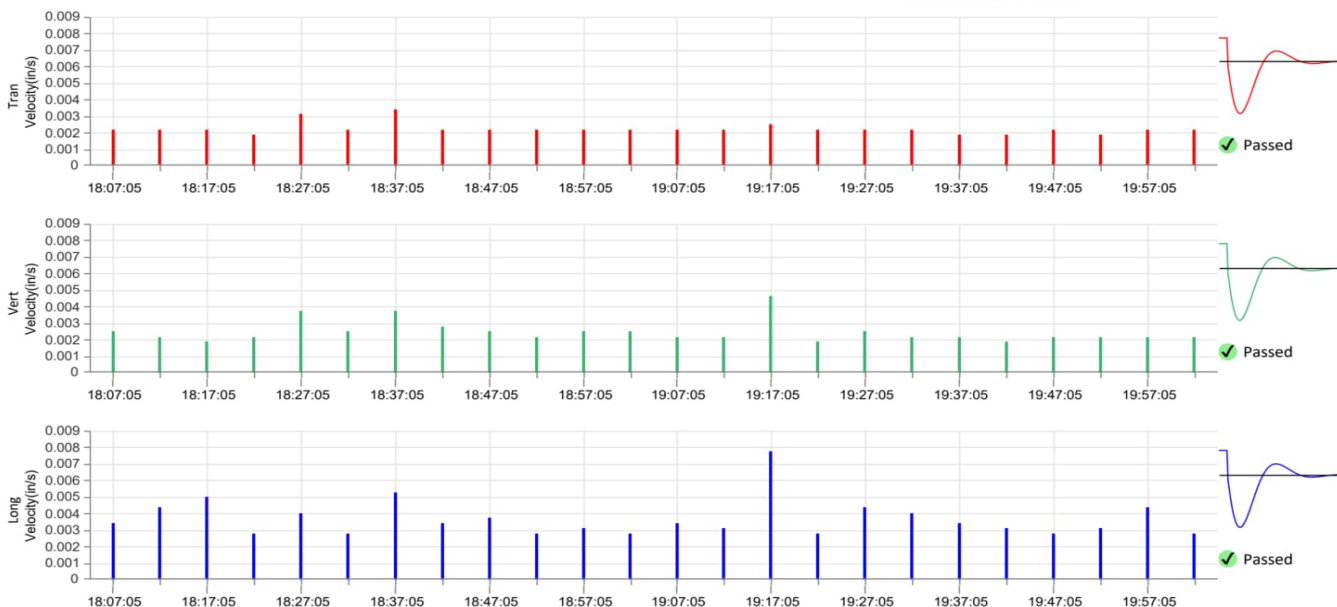
**USBM RI8507 And OSMRE**  
Velocity versus Frequency (Zero Crossing)

Peak Vector Sum 0.0079 in/s at January 10, 2025 19:17:05

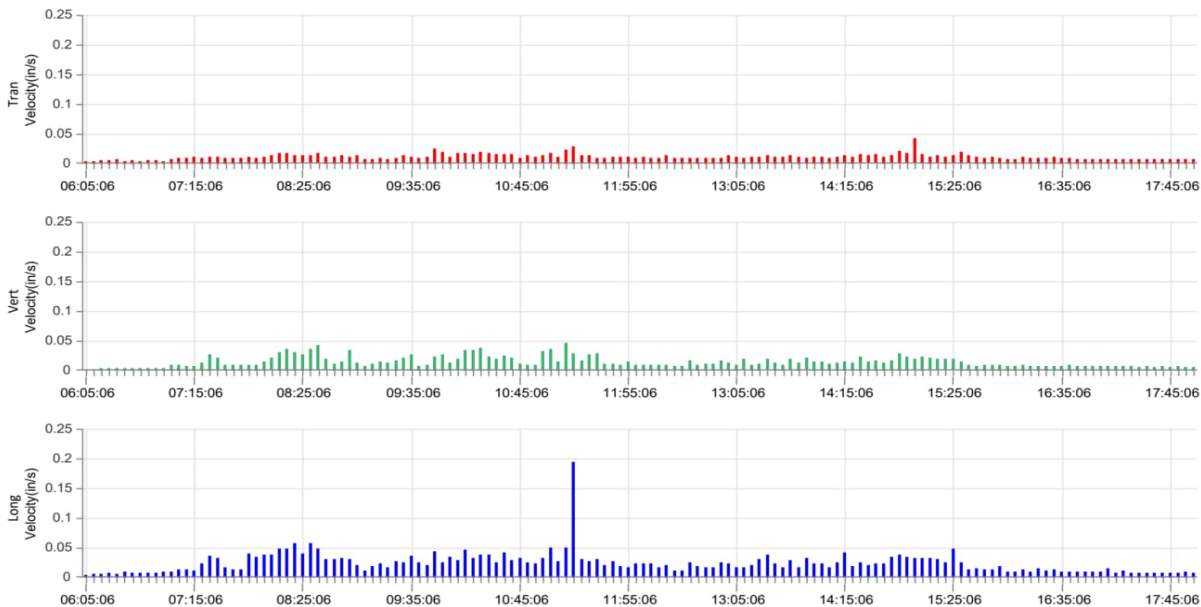
**USBM R18507 And OSMRE**  
Velocity versus Frequency (Zero Crossing)

Peak Vector Sum 0.1962 in/s at January 13, 2025 11:20:06
