DAILY FIELD REPORT

Project	Former A&A Brake Service Site	Report No.	100
BCP Site	NYSDEC BCP SITE C224372	Date	1/14/2025
Location	558 Sackett Street	File No.	0206384
Client	Sackett Heights LLC	Temperature	H: 36°F L: 24°F
Contractor	Blue Sky Builders, International Concrete	Wind Direction	NW to SE, up to 14 mph
Weather	Sunny	Personnel on Site	Annilese Stewart
Humidity	48%	Time on Site	6:30 am to 3:00 pm

WEEKLY MONITORING REPORT

Project Address:
558 Sackett Street,
Brooklyn,
Brooklyn NY 11215
BBL:/443/55

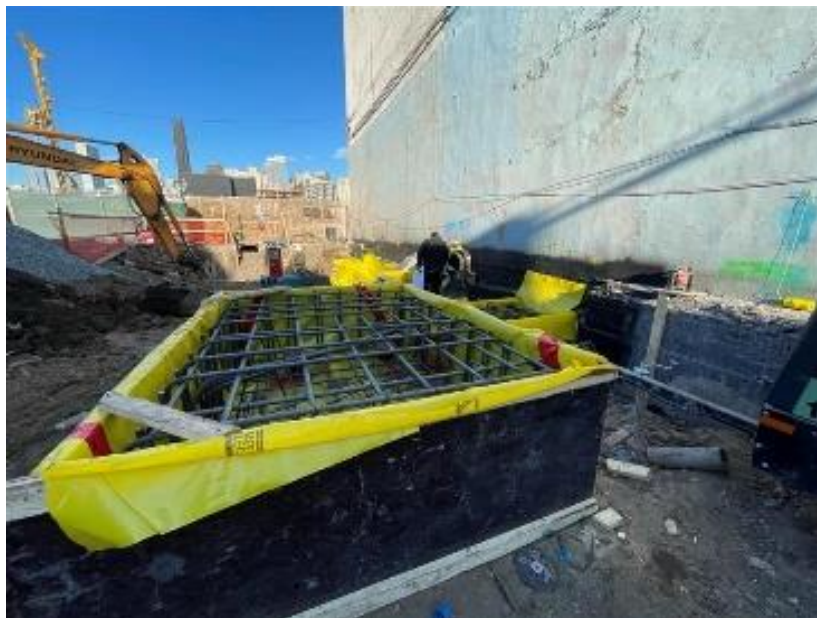
Photo 2: View of contractor installing rebar in footing frames, facing northeast.
