DAILY FIELD REPORT

Project	Former A&A Brake Service Site	Report No.	101
BCP Site	NYSDEC BCP SITE C224372	Date	1/15/2025
Location	558 Sackett Street	File No.	0206384
Client	Sackett Heights LLC	Temperature	H: 32°F L: 23°F
Contractor	Blue Sky Builders, International Concrete	Wind Direction	NW to SE, up to 12 mph
Weather	Cloudy	Personnel on Site	Annilese Stewart
Humidity	62%	Time on Site	6:30 am to 3:00 pm

WEEKLY MONITORING REPORT

Weekly Monitoring
1/15/2025 - 1/15/2025

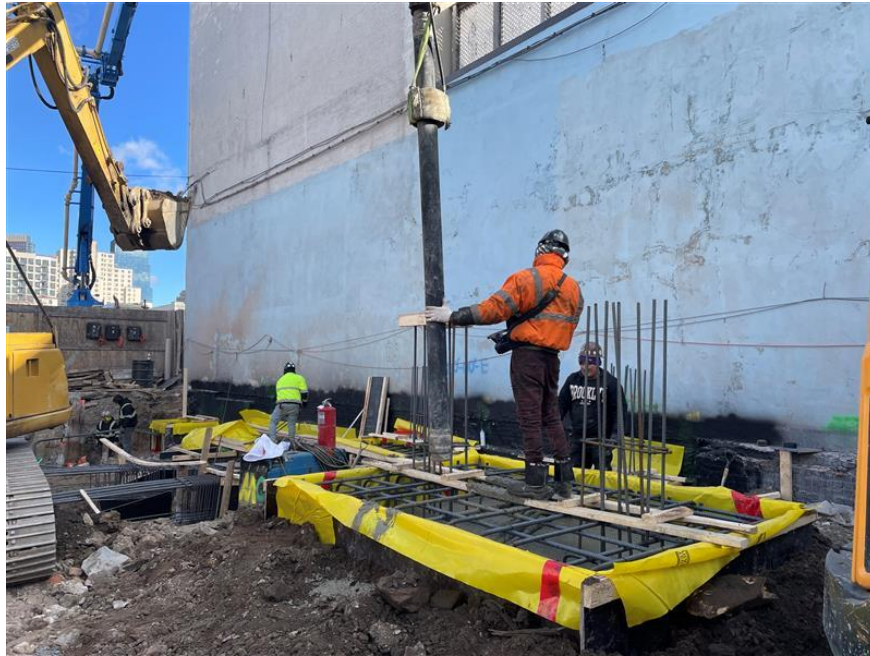
Photo 1: View of contractor pouring concrete into footing frames, facing Northeast.

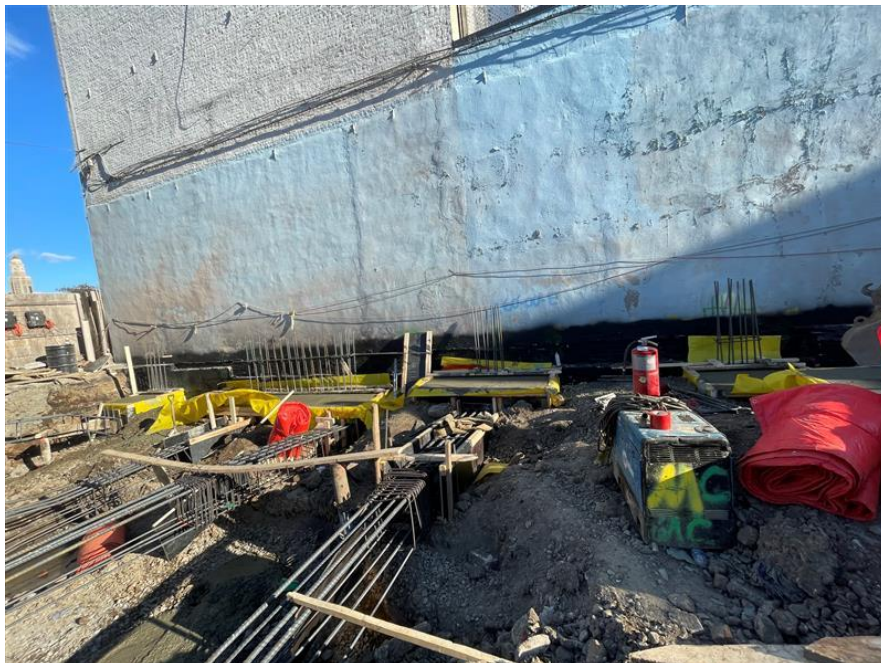
Photo 2: View of completed footing frames, facing East.
