# DAILY FIELD REPORT

<b>Project</b>	Former A&A Brake Service Site	<b>Report No.</b>	103
<b>BCP Site</b>	NYSDEC BCP SITE C224372	<b>Date</b>	1/17/2025
<b>Location</b>	558 Sackett Street	<b>File No.</b>	0206384
<b>Client</b>	Sackett Heights LLC	<b>Temperature</b>	H:43 °F L:27 °F
<b>Contractor</b>	Blue Sky Builders, International Concrete	<b>Wind Direction</b>	WSW to ENE, up to 4 mph
<b>Weather</b>	Sunny	<b>Personnel on Site</b>	Eddy Nunez
<b>Humidity</b>	60%	<b>Time on Site</b>	6:30 am to 10:00 am

## WEEKLY MONITORING REPORT

**Project Address:**  
558 Sackett Street, Brooklyn,  
Brooklyn NY 11215

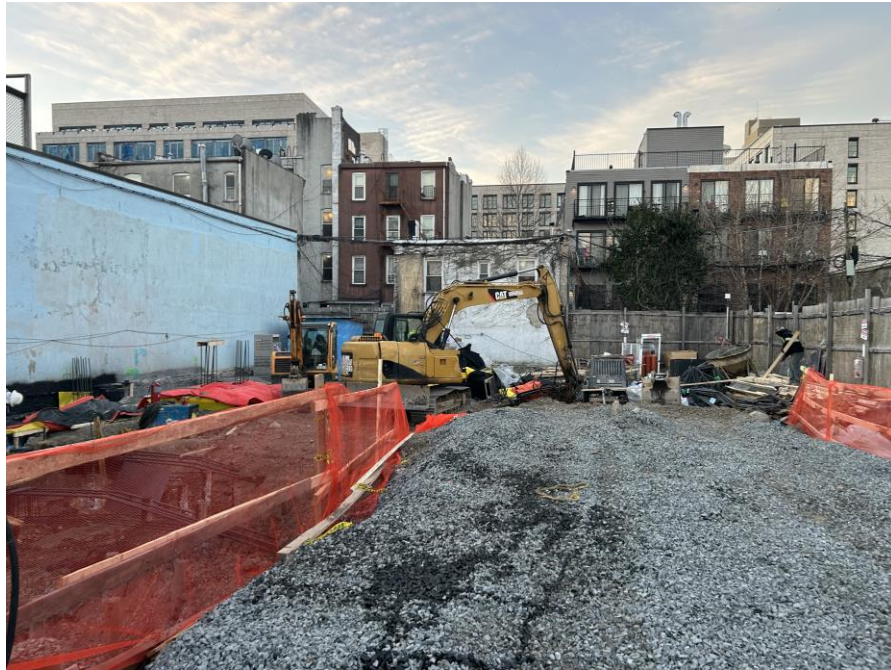
*Photo 1: Overview of site conditions, facing south.*

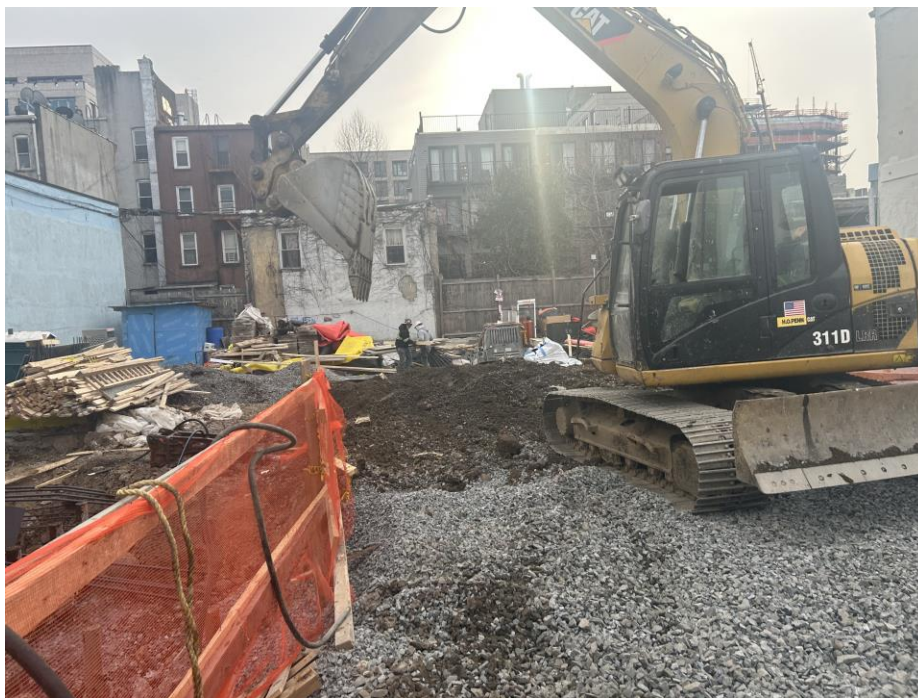
*Photo 2: View of excavation in preparation for soil export, facing south.*
